Rupture of a crude oil storage tank

October, 25th, 2005

Kallo – Belgium

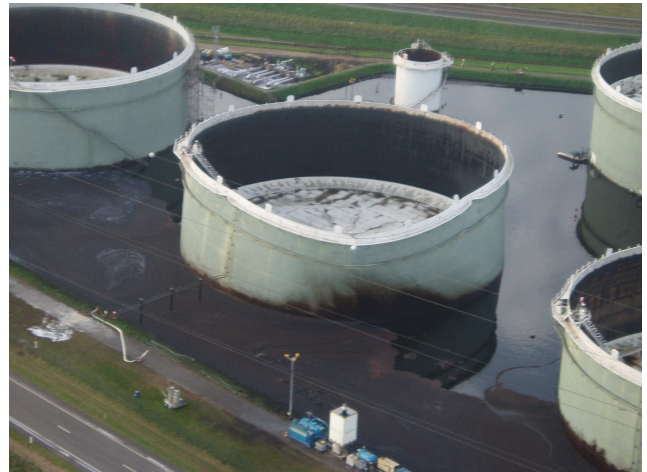
Because the content of the storage tank was released in such a short time, an enormous crude wave was created. This wave moved in the direction of the several meters high earth dike, which fortunately resisted against the power of the wave. The released crude oil filled the whole bund (40 000 m² large) with crude up to a height of 1 m.

Figure 1 shows a picture of the situation in the bund the morning after the major accident happened.

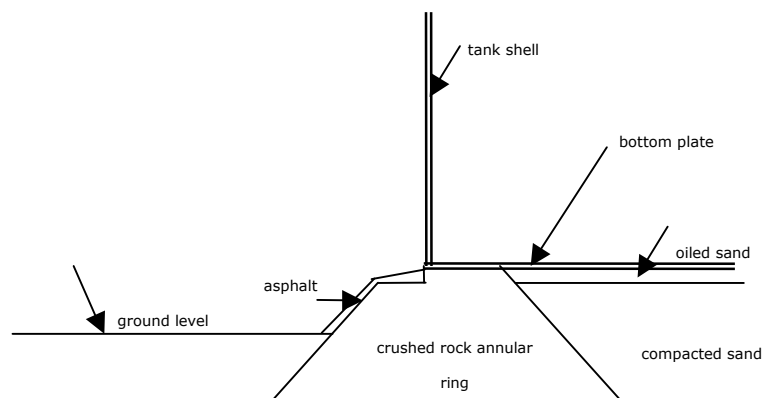
Figure 2: Schematic view of the tank foundation

The foundation of storage tank D2 consisted of a crushed rock annular ring. The rocks had a diameter between 50 mm and 150 mm. The crushed rock annular ring had a height of approximately 120 cm of which a part was below the ground level. The crushed rock ring had a width of approximately 340 cm at the bottom and 100 cm at the top. The shell was situated in the middle of the width of the crushed rock ring. The inner part of the annular ring was filled with compacted sand. Above this sand there was a layer of 5 cm consisting of oiled sand, to avoid external bottom corrosion. Figure 2 provides a schematic view of the foundation of storage tank D2.

As mentioned before, a gutter was situated in the tank bottom at a distance of 1,5 m from the tank wall. This is just beyond the annular plates on which the tank shell is welded. The first normal bottom plates after the annular plates were cracked during the accident. The gutter has been formed due to settlements in the tank foundation, which at that place consists of compacted sand. The gutter has probably been formed during the first hydrostatic tests on the storage tank. The moment a storage tank is loaded for the first time, the compacted sand settles. In the neighbourhood of the crushed rock annular ring, which consists of coarse rocks, it is difficult to compact the sand bed in an appropriate manner during construction. At the moment the storage tank is loaded for the first time, the sand in that area will be more compacted, but because of the existing holes in the crushed rock annular ring a part of the sand will disappear in the holes between the coarse rocks. Due to these phenomena a gutter is formed in the bottom plates nearby the crushed rock annular ring. Calculations based on a finite element method showed that based on the information about the foundation of the tank in combination with the underground under the tank foundation and the size of the storage tank, the forming of the gutter could be predicted.

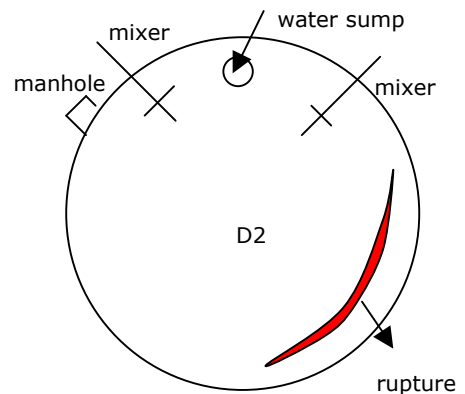
Figure 3: Schematic view of the bottom of storage tank

The investigation of tank D2 showed that the bottom plates in a long, small circular band at approximately 1,5 m from the shell of the storage tank were extremely weakened due to internal corrosion. In this band the thickness of the bottom plates was nearly reduced to zero. This band had a length of approximately 35 m and a width of approximately 20 cm.

In this band the bottom of the tank formed a gutter. In this gutter uniform, internal corrosion was found and no pitting corrosion.

During the exploitation of storage tank D2 a gutter was formed in the bottom of the tank. This gutter is situated at a distance of 1,5 m from the tank shell. Due to the formation of the gutter the present water could not longer flow to the drain water system to be removed. The accumulation of stagnant water in the gutter caused strong corrosion which strongly reduced the thickness of the bottom plates in that area.

In the gutter in the bottom of the tank, the present water could not longer flow towards the water sump. This situation of stagnant water in the gutter enabled very fast corrosion in the gutter with the rupture of the tank bottom as the major consequence.

Before start-up all crude oil storage tanks shall be coated with a lining to stop the internal corrosion of the bottom plates.

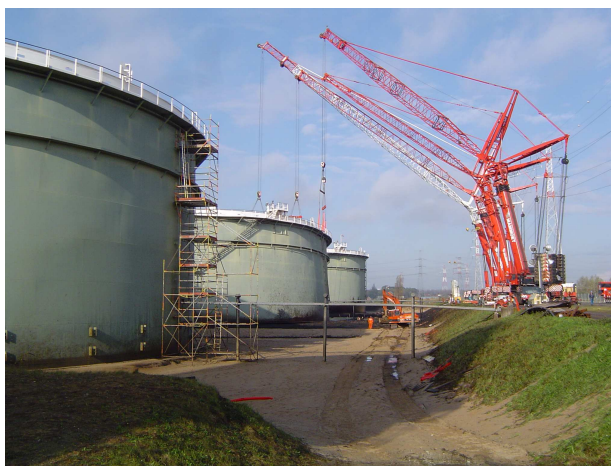
Figure 4: Major cranes stabilising tank D2

After the release the storage tank was leaning forward and a part of the foundation of the storage tank had disappeared.

The stability of all storage tanks was periodically measured. The stability of storage tank D2 on the place where the foundation was blown away, was achieved by hanging the storage tank on 4 large cranes (figure 4).
