Explosion of a cereal silo

August 20, 1997

Blaye – [Gironde]

Explosion
Food handling facility
Port silo
Cereal
Explosive atmosphere
Dust removal circuit
Casualties

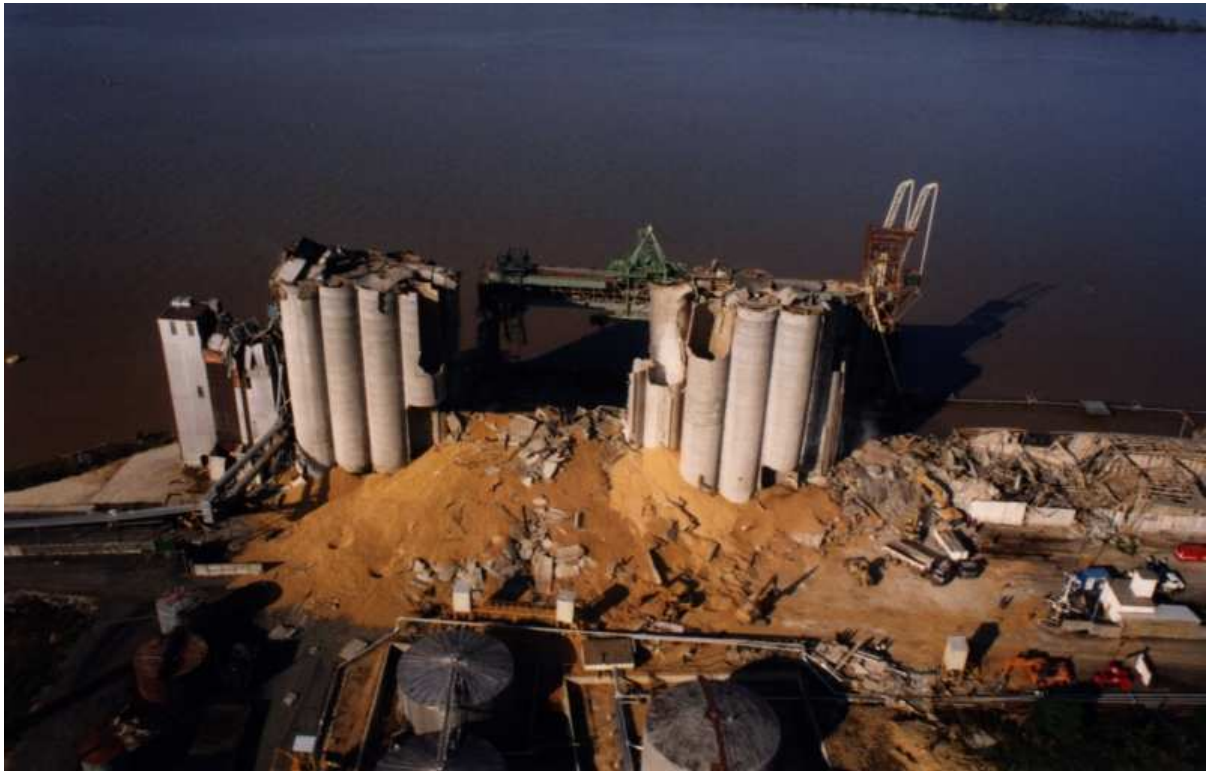
The vertical silo collapsed over its central and northern parts, with the northern part effectively burying the installation offices. Only 16 of the 44 cells were still for the most part intact after the accident, 9 on the south side and 7 on the north. One characteristic of this disaster was the collapse of two sets of cells: the first on the northern end, which had abutted the material handling tower; and then the central section of the silo (see photo).

The northern handling tower, as well as the immediately adjacent cells, were almost entirely destroyed. Over roughly half of its initial height, just a curved half-shell of this tower was still standing, as the tower's sides that had formed the walls of adjacent hoppers were slammed backwards, onto the shaft of a neighbouring cell. This observation indicates the presence of an explosion within the handling tower, which would have occurred after the eventual explosions taking place inside the adjacent storage units.

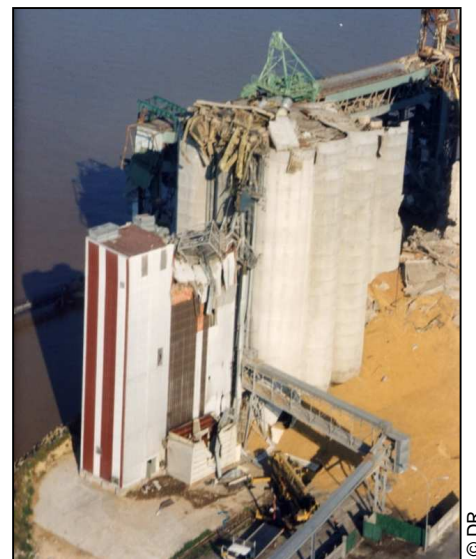
Southern silo zone

The southern tower slumped onto the tops of cells. Components of the cleaners-separators (rubber balls from the sieves) found calcinated at the surface reveal the passage of fire or expansion of burnt gases in this tower.

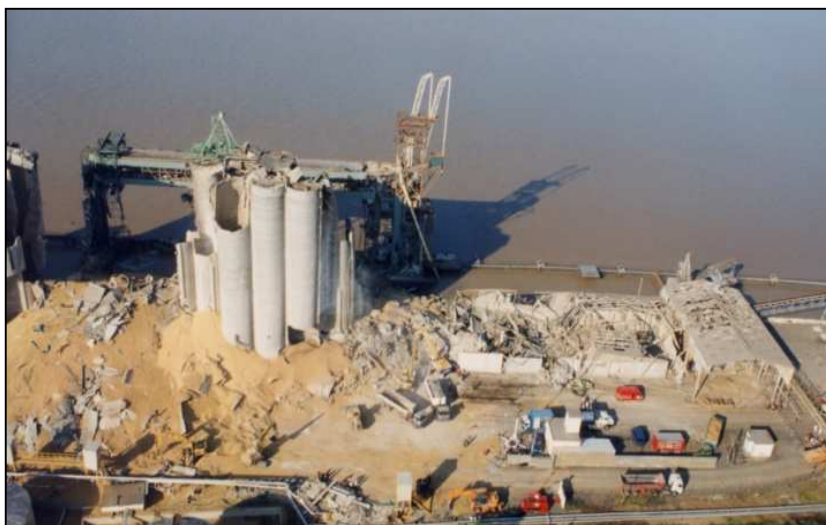
Northern silo zone

The elevators located inside the handling tower sustained heavy damage; the observations that could be recorded indicate that the drive pulleys showed no traces of slipping, as the axles of these elevators did not seem blocked in their main bearings, and the scraps of metal duct found had neither swollen nor burst; moreover, the pieces of bucket straps recovered showed no signs of combustion. The elevators located in the southern part of the silo were rather damaged by the collapse of surrounding concrete structures; no trace of combustion could be identified on these facilities other

than a mark roughly a meter long on the external part of an elevator duct. The reclaim conveyors in the under-cell space were damaged by collapse of the storage units. A good number of upper covers on cases housing these conveyors were blown off. In the northern part of the silo, a conveyor displayed unmistakable signs of friction at the head (leading part) and many blades on the conveyor chain were missing.

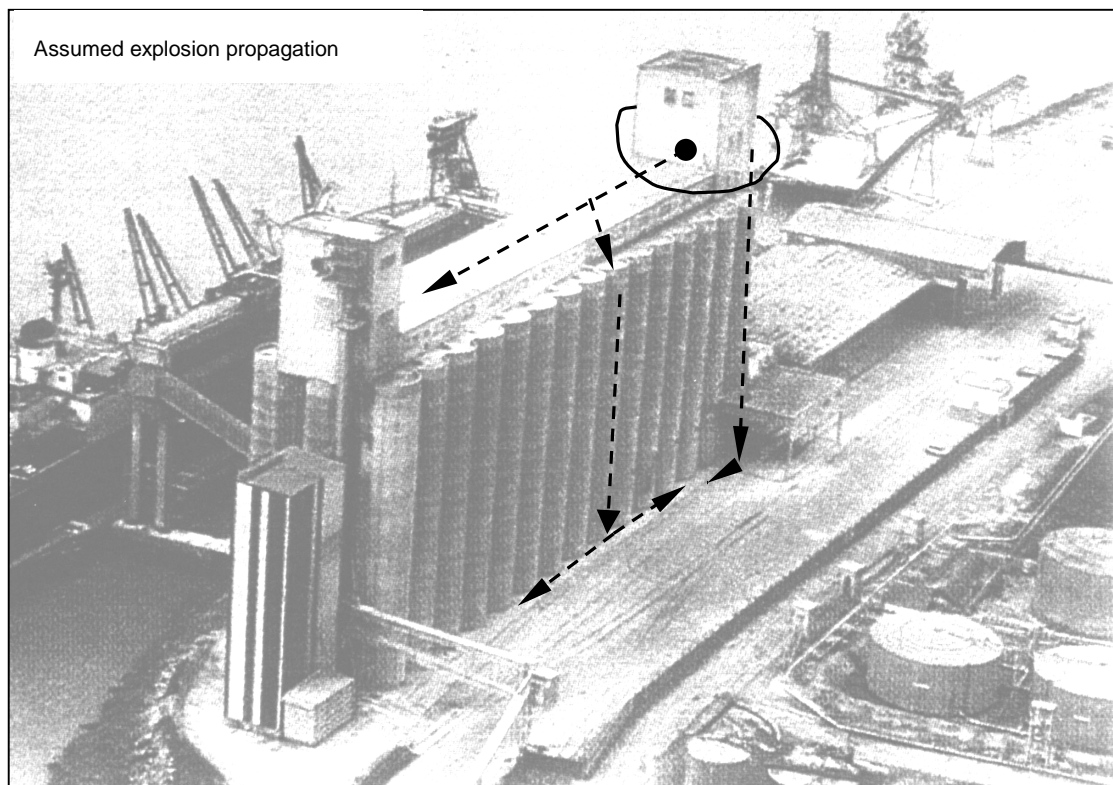
The first-hand accounts collected served to determine that the explosion originated in the northern handling tower before propagating into the over-cell gallery and was able to reach the southern end of this gallery, as evidenced either by a return of dust into suspension or a dusty atmosphere, or a combination of both.

The flames from this explosion, most likely in the form of a flame burst, wound up entering two, or even three, of the open storage units.

The burst of flames penetrating the storage units, which contained airborne dust as a result of silo loading operations, then caused a violent explosion. The geometry of these storage units, in particular their elongated shape, no doubt contributed to enhancing the pressure effects. This remark would apply especially to the hopper that could have contained the corn. Given that the height-to-hydraulic diameter ratio was in the vicinity of 10, it is altogether possible that this condition, in combination with the reactivity of corn, accounted for a considerable share of the damage recorded in the central part of the silo.

The photo below shows a schematic depiction of the supposed explosion path. Overall, the explosion phenomenon could have lasted several seconds.
