Gas oven explosion

April, 1st, 2003

Geleen

THE INSTALLATIONS IN QUESTION

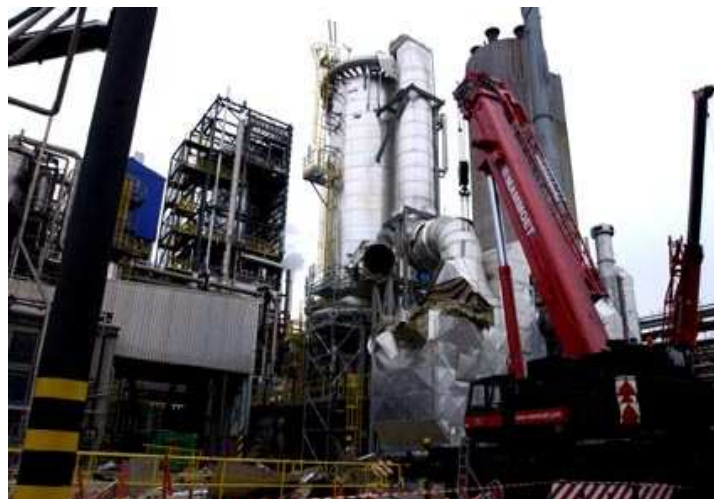
On restarting the oven filled with a combustible mixture of gas and air, which was *probably ignited by an errant spark from a ventilator started by an operator.*

The explosion caused the lid of the oven, on which a maintenance crew was working, to be blown off. The lid fell down in the oven, together with the crew who were standing on it.

At *the moment of the accident* three people carried out maintenance work on top of the lid of the oven. The temperature in the oven was still 350°C and all three were killed tragically.
