Explosion of a fireworks storage

14 February 1991

Culemborg

The Netherlands

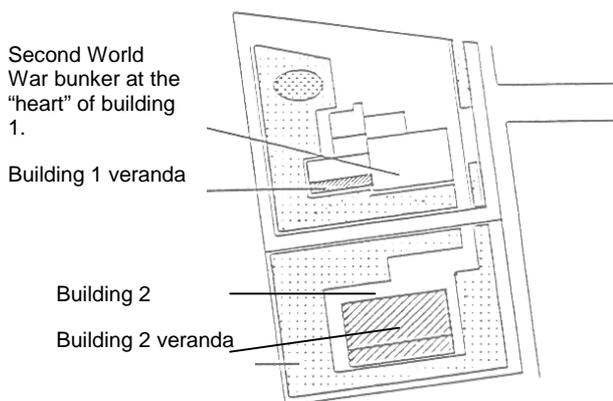
The first building (building 1) comprised a bunker that dated back to the Second World War, 5 small storage rooms and one 25x16 m meeting room.

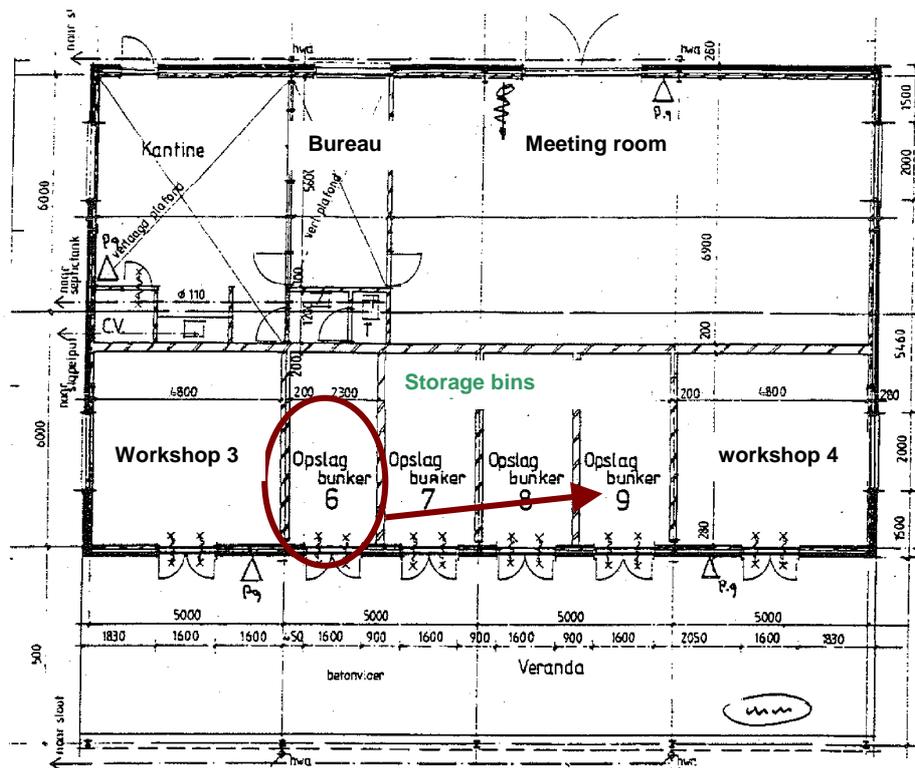
Given the quantities involved in the explosion and their impact, all fireworks stored in the new building exploded in mass. Such an explosion was not planned for fireworks under the 1.3 risk category. The safety distances between the buildings and the outside was moreover calculated taking into account a significant thermal risk and not a blast effect. These distances were not large enough to counter the effects of a mass explosion.

The analysis of craters and fissures in the concrete slabs revealed that the explosion probably occurred in the warehouse of room 6 and was immediately followed by another explosion in rooms 7, 8 and 9.

Plan of the «new building » levelled by the explosion. It most likely started in bin 6 and spread on to the other bins.
