# Explosions followed by fire outbreak at an oil storage depot

11 December, 2005

## Buncefield – United Kingdom

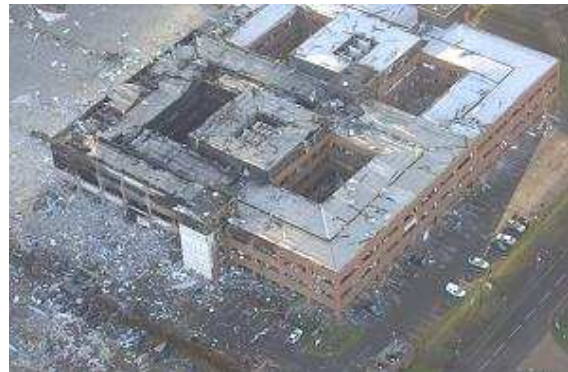
*Photograph 1: Devastated building at the terminal site*

The blast from the explosion caused **sizable damage within a 800-m radius**: shattered windows, doors broken, the warehouse wall completely destroyed, the roof on a neighbouring house blown off, etc. Cars parked nearby were burned.

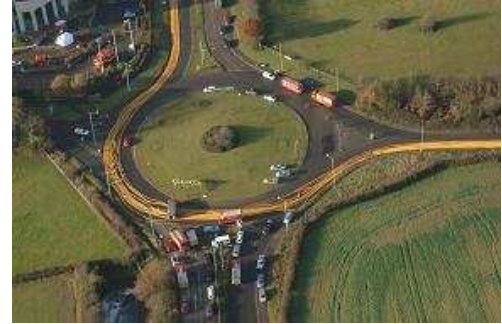
*Photograph 2: Pipes supplying water to emergency teams*

Emergency units had to cope with several difficulties during their mission. First of all, fire fighting equipment had been destroyed by the explosions. The site's water supply reserves could not be used due to destruction of the pumping station located north of retention zone A (see Diagram 1), which had enabled managing onsite water flows. The northern lagoon (fire extinction water supply) had also incurred serious damage. No onsite means of extinction could be employed by fire-fighters on this sector of the terminal. Moreover, the site was covered by a mix of extinction water and fuels flowing out from tanks, thereby hindering access to the various installations.

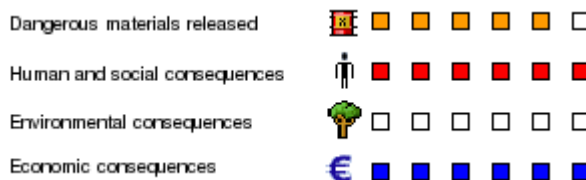
The index relative to quantities of hazardous substances equals 5 since approximately a third of the 35,000 m<sup>3</sup> of hydrocarbons stored onsite at the time of the accident escaped or were destroyed in the fire (parameter Q1). Parameter Q2 relative to the quantity of substances that actually contributed to the explosion in TNT equivalences has been rated at a level 3 given that major damage could be observed at distances of up to 800 m.

The index relative to human and social consequences is evaluated at 6 since 4,000 people were forced out of work as a result of damage caused by the explosion on buildings belonging to some 80 companies. The 2,000 nearby residents evacuated from their homes for a half-day yields a level 5 for the H7 parameter and the 43 injured victims reflect a level 4 for the H4 parameter.

The index relative to economic impacts also equals 6, given that the total cost incurred due to the accident should, in all likelihood, wind up topping the 750 million euros.

Since the environmental impacts were not precisely known (i.e. pollution of the water, air and soils), the corresponding index value cannot be determined.

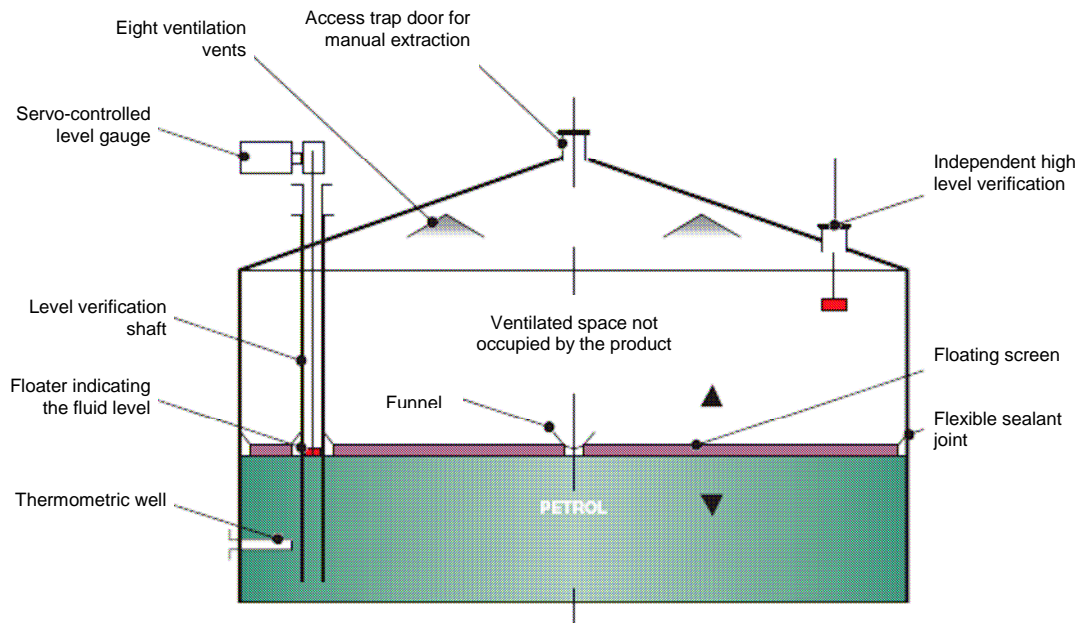
Diagram 2: Control instrumentation present on Tank 912

The tank had moreover been equipped with an **independent, "high level" control system** with both a visual and sound alarm that at the same time closes the pertinent set of valves on the piping network. An alert is sent to the instrumentation consoles and computer monitoring system of the carrier, who must then also proceed with closing the client's distribution valve.

Moreover, a control room switch allows cancelling the transmitted signal sent to the fuel supplier during the "high level" test periods. When placed in the active mode, a red indicator lights up on the control panel.

Neither of the two automatic level detection systems within the tank, as detailed above, was operable, and the gasoline supply into Tank 912 was not shut off. An expert evaluation was conducted to determine the reasons for malfunction of the automatic control and tank gauging systems. Following tank overflow, an explosive cloud formed and then spread over the site.

The information stemming from the gasoline distribution control system indicates that no high-level alarm from the first company's western site had been received. It was not possible however to test the high-level control gauge nor even verify the state of cables between Tank 912 and the substation, due to the extent of damage sustained. The high-level gauge could be located and assessed.

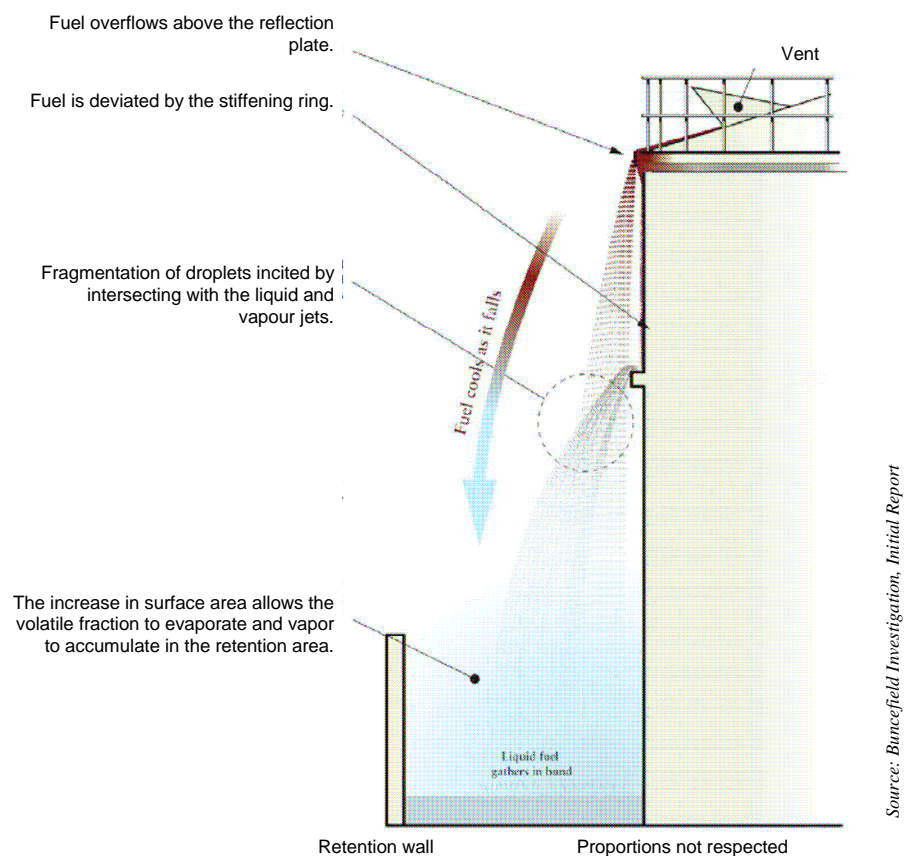
Diagram 3: Tank 912 overflow phenomenon

The first and most violent explosion occurred at the level of the Fuji and Northgate parking lots, completely devastating this part of the site. By spreading over this uncluttered zone, the necessary explosive conditions (i.e. a concentration lying between the lower explosive limit - LEL - and the upper explosive limit - UEL) were in fact attained. Gasoline vaporization was facilitated by 2 factors:

- Initially, yet to a more minor extent, product flow deviation by means of a tank stiffening ring (see Diagram 3).
- But more importantly, the high concentration of non-stabilized butane (10%) in this type of "winter" fuel incited both a high amount of gas evaporation even at relatively low temperatures (high vapour pressure: 70 - 100 kPa) and the formation of a butane cloud (estimated at several tons, given the quantity of gasoline that poured out).
