FIREWORKS ACCIDENT ANALYSIS

I Accident statistics at a glance	3
II Production	5
III Storage	6
IV Transport	7
V Destruction	8
VI Use by consumers	9
General recommendations	10
Bibliography	11
Selection of French accidents quoted in the text	12

The present summary relies on an analysis of 316 accidents (102 in France, 214 elsewhere), as extracted from the ARIA¹ accident database and primarily involving classified facilities or potentially classified sites, in addition to a few selected cases, whose lessons are easily transposable (e.g. accidents involving black powder). In light of the available data and specificities of some of the events related to the fireworks themselves (e.g. accidents during use by the general public) but not necessarily input into the database, this summary is not intended to provide statistical analyses, but instead the basis for drawing lessons on risks inherent in these products during manufacturing, storage, use and disposal.

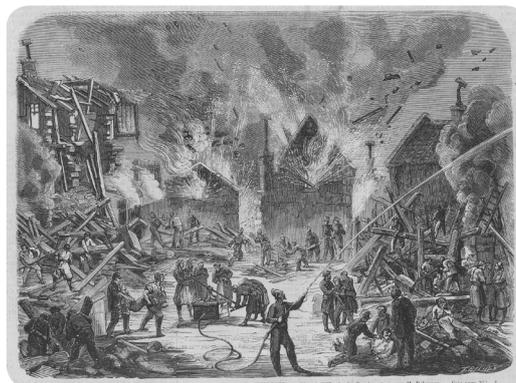
Explosion and fire at a Paris fireworks factory in 1866
ARIA 39303 - Source : MEDDTL / C.S. (R.R.)

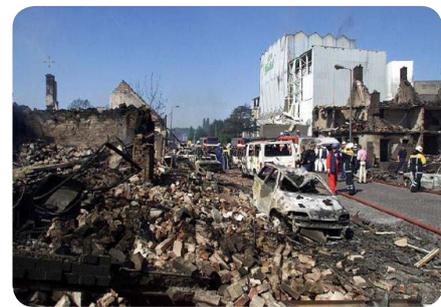
Destroyed neighbourhood in Enschede
ARIA 17730 ([11] R.R.)

An investigation was conducted, but the cause of the accident could not be determined (malicious act? handling error? short-circuit? self-ignition?). Neither the structures nor containers appeared to offer sufficient protections relative to the fire and explosion risk; moreover, they were not or inadequately equipped with fire detection and extinction resources. Their layout did not respect regulatory distances. The risk classifications among stored products had most likely been underestimated or the products poorly classified (fireworks imported from China). [...] (ARIA 17730 [11])

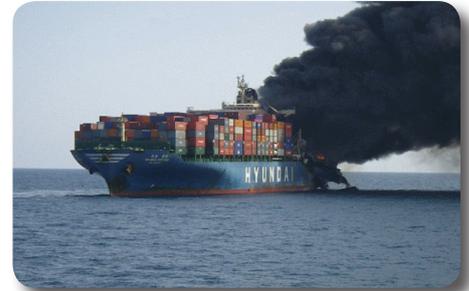
ARIA 36593 - Fire aboard a container ship
 Note: Though the transported fireworks did react, they were not the cause of fire outbreak (non-declared chemical products).
