WHEN NATURAL AND TECHNOLOGICAL
HAZARDS COLLIDE

**OVERVIEW OF THE INDUSTRIAL ACCIDENTS
CAUSED BY THE GREAT TOHOKU
EARTHQUAKE AND TSUNAMI**

JAPAN, MARCH 11th, 2011

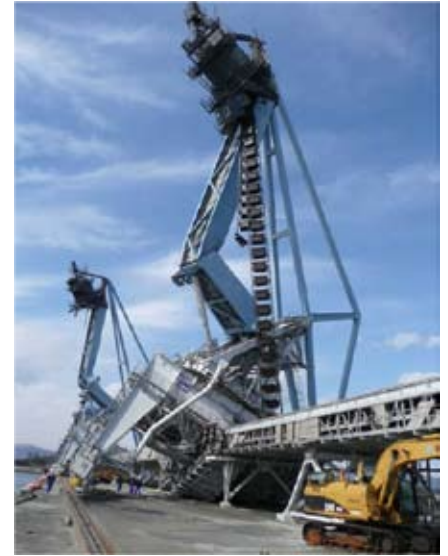
Crane of the Port coal conveyor damaged by the tsunami at the Sinchi-Soma plant
(Source : MLIT)

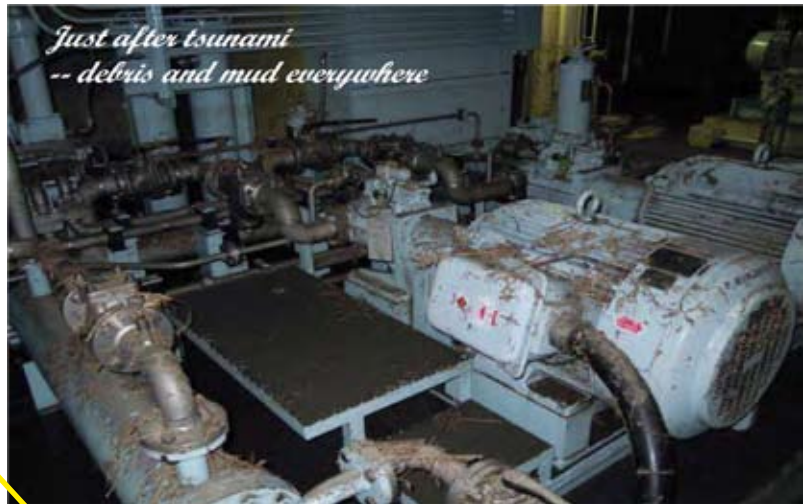
Ground floor of the turbine building in the Iwaki plant, April 2011 - Nakoso (Source: Clean Coal Power R&D)

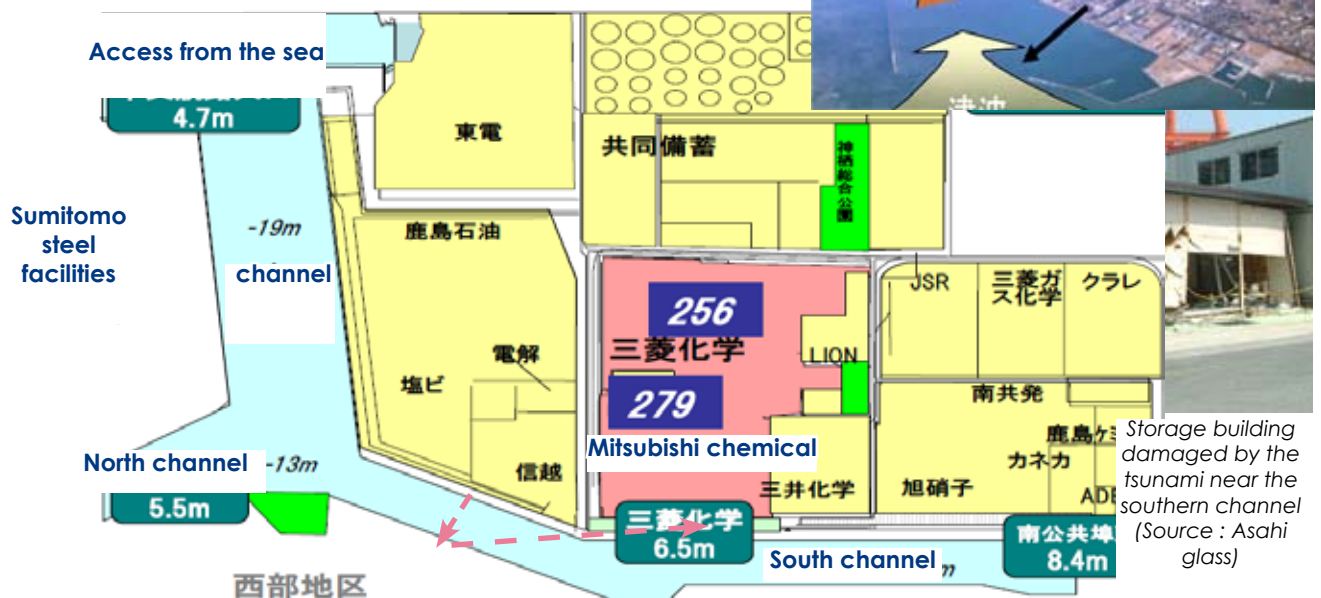
The complex is located in the artificial port of Kashima, which was excavated from former farmland and is thus particularly vulnerable to tsunami. The tsunami of March 11th was constrained by the main channel and amplified in the shallower side channels. The sandy soil is another factor that led to extensive damage from liquefaction during the quake (Source : METI)

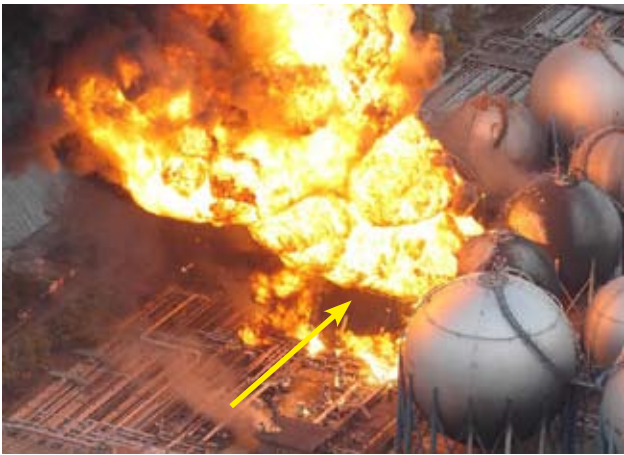
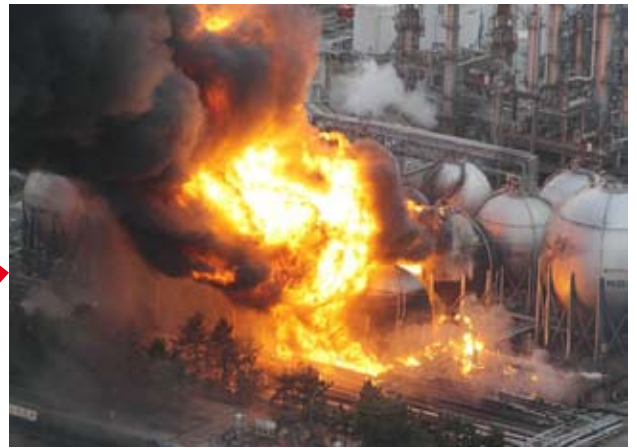
Progression of the damage caused in the afternoon of March 11th and the night of March 11-12th (Source : Cosmo oil)

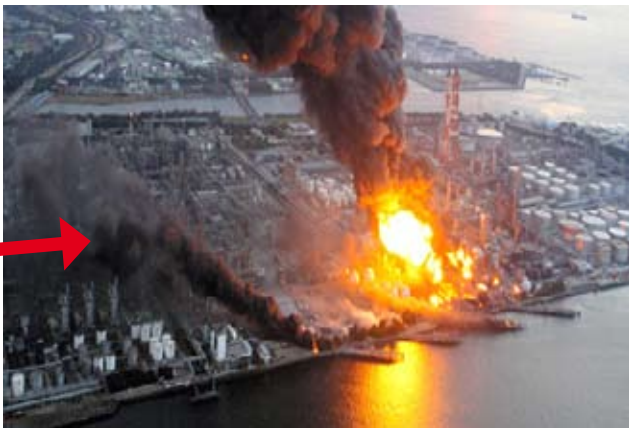
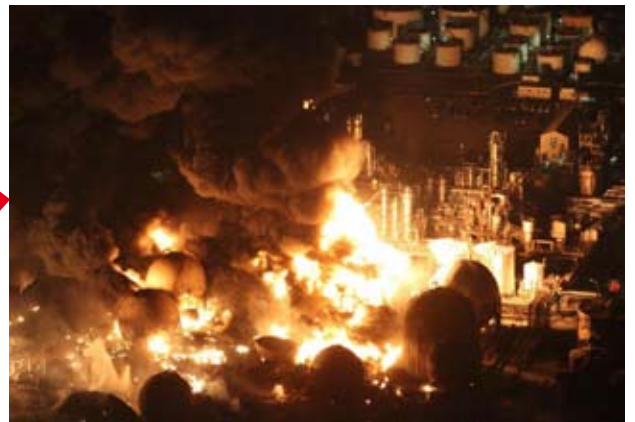
View of a BLEVE from the opposite side of Tokyo Bay (estimated diameter of the largest BLEVE: 600 m). Below: piece of a sphere. (Source : NRFID)

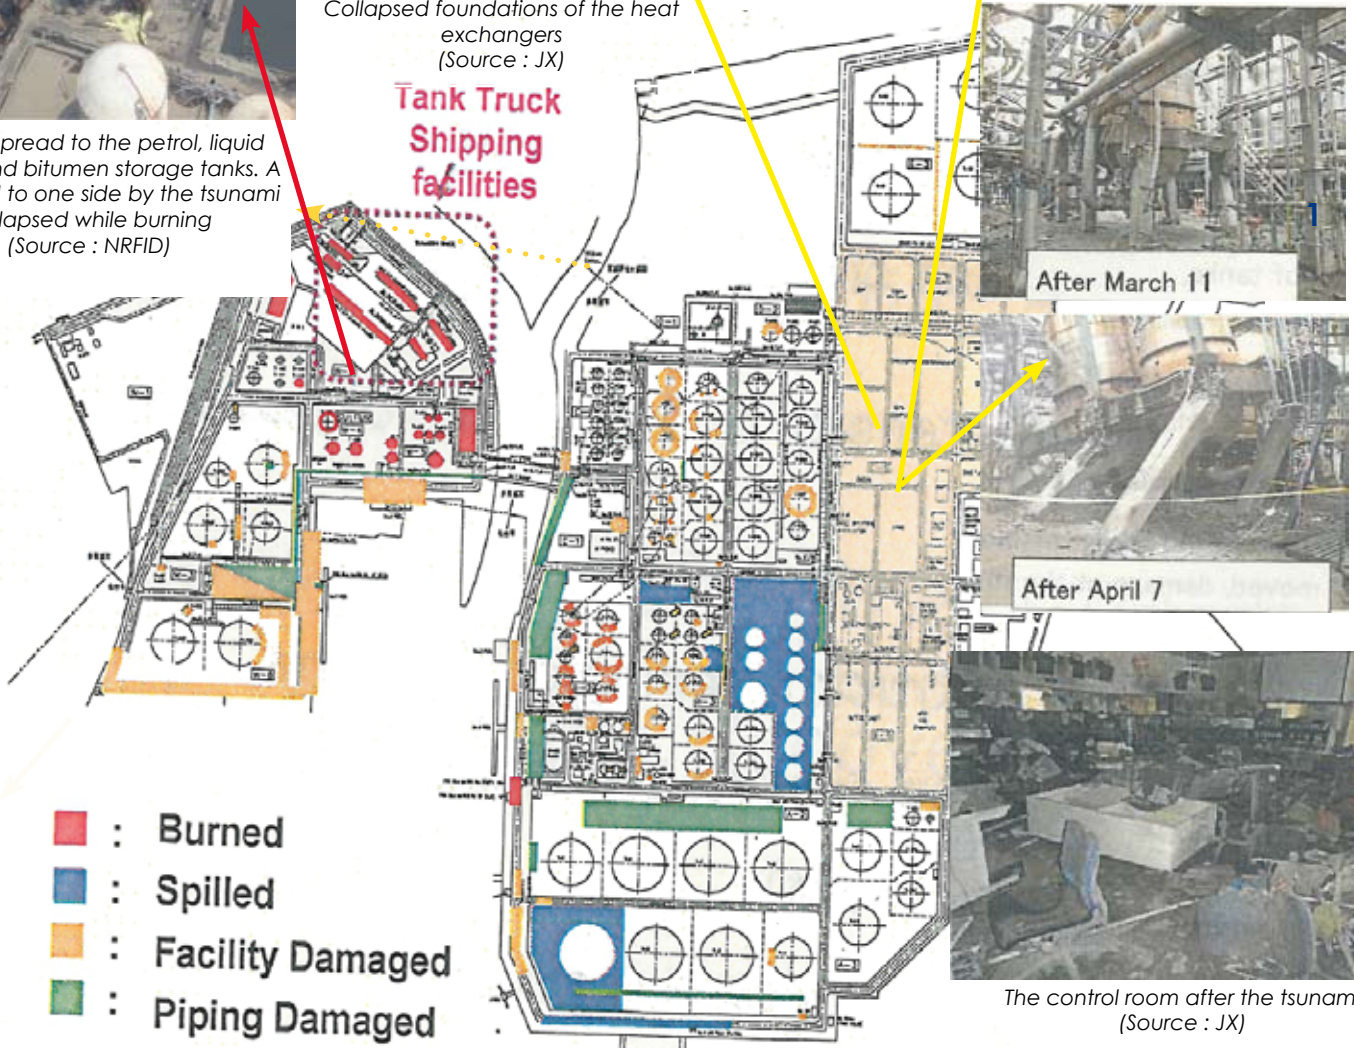
Below: The foundations of the FCC reactor collapsed in two stages. First, from debris carried by the tsunami, then from the aftershocks of 7 April 2011 (Source : JX)

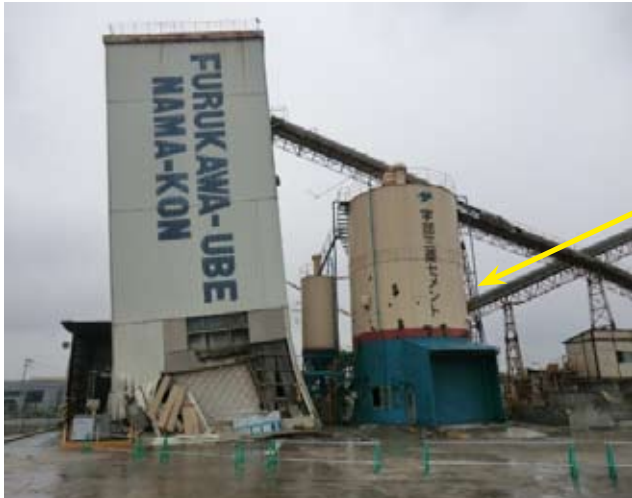
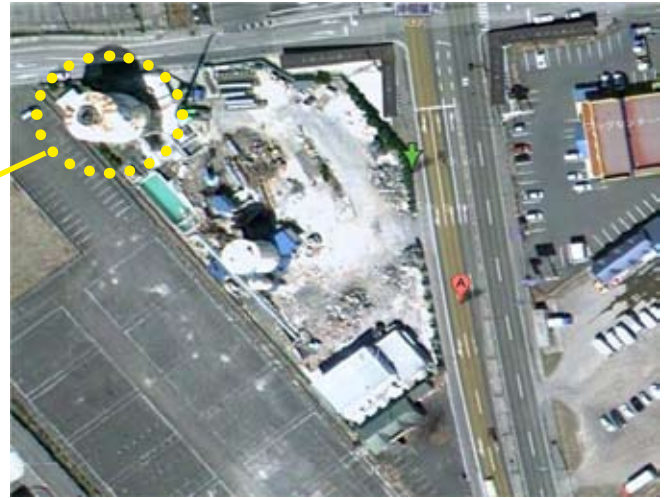
Seismic damage at a concrete plant in Ube (Source : Google Maps / amateur photo)

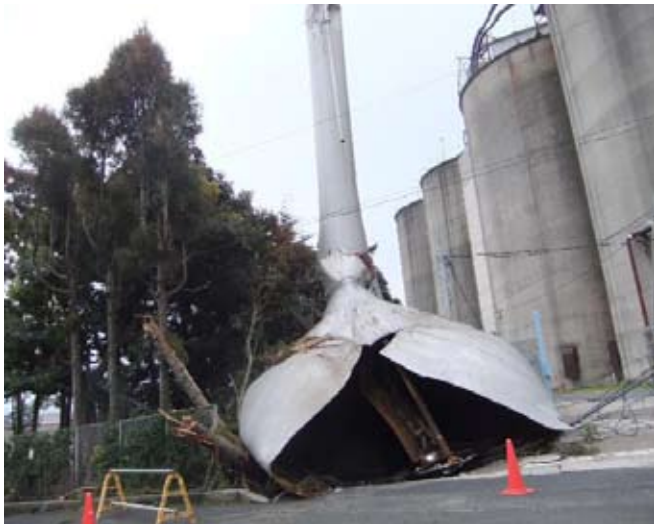
Cement plant in Hitachi; water storage tank ripped open by the earthquake (amateur photo)

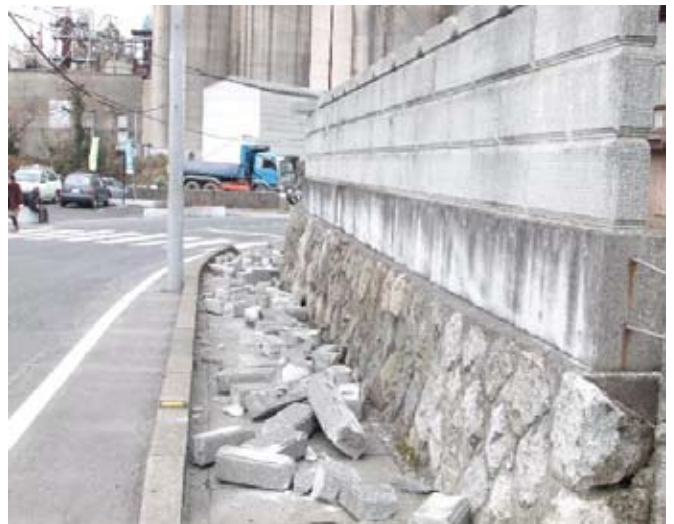
Cement plant in Hitachi; wall damaged by the earthquake (amateur photo)

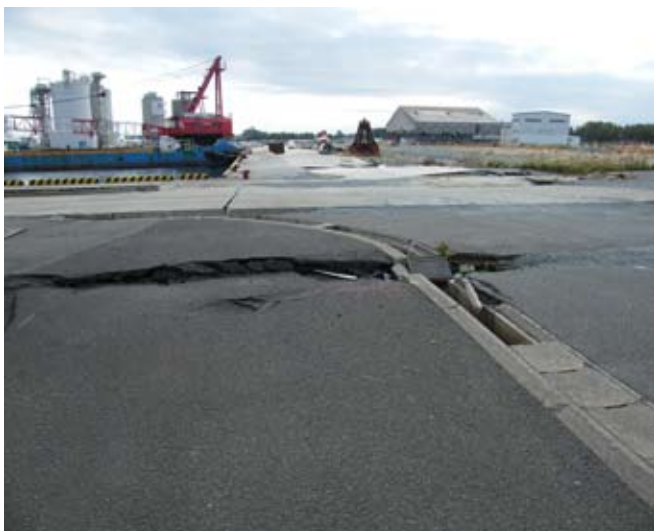
Subsidence of the docks near the Port of Soma concrete plant (Source : DGPR)

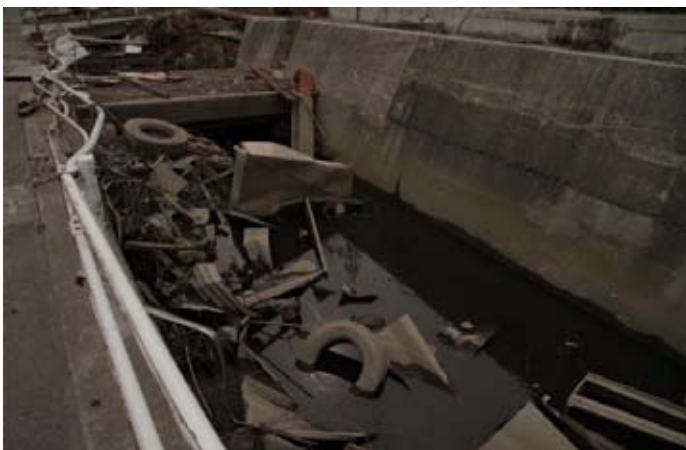
Around 1,000 m³ of fuel oil from damaged pipes were lost in the Port of Ōfunato (amateur photo)

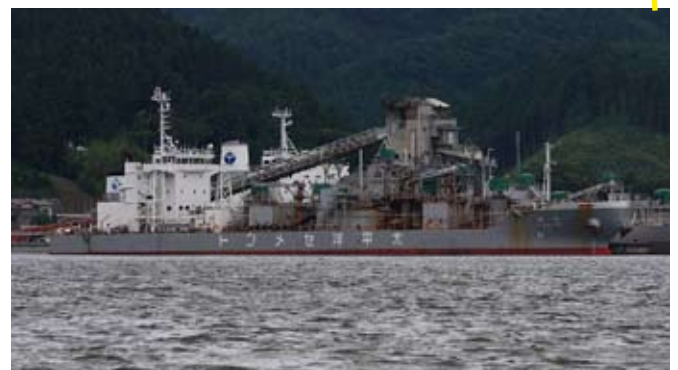
The cement loading terminal sustained little damage on March 11th (amateur photo)

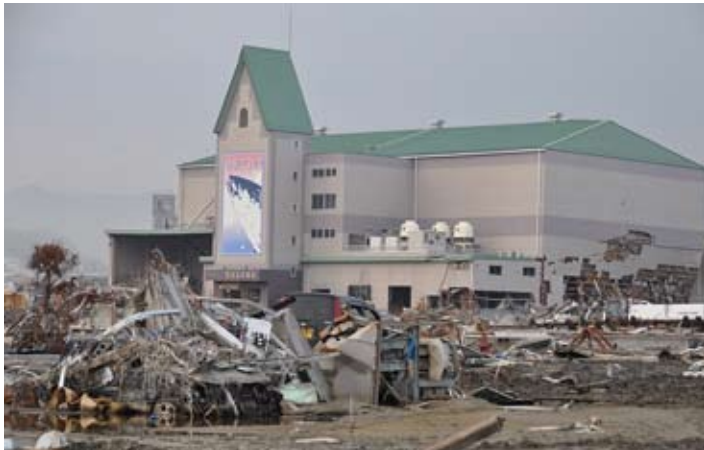
Fish freezing plant hit by the tsunami in the Port of Kesenuma (amateur photo)

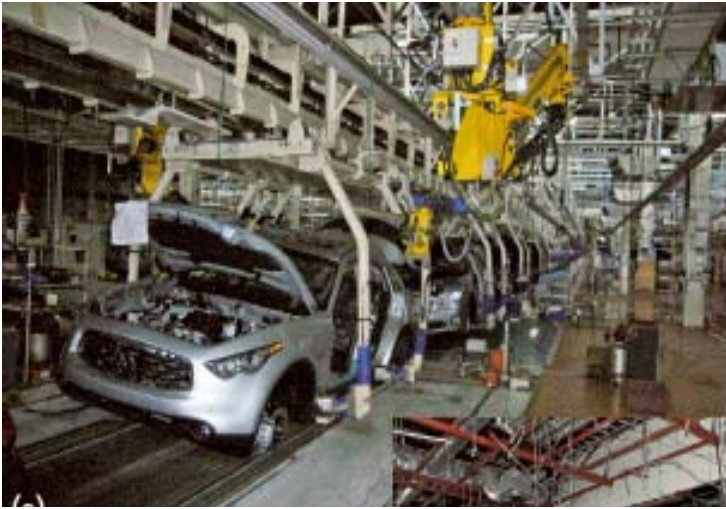
Car tilted out of its berth in Tochigi (Source : Nissan)

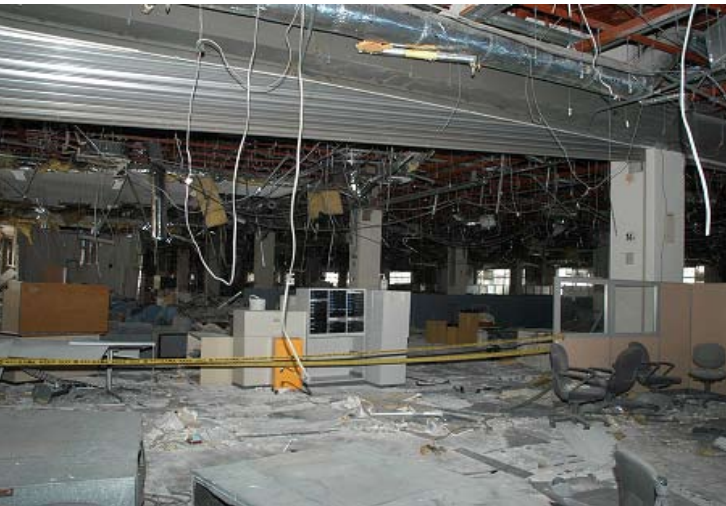
Overview of the earthquake damages in the R & D center of Tochigi (Source : Honda)

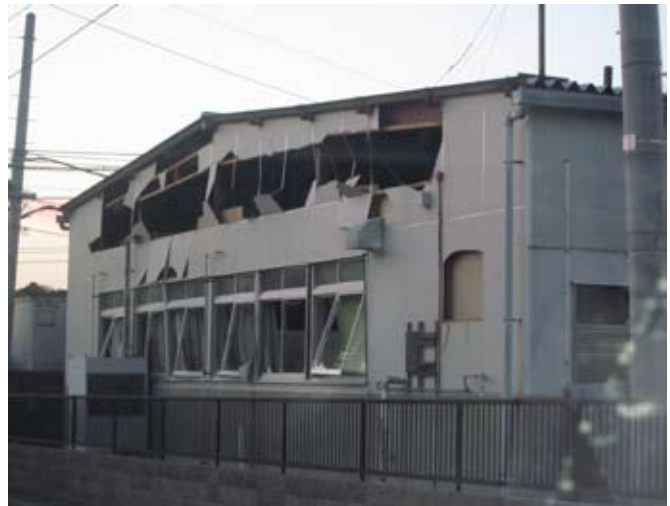
Effect of the KUREHA plant's hydrogen explosion on a neighboring building (amateur photo)

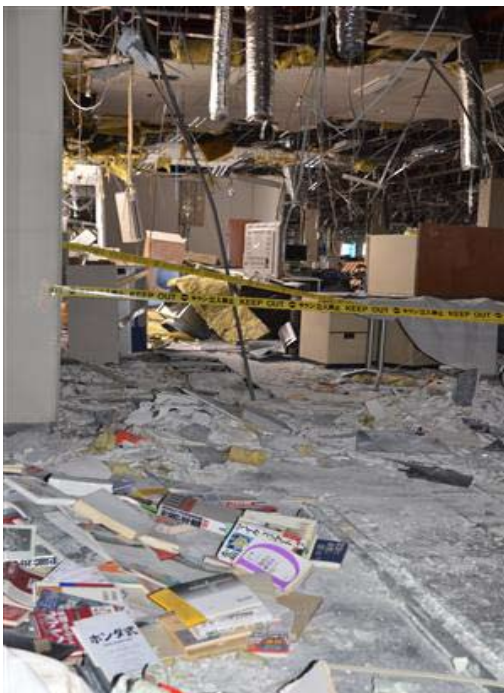
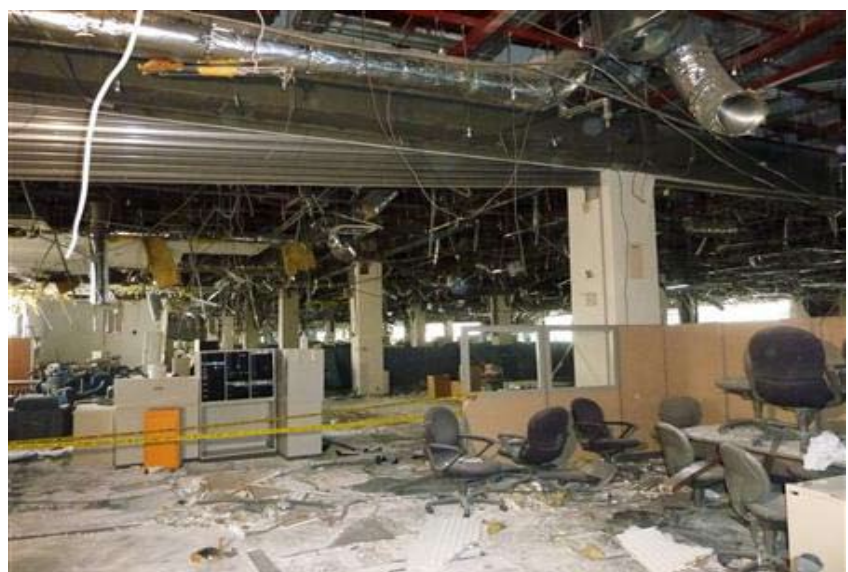
Overview of the earthquake damages in the R & D center of Tochigi (Source : Honda)

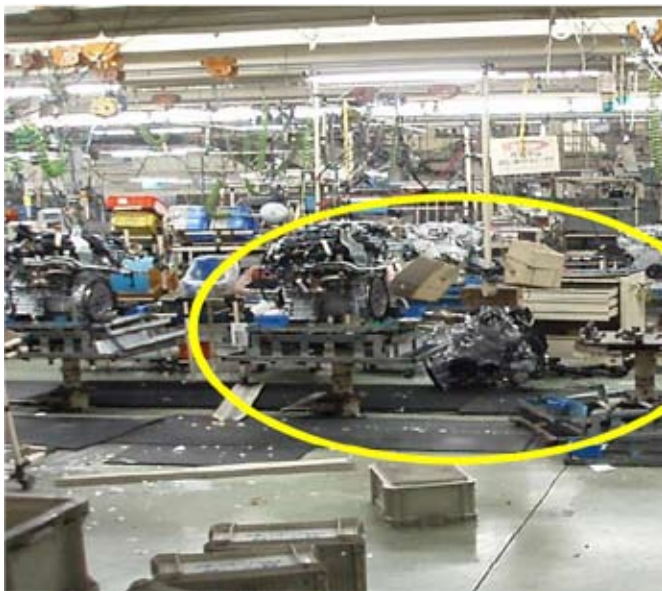
Engines and components knocked off the assembly line
(Source : Nissan)

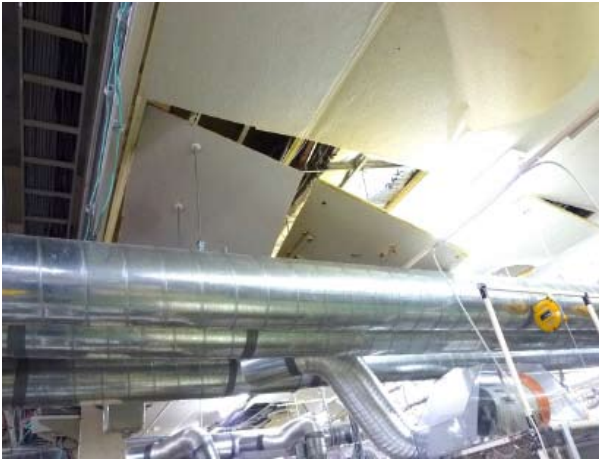
Damage to the suspended ceilings on the second floor of the main building (Source : Fujitsu)

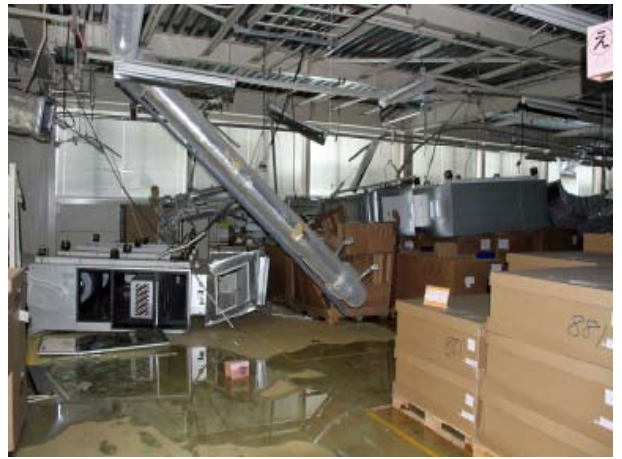
Collapsed AC duct and water on the floor of the storage area (Source : Fujitsu)

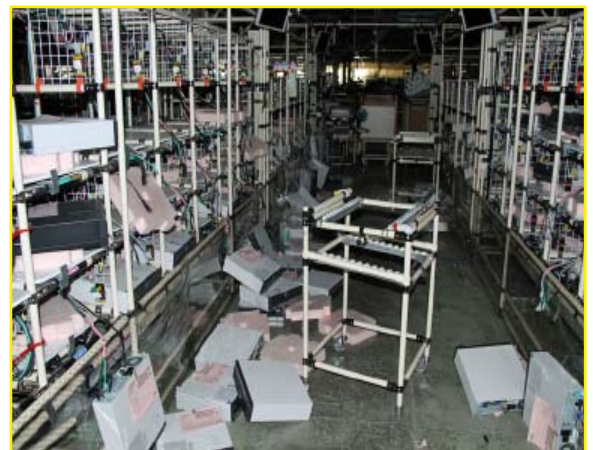
Fallen PCs in the desktop PC testing room (Source : Fujitsu)

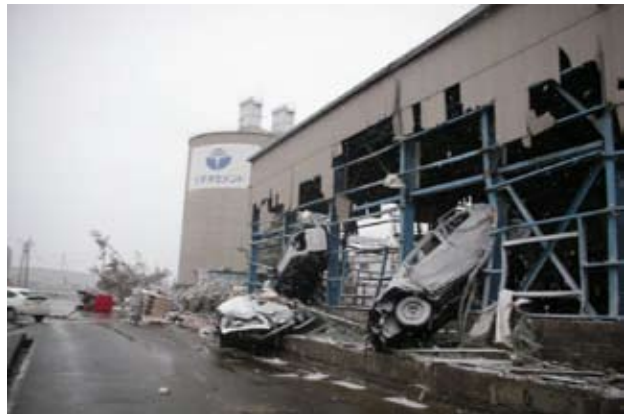
Warehouses damaged by the tsunami and large debris in the Port of Sendai (amateur photo)

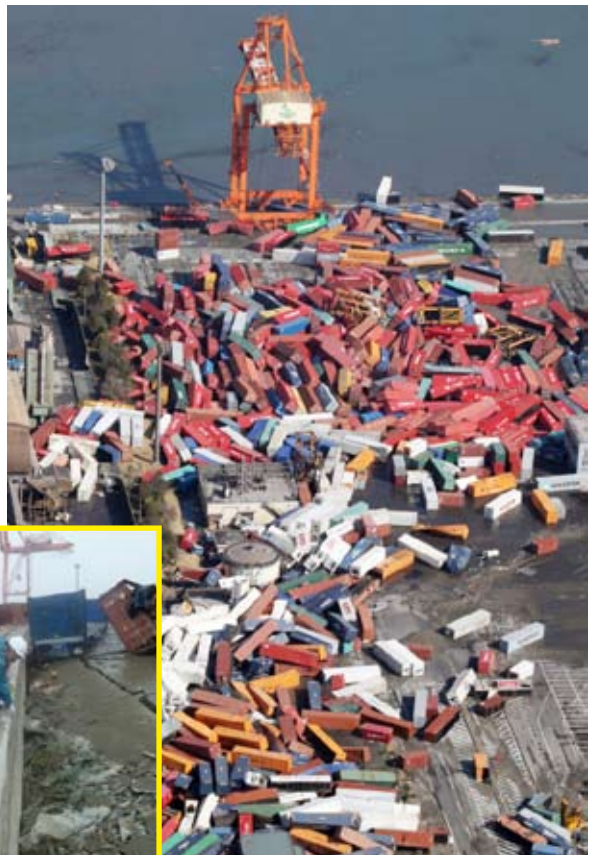
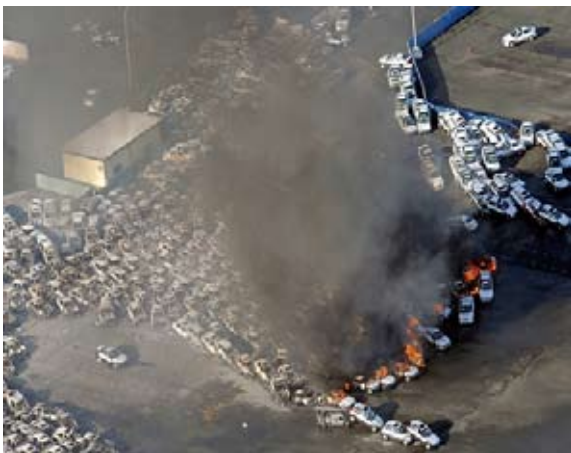
Cars awaiting export that were swept away by the tsunami then caught on fire in the Port of Hitachi. The fire is believed to have been caused by a battery submerged by seawater (amateur photo)

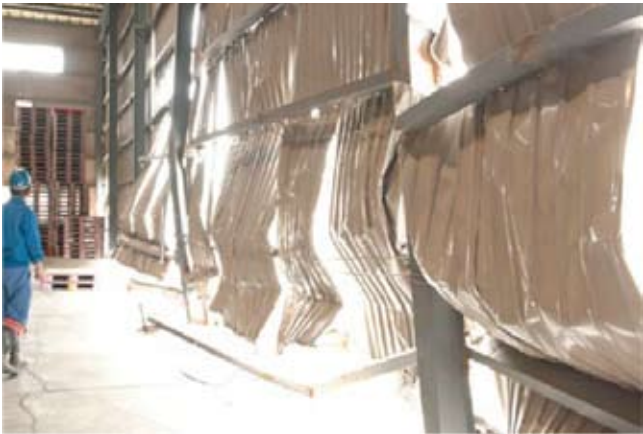
Walls damaged by the tsunami
(Source : JPR)

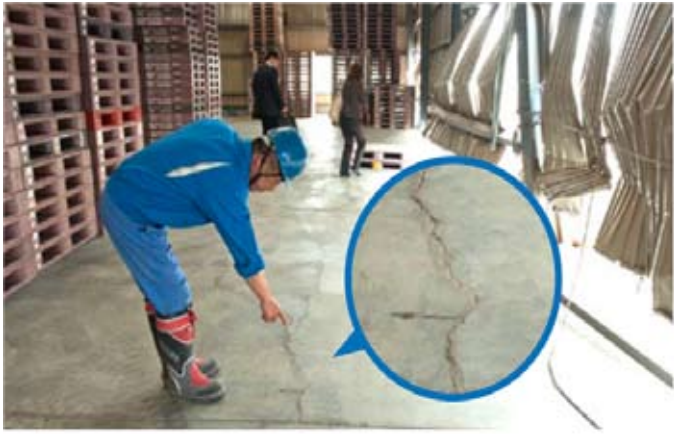
Floor cracks caused by liquefaction
(Source : JPR)

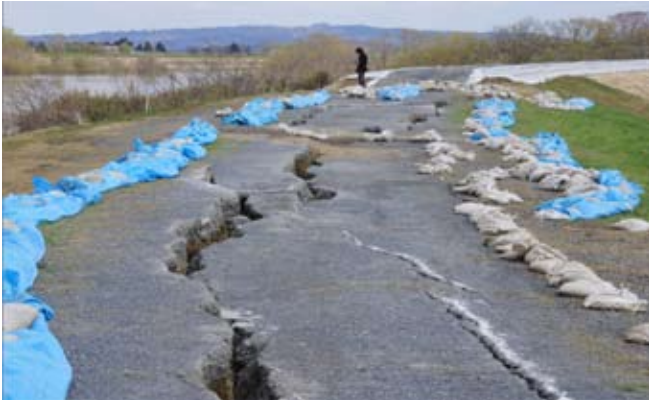
Cracks on a dike on the Naruse river
(Source : EERI)

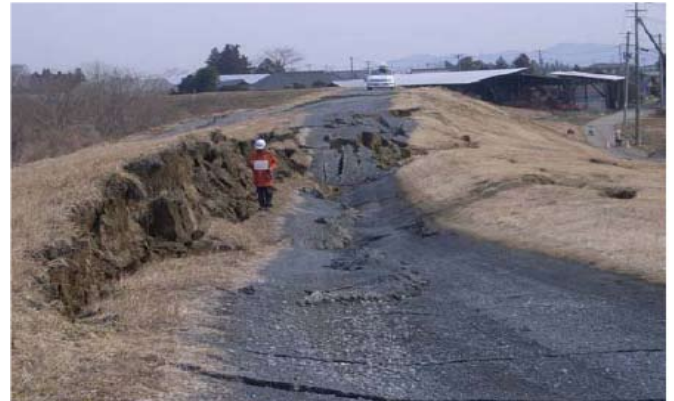
More than 2 m of settlement from vertical liquefaction were measured on this portion of the dike (Source : MLIT)

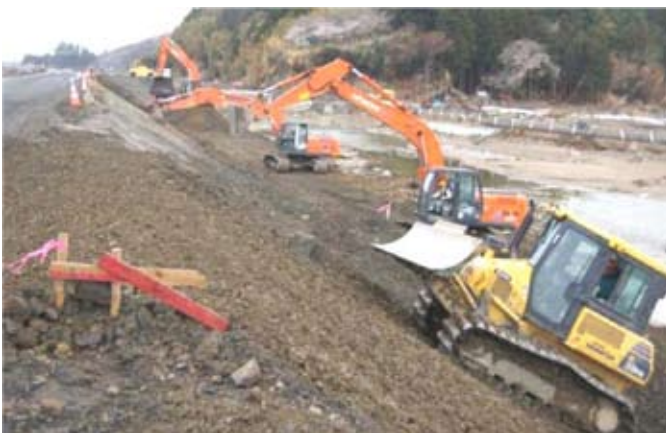
Dike along the Kitakami river being rebuilt in April 2011 after sustaining damage from the tsunami. The tsunami submerged the river's dikes along a distance of 5.5 km from its mouth and caused it to overflow its banks by more than 49 km inland (Source : GEER)

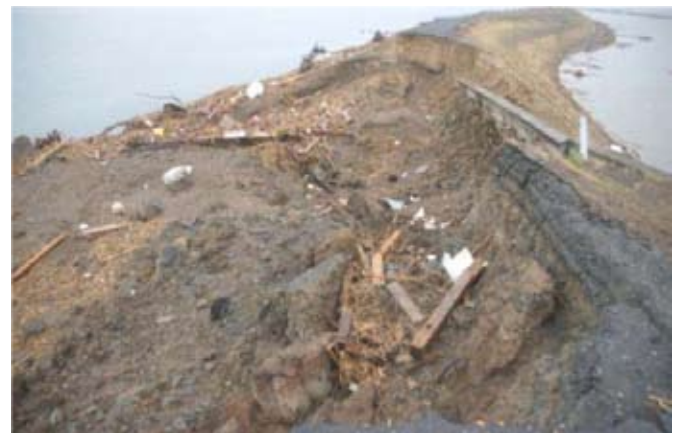
This dike section, located 4 km from the mouth of the Kitakami river, was heavily eroded after being submerged by more than 1.7 m of water from the tsunami (Source : GEER)

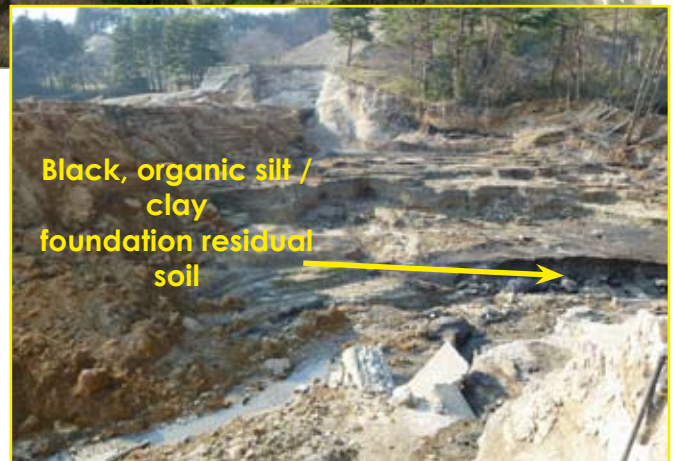
View of the foundation of the main dam following the breach (Source : JCOLD)

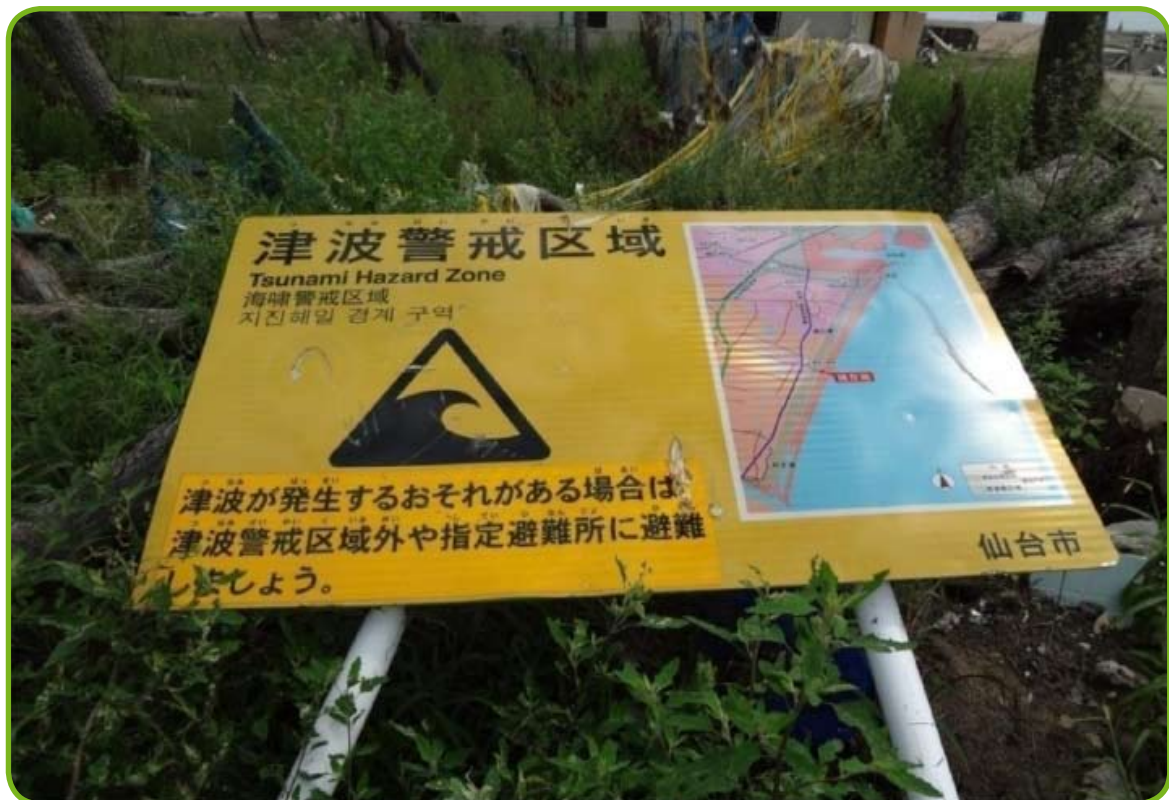
Uprooted tsunami hazard zone sign in the village of Arahama, near Sendai. The area submerged on March 11th, 2011 was nearly double that indicated on the sign
(Source : Rick Wilson / California geological survey)
