Leak of gaseous VCM

13 December 2018

Saint-Fons (Rhône)

Heavy chemistry
 Gas release
 Polymerisation
 Alarms
 Ergonomics

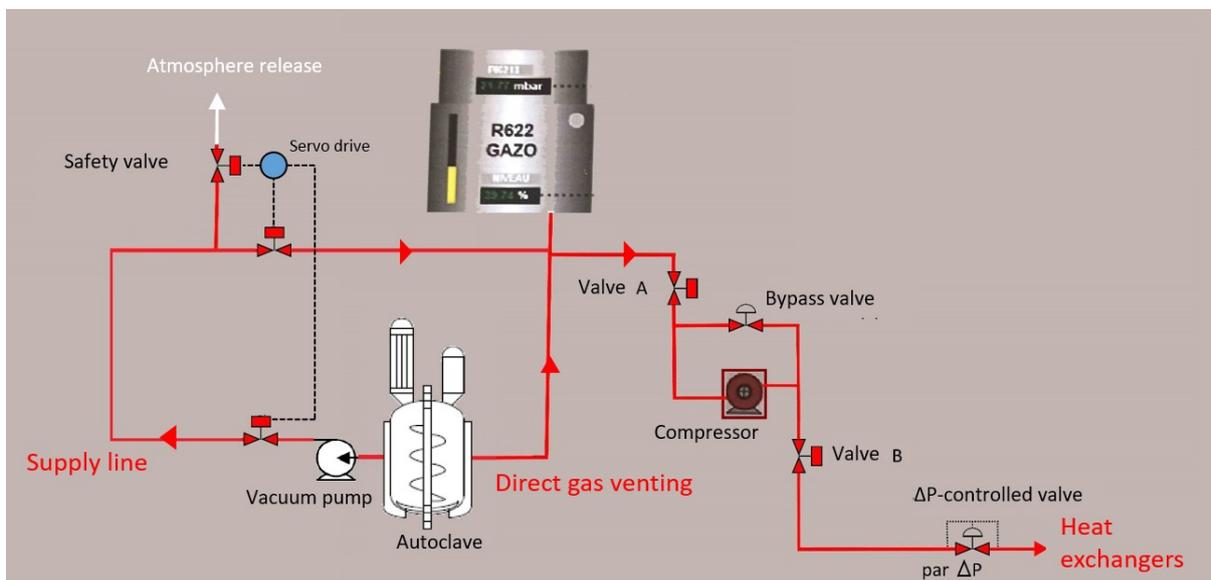
Figure 2: simplified diagram of the venting of gases to the gasometer and conveyance to the condenser

During the PVC manufacturing process, at the end of the polymerisation reaction, the gas in the autoclaves is vented to discharge the VCM that has not been transformed. An initial direct gas venting operation takes place by balancing the autoclaves and the condensation unit's exchangers. The gaseous VCM remaining in the autoclaves is temporarily stored in a gasometer. After a second gas venting operation by balancing the autoclaves with the gasometer, vacuum pumps draw the content remaining in the autoclaves toward the gasometer via a supply line. This line features a safety system (servo-control) that closes the valves on the vacuum pumps' inlet and the valve upstream from the gasometer and opens the safety valve. The opening of this valve causes a release of 0.33 kg of VCM into the atmosphere at a slow rate, corresponding to the purge of the supply line. This system is triggered if one of the following conditions is met:

The gasometer acts as a buffer tank for VCM that will be conveyed via compressors to the exchangers of the condensation unit. When filled with gas, a bell rises, and when emptied, it lowers. Thus, reference is made to the level of gas in the gasometer, measured by the height of the bell. The compressors' bypass valves regulate the gas level in the gasometer. When the level rises, the compressors discharge by closing the bypass valves to convey the VCM to the condensing unit. The bypass valves open when the gasometer's level drops below 20%. The compressors can then remain in operation; the VCM circulates in a loop via the bypass valves and the level in the gasometer stops falling. As a safety measure, the compressors stop if the level reaches 15%.

The cause of the event was attributed to the unintentional opening of the gas venting system due to an air supply failure. The choice of the opening mode (air fail to open) was based on a historical risk analysis. The operator does not have any internal feedback regarding unintentional opening events in its incident reports. The valve's opening is primarily associated with a risk of high oxygen content in the gasometer's supply line. It resulted in a release of 0.33 kg. This event was not monitored as the valve was not identified as a release point, but rather as safety equipment.

Following an expert evaluation, the actuator was deemed to be operating correctly. The operator's assumption of a lack of air was based on congestion forming in the valve's distribution system, notably caused by:

- humidity in the industrial air, produced and dried on-site, and supplying the valve at the end of the line;
- temperature of - 3 °C, thus limiting the flow of air; an ice plug may have formed in the line.

The operator had not identified that the safety valve on the degassing line could be the cause of an atmospheric release of VCM, except when it is performing its safety function. It had not identified the risk of congestion that could disrupt the valve's supply system even though the servo drive was operating normally. Therefore, the scenario of a VCM release due to an unintentional opening of this valve was not considered in the hazard study.

Therefore, the valve had not been equipped with a discrepancy alarm (reporting a difference between order and actual state). The valve was displayed as "open" in green on the mimic panel, without identifying the opening order. It should have been in the closed position and displayed in red. Also, the outlet of the exhaust system was not equipped with a VCM measuring device. A study conducted in 2014 showed that the installation of a VCM detector was not possible due to humidity being present.

- operational or system modifications, e.g., the transmission of valve limit switch information to the control system;
- recommendations for studying possible improvements, for example, e.g. studying the possibility of closure when an air supply failure occurs on the safety valve in question.

The operator changed the valve's supply medium to nitrogen.

- a study was conducted on the possibility of installing a VCM detection system near the discharge of the safety valve on the VCM intake line on the degassing system, including an alarm in the control room and operator intervention;
- alarms were added on valves that could be a source of VCM release. As a result, various "alarm procedure" sheets were reviewed or created;
- displays on the process monitoring software were standardised for easier identification of possible failures;
- information was added to the displays of the gasometer mimic panels and on the screens in the control room, including a review of the informal training module;
- the procedure for contacting the site's on-call technician was updated.

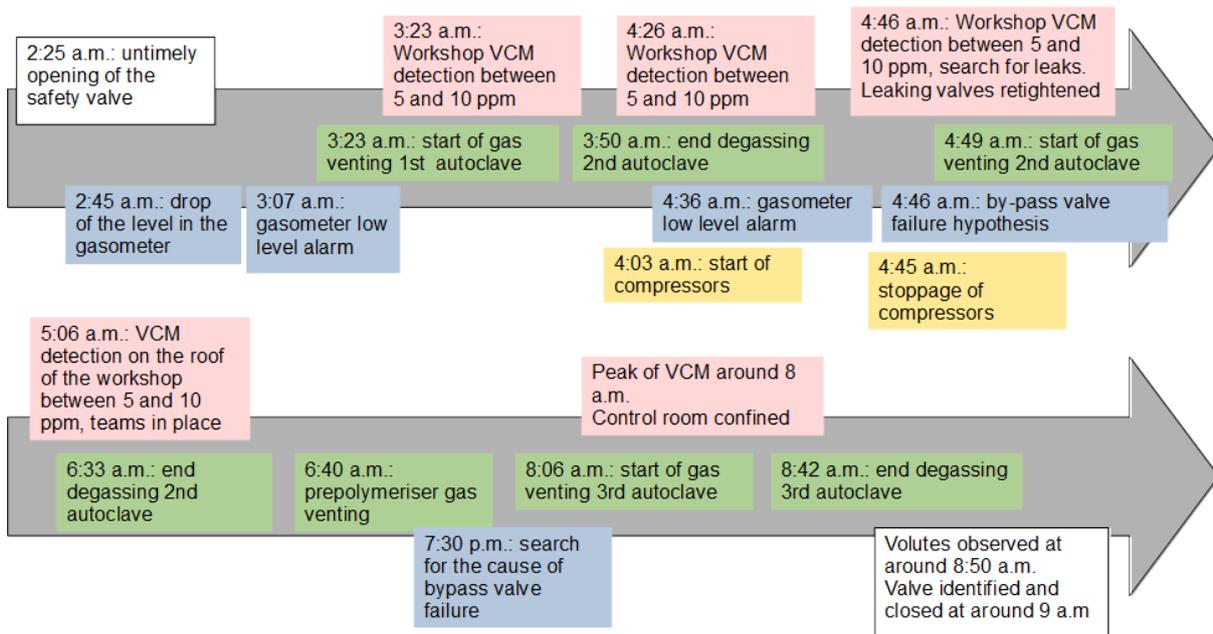
Figure 3: Chronology of the event

At 2:25 a.m., the safety valve on the gas venting system supply line opened, allowing VCM to be released into the atmosphere for 6.5 hours. The operators did not notice the discharge: no alarm sounded to warn them that the valve was open; it was simply indicated as 'open', in green, on the mimic panel. None of the valve opening conditions described above were observed in the control room. Although the valve's status information is available on the mimic panel, it is not permanently on display in the control room.

At 2:45 a.m., the crew on duty noticed that the level of VCM in the gasometer had dropped. At 3:07, 4:36 and 4:45 a.m., the gasometer's low-level alarm (15%) sounded, causing the compressors to stop sending VCM gas to the condensers, as foreseen by the process explained above. The operators on duty suspected that the bypass valves had malfunctioned and had not opened fully, as expected upon reaching the 20% level.

A few minutes later, VCM measurements from 3 chromatographic detectors (continuous analysers), installed on the upper floor of the workshop where the autoclaves were located, showed concentrations above 5 ppm (the exposure limit value for workers is 1 ppm for 8 hours of exposure). The alarms of these detectors began sounding in the control room. At 4:26 a.m., 2 other detectors on the workshop's ground floor triggered the 5 ppm alarm, and then at 4:46 a.m., the 3 detectors on the upper level sounded again when 10 ppm was reached. As stipulated by the "search for leaks" procedure, the operators donned their gear and conducted a leak search with a portable analyser. They noted that the valves on two pieces of equipment were leaking, and suspected that a substantial leak had occurred, which, in their view, would explain the various detections. The first level maintenance crew tightened the valves, and the shift supervisor filed a request for intervention with the general maintenance department.

At around 8 a.m., a peak of VCM at 12 ppm was detected on the roof of the LAP. At 8:14 a.m., the control room was locked down (containment mode) following the established procedure. At 8:42 a.m., the operators stopped the degassing operations, suspecting that they were the cause of the leak. The morning shift searched for the leak's source and suspected a leak on the gasometer safety valve. Operators went to the site and observed volutes above the degassing section, which confirmed their hypothesis. At around 9 a.m., the crew on duty manually closed the safety valve which had opened unintentionally. The release of VCM was stopped.
