Smoke generation in a wind turbine nacelle

01/08/2020

Issanlas (Ardèche)
France

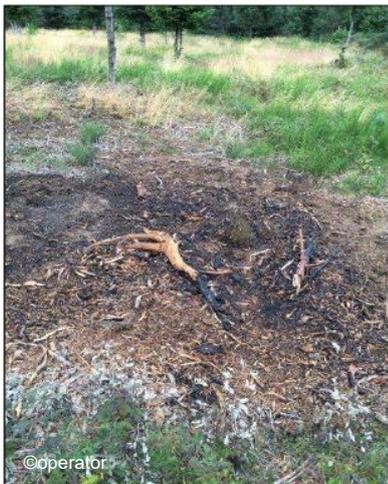
Damage on the ground

Smoke was visible and debris fell at the foot of the wind turbine and burned approximately 20m² of vegetation at the foot of the wind turbine.

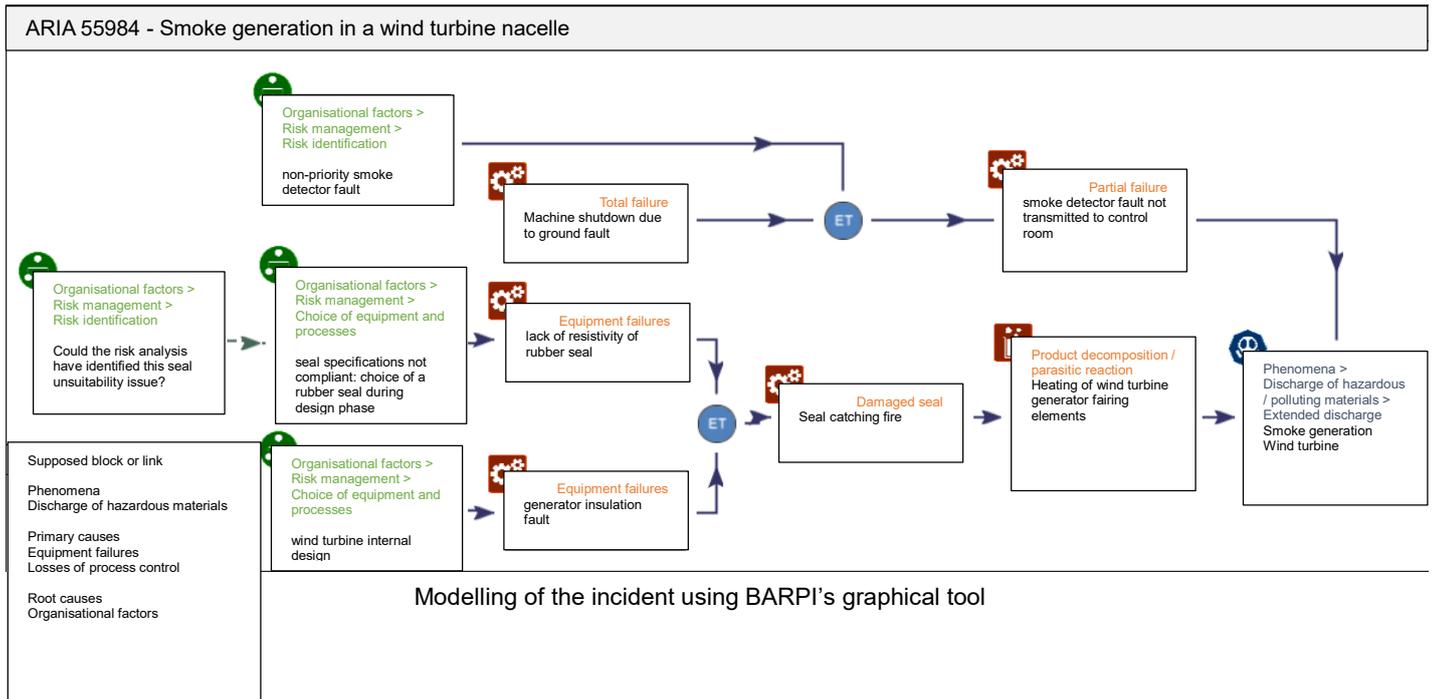
No damage to the blades was observed. The internal damage remained focused on the generator in the nacelle:

- Rubber seal between the generator fairing and destroyed stator windings,
- Melted Perspex protection elements,
- Soot deposits on stator windings.

On restarting the machine, a rubber seal between the generator fairings and stator windings caught fire. The heat given off by this fire caused the wind turbine generator fairing protection elements (varnish, Perspex housing, rubber body) to heat up, which caused smoke to be generated.

After analysis, the operator observed that the specifications of the rubber joint, designed for the type of wind turbine involved, and which serves to direct the air flow onto the generator, did not match the properties ultimately expected. **The characteristics of the seal combined with a local generator insulation weakness** triggered a resistive electrical fault that caused sufficient heating to make the seal catch fire.

Generator insulation has been reinforced.

The rubber seals have been removed until they can be replaced with seals meeting the required specifications. The wind turbine can operate without a seal because the only risk is a temperature increase. If a temperature increase is observed, power may be limited. During the wind turbine restart process, the operator has reinforced supervision by monitoring various parameters manually.

The rubber seals in the 22 affected wind turbines have been replaced with silicon seals, used on machines commissioned since 2017.
