Explosion of a hydrogen tank

1st October, 1988

Saint-Fons (Rhône)

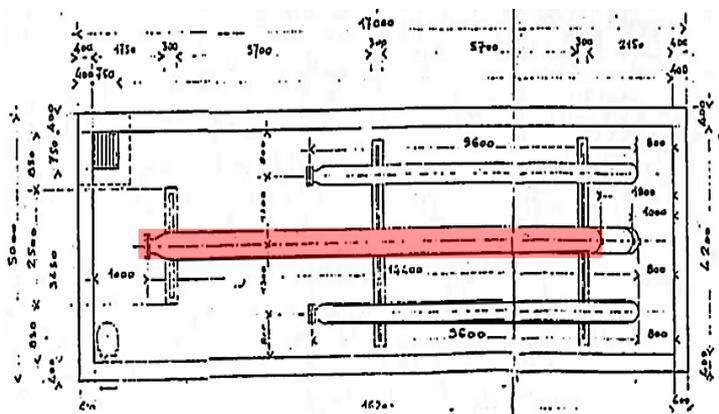
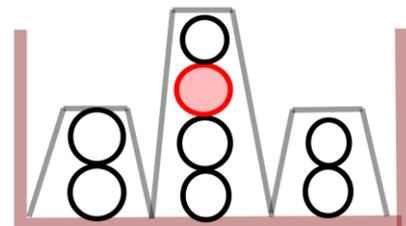
Top and front views of the pit

The cylinder was in the middle of the pit and above 2 other cylinders

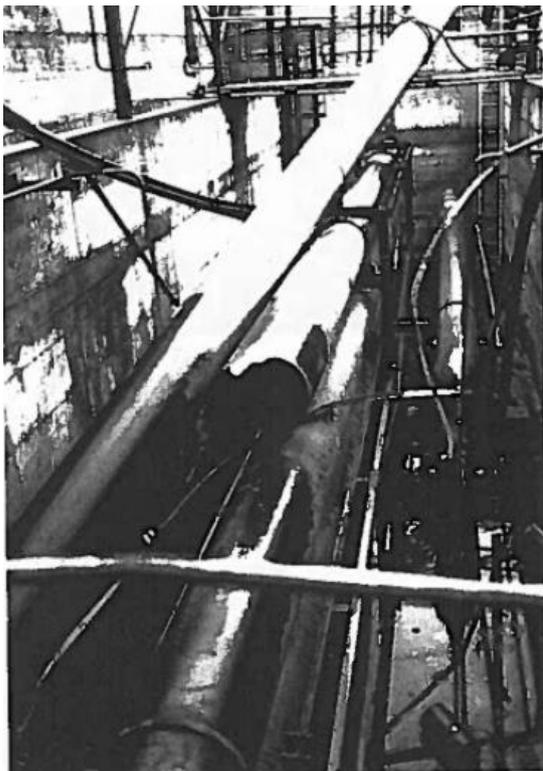
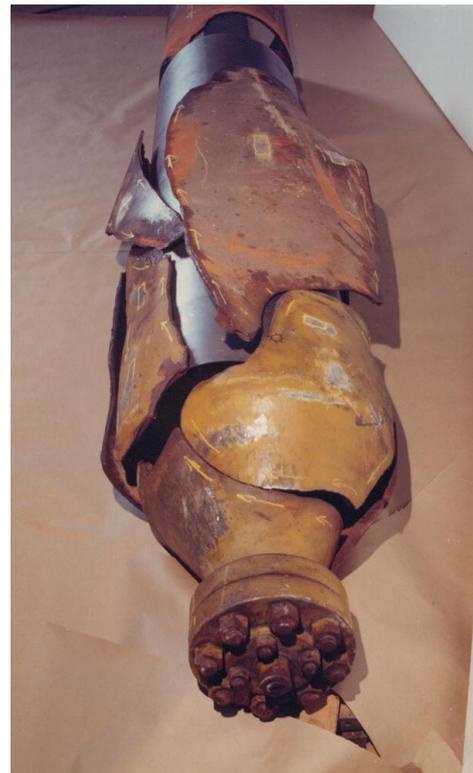
View of the pit after the accident and the cylinder reconstructed for expert appraisal - All rights reserved

Ten or so cylinder fragments were found after the accident: 6 in the pit and 2 outside the plant (up to 150 m away). One of these fragments severed the compressed air line supplying the storage facility's isolation valve.

Propelled to the side opposite its rupture (toward Saint-Fons), the exploding cylinder collided the pit's east wall, and then flew back in the opposite direction.

Hydrogen embrittlement of the steel was the first assumption to explain the fast failure of the pressure vessel in the 1st quarter of its length (valve side). The damage observed on the facilities can be explained by the potential energy stored in the cylinder (Potential Energy = Pressure x Volume) and its sudden release at the moment of rupture (pneumatic explosion). On the other hand, a model based on the TNT equivalent of the mass of H₂ contained cannot explain the observed damage.

An expert assessment attributed the accident to a time-dependent rupture (static fatigue) of the cylinder resulting from H₂ embrittlement of the steel on the front support cradle. The cylinder was recycled, having already been used at other sites, notably as a nitrogen storage tank. The various documents in the pressure vessel's file give no precise indication as to the type of the metal used in its construction.

For economic reasons, the activity of the units connected to the storage facility was quickly resumed. These units were supplied directly via an existing 35 bar line. Before commissioning, the piping underwent a leak test with helium followed by a hydraulic test coupled with a dye penetrant inspection to search for external cracks. Impact tests (resiliency) and crystallographic examinations in addition to these tests. All the examinations showed no traces of hydrogen embrittlement.

These points underscore the importance of preparing pressure equipment files, notably regarding the characteristics of the steels used. It is worth collecting this information, particularly for older equipment. Failing this, their replacement should be considered. Furthermore, it should be ascertained whether their recycling as part of a new process poses no problem.

Lastly, the operating conditions for a pressure vessel, particularly when used as an accumulator tank, should be analysed in light of the fatigue phenomena.
