# Fire at a waste treatment plant covering nearly 18,000 m<sup>2</sup>

2 November 2013

**Fos-sur-Mer (Bouches-du-Rhône)  
France**

Fire  
Waste  
Difficult emergency response  
Operating loss  
Delayed detection  
Malicious act

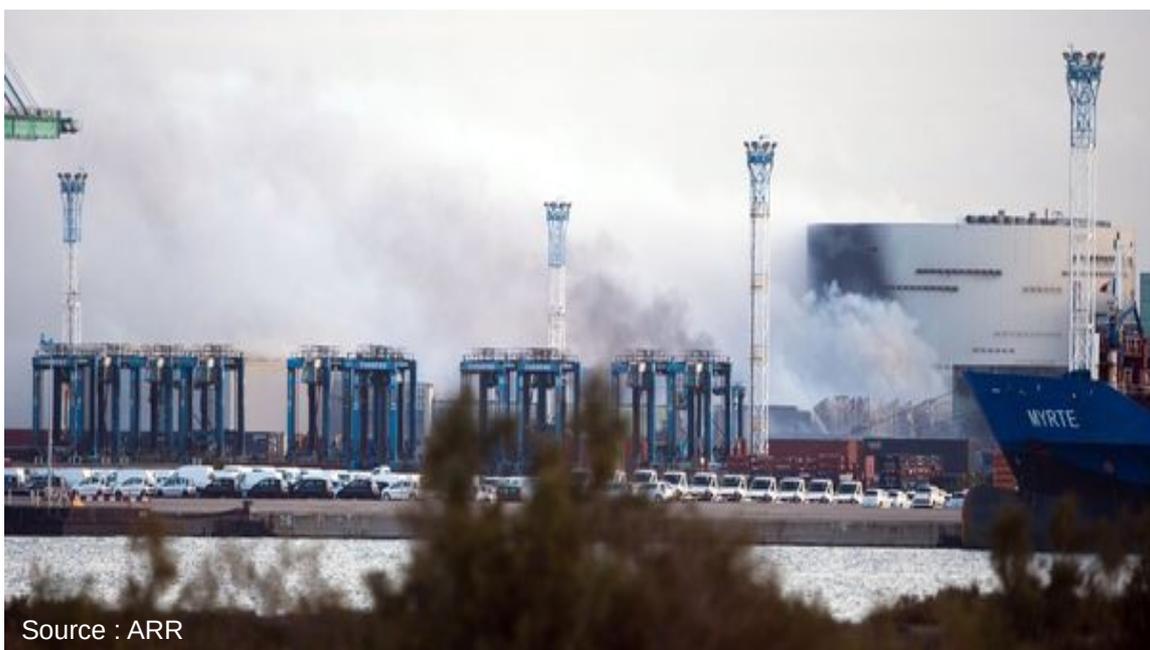
Overview of the fire that broke out at the Fos-sur-Mer municipal solid waste treatment plant

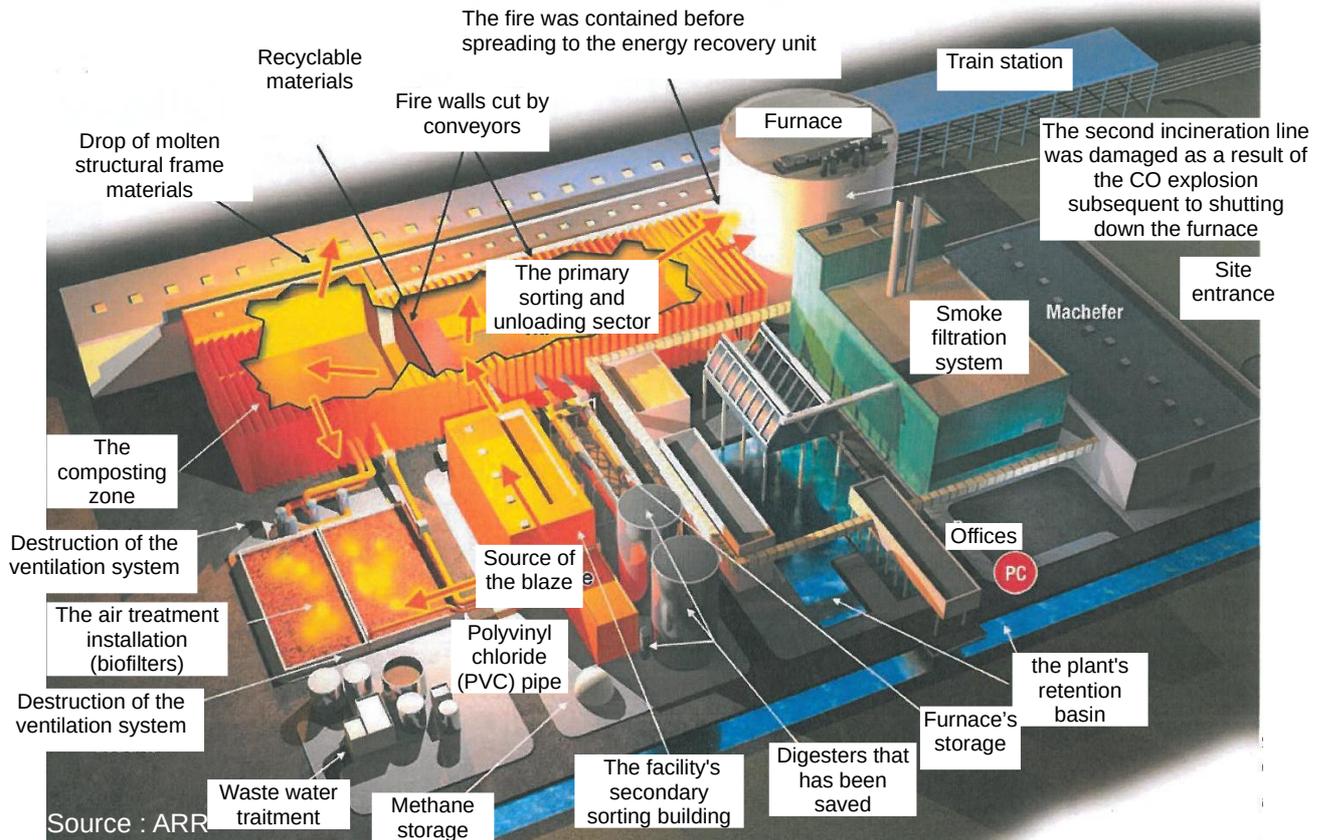
On the night of 2 November 2013, fire broke out in the organic recovery unit located inside the facility's secondary sorting building. This unit was idle at the time. The blaze then quickly spread to the composting zone and ultimately to the primary sorting and unloading sector.

**Diagram of how the fire spread inside the plant**

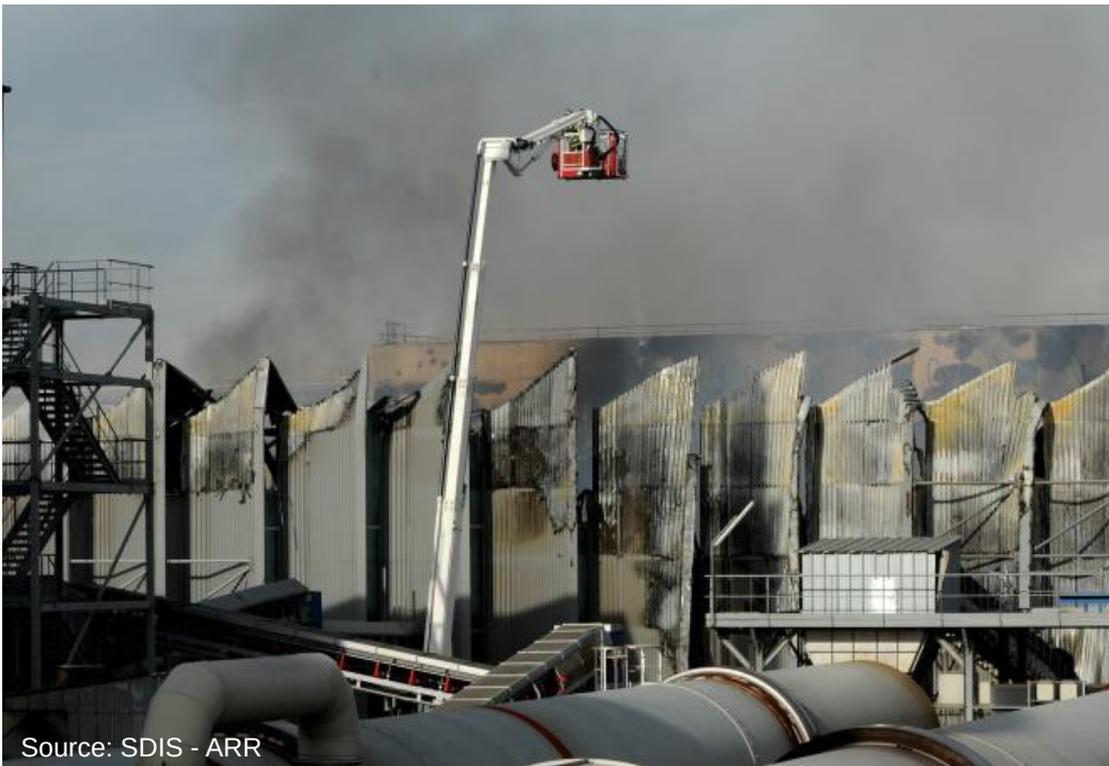
**Primary sorting building ablaze**

In less than an hour, the fire had engulfed the entire primary sorting zone. Then it advanced via conveyor belts crossing the fire walls as well as via the glued laminated timber frame atop these walls.

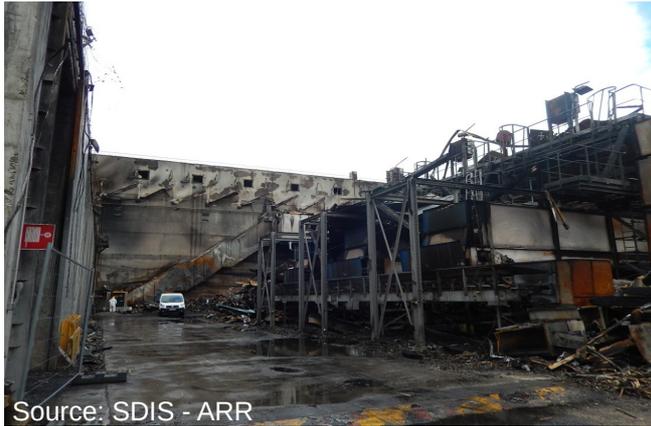
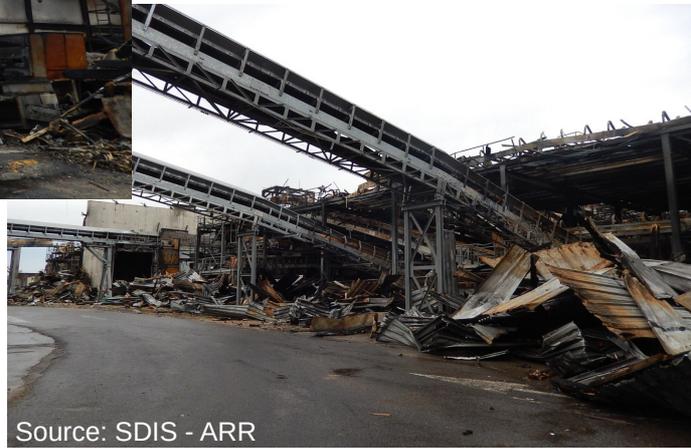
The primary and secondary sorting buildings as well as the composting platform were destroyed; these facilities accounted for over a third of all housed installations, for a total floor area around 18,000 m<sup>2</sup>.

The dismantling of the primary sorting building and the "composting" building has been completed, while the secondary sorting building has been nearly entirely dismantled, except for a few pieces of machinery awaiting expert appraisal as per the insurer's request. The site rebuilding project application was officially filed on 17 September 2014.
