# Untimely injection of foam into a warehouse containing phytosanitary products

30 April 2012

**Ludres (Meurthe-et-Moselle)  
France**

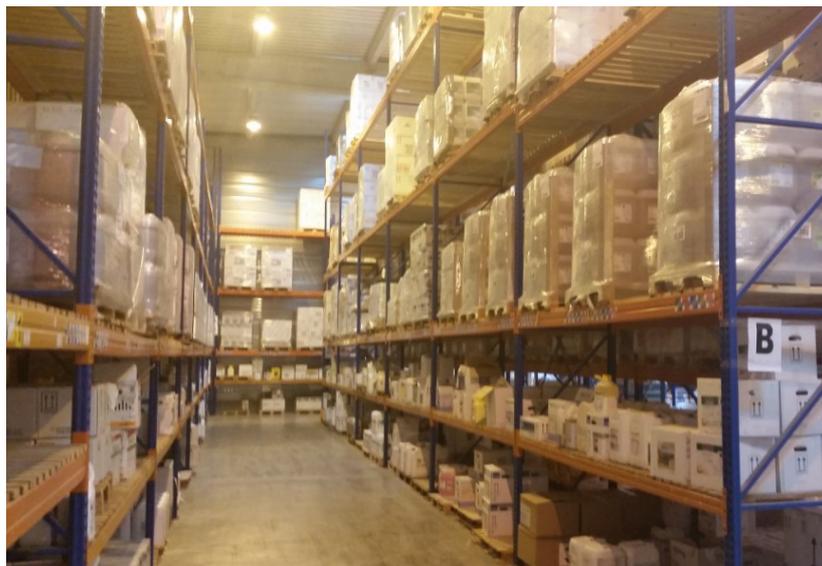
Figure 2 : Interior of Cell 1 (Source Operator - ARR)

Cell 1, laid out over a 1000 sq. m<sup>2</sup> floor area and 10 m high, stored flammable and/or toxic or highly toxic substances for humans (Fig. 2). Like the other cells, it had been fitted with metal storage racks.

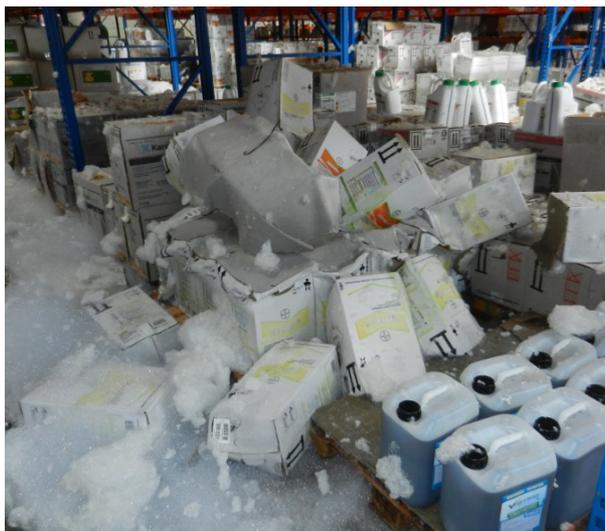
Figure 3 : Cell 1 after activating the foam extinction  
(Source Operator - ARR)

- round-the-clock (24/7) site monitoring (excluding warehouse opening hours) due to the lack of an operational automatic fire detection system for over a year;
- damage sustained by the fire extinction system (pump destroyed, emulsifier stock depleted, etc.);
- operating losses tied to reduced activity schedules imposed by administrative and judicial authorities for 6 weeks;
- the requirement to repackage a number of bottles, including the destruction of some that had become unsellable (Fig. 3).

The "economic consequences" index received a "2" rating due to the cost of monitoring operations and the extent of operating losses stemming from both a decline in business activity and stock damaged by the foam.

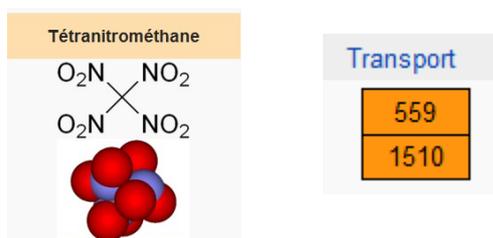
Figure 4 : Tetranitromethane and its 4-digit UN code, identical to that under the heading entitled "Storage of combustible materials, products or substances in enclosed warehouses" listed in the French ICPE installation nomenclature

When fire-fighters became aware of this "printout" version of the cell's inventory, they assumed that the numbers used by the warehouse operator to classify the various stored products and their weights corresponded to the current UN numbering system for transporting hazardous substances, whereas in reality they corresponded to the French ICPE (designation for environmentally sensitive installations) category numbers associated with these products.

Among the numbers listed in the report, i.e. category no. 1510, the storage of combustible materials under the ICPE regulations was mistaken for the same UN number, which corresponded to Tetranitromethane, a toxic combusive product (see Fig. 4). Responders thus considered that, despite the absence of visible signs of ignition from the outside, a fire might have been smouldering within the foam and moreover fed by this combusive product. Accordingly, a physical investigation by a three-member team wearing self-breathing type masks was decided so as to remove this doubt.

- ensure that inventory report documents made available to emergency services clearly underscore the fact that the numbers used are those of the environmental authority headings (if any, e.g. coloured insert on the front or upper part of the document, addition of the mention "ICPE No." in the number column). This consideration must also be regularly pointed out by the operator during interactions with local fire service representatives, e.g. when conducting joint drills or preparing / updating the external emergency plan for Seveso-rated facilities;

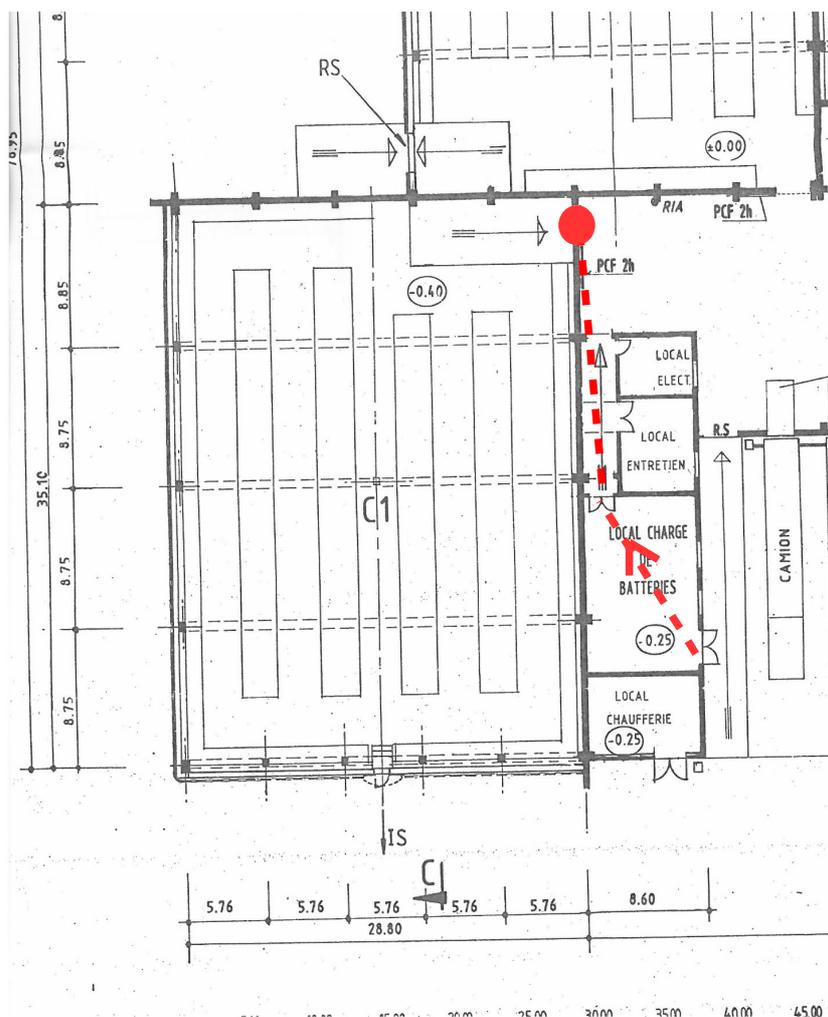
Figure 5 : Path followed by the three fire-fighter investigation team (ARR)

- Around 8:00 pm: Despite the absence of any visible signs of fire, fire-fighters decided to inspect Cell 1: three fire-fighters roped together wearing insulated self-breathing apparatuses penetrated into the foam that covered the adjacent premises in order to access the door to Cell 1 (Fig. 5). A few minutes later, two of them exited the cell in a state of physical exhaustion while the 3<sup>rd</sup> member was reported missing. Another reconnaissance effort found him unconscious lying on the floor in a state of cardiorespiratory arrest. He was quickly resuscitated and then transported to hospital in a critical condition.

The two surviving fire-fighters of the three-man reconnaissance team, as well as the members of subsequent investigation parties, reported that the foam inside the buildings did not display the same consistency as that observed outside. They all complained of real difficulty in advancing into the foam, which entailed coping with a highly viscous substance that constrained any kind of movement. They also expressed that the foam had been an obstacle to vision, to such an extent that a hand placed in front of the eyes remained invisible. Similarly, the foam acted as sound insulation, thus preventing verbal exchanges (besides radio) with the other two fire-fighters in the trio. In addition, they mentioned that shortly before exiting the premises, the foam wound up penetrating inside their breathing masks. The team's progress had been slowed to a point that they were not even able to enter Cell 1 and had to turn around barely after reaching the door (red dot in Fig. 5).

- ban access to cells filled with foam; nonetheless, employees required to violate the ban in order to gain entry, in particular to implement measures necessary to destroy the foam, must imperatively be attached to a life line;
