# Pneumatic explosion during an intervention on a pipe at a pyrotechnic plant

30 July 2014

Pont de Buis (Finistère)

Pyrotechnics  
Pneumatic explosion  
Organisation /  
Procedures

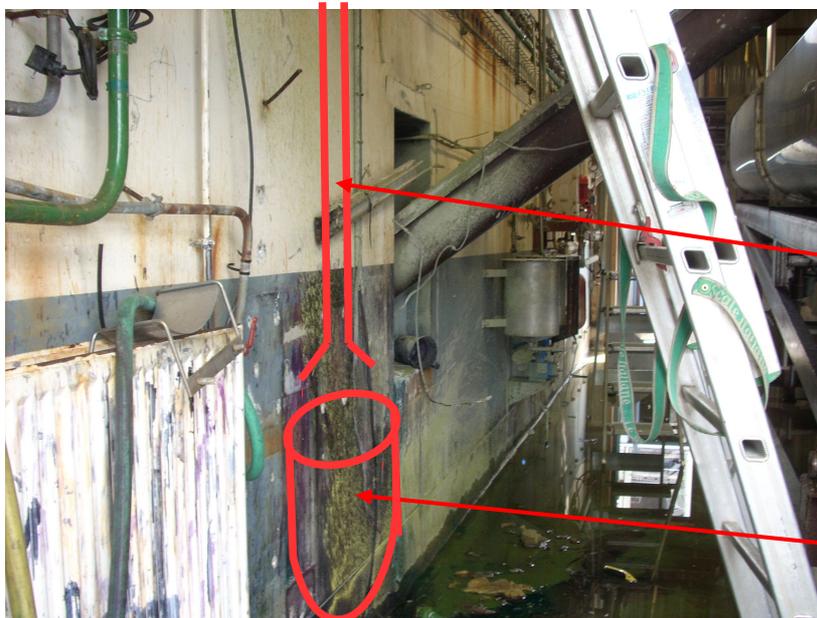
*Location of the suction pipe that was rendered inoperable, i.e. the origin of this accident*

*Location of the former dye tank (under the pipe at the origin of the explosion)*

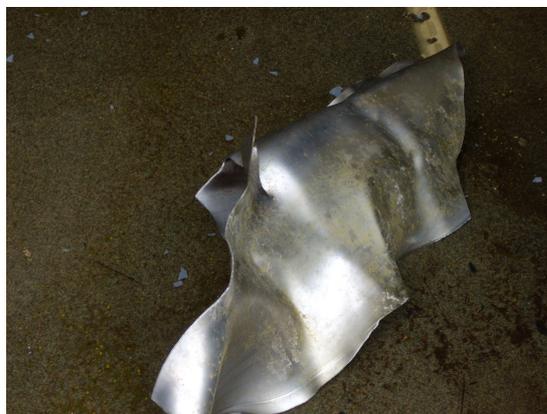
Pyrotechnic dust residue (a yellowish substance with powdery texture) was present on the metal debris of the stripped pipe (found on the floor of the workshop and outside the building, along the path of the foil that had been ripped apart). These observations indicated that **the pipe had not been adequately washed** during preliminary rinsing steps.

**Metal debris, from the pipe blasted by the explosion, found on the floor. The picture on the left shows residue from pyrotechnic dust (yellowish) covering the inner pipe wall.**

The fire most likely broke out due to ignition of this powder residue and/or pyrotechnic dust accumulated inside the pipe. This build-up was correlated with the **heating produced by friction of the metal saw blade on the stainless steel suction pipe (hotspot).**

The operator extended and consolidated its dedicated procedure. **The cleaning guideline would contain a checklist** detailing, workshop by workshop, the sequence of preliminary washing operations to be performed depending on the specific situation (index change, weekly cleaning, installation shutdown). A fact sheet recorded the successful execution of these operations and was submitted to a manager for final validation. These preliminary measures allowed the manager responsible for the validation step to authorise or reject subsequent works. This modified order, with a double validation required by both technician and management prior repairs, was tested during the winter 2014 closure.
