Ammonia leak within a slaughterhouse

June 11, 1997

Cuiseaux (Saône et Loire)

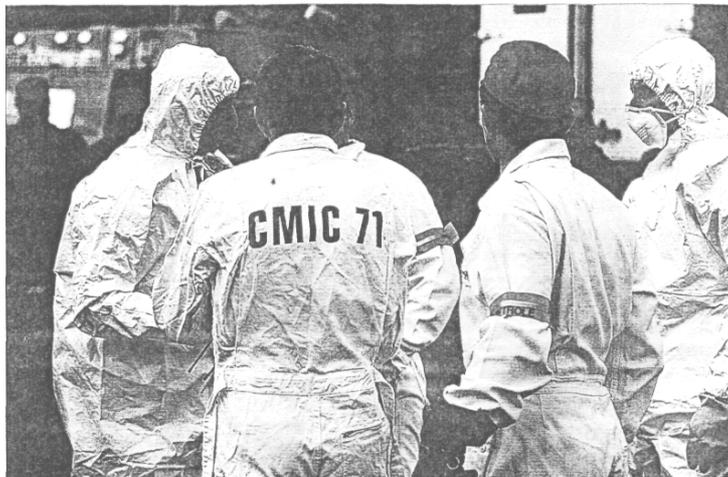
Fire-fighters on the scene (from the magazine "Sapeur pompier", October 1997 issue)
