Explosion of a cereal silo

August 20, 1997

Blaye – [Gironde]

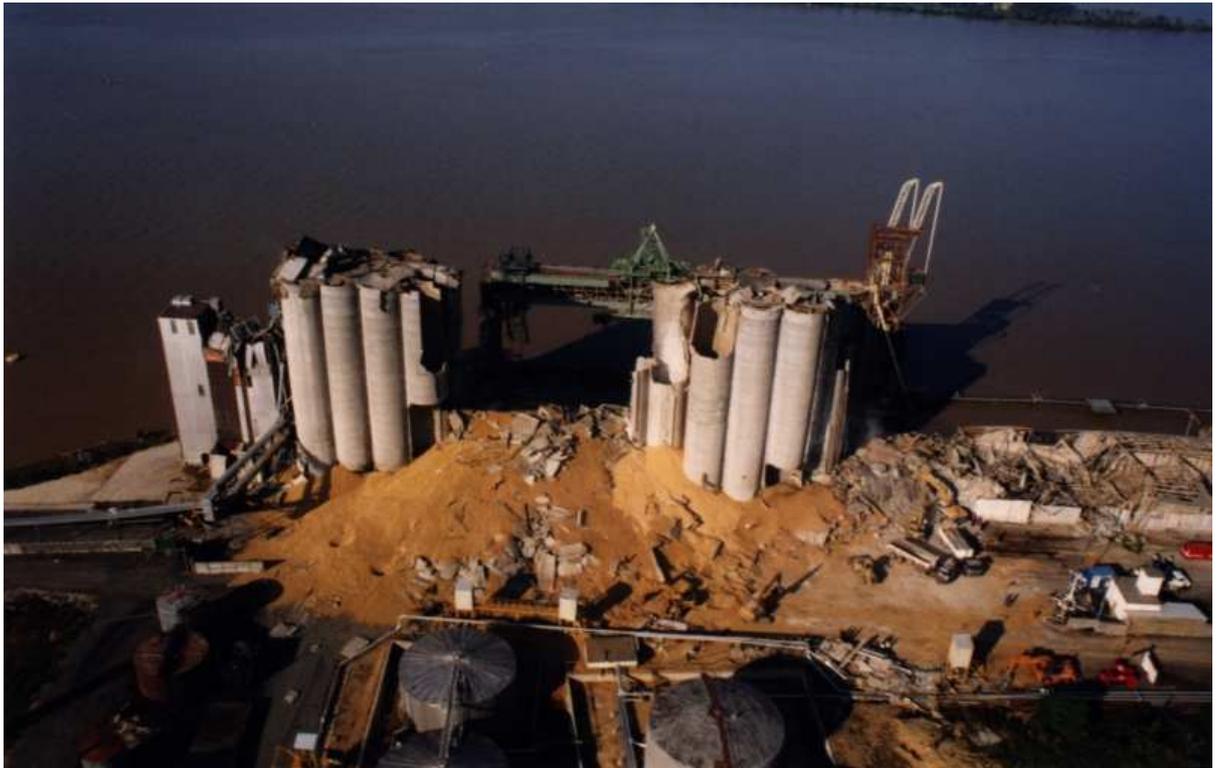
The vertical silo collapsed over its central and northern parts, with the northern part effectively burying the installation offices. Only 16 of the 44 cells were still for the most part intact after the accident, 9 on the south side and 7 on the north. One characteristic of this disaster was the collapse of two sets of cells: the first on the northern end, which had abutted the material handling tower; and then the central section of the silo (see photo).

The northern handling tower, as well as the immediately adjacent cells, were almost entirely destroyed. Over roughly half of its initial height, just a curved half-shell of this tower was still standing, as the tower's sides that had formed the walls of adjacent hoppers were slammed backwards, onto the shaft of a neighbouring cell. This observation indicates the presence of an explosion within the handling tower, which would have occurred after the eventual explosions taking place inside the adjacent storage units.

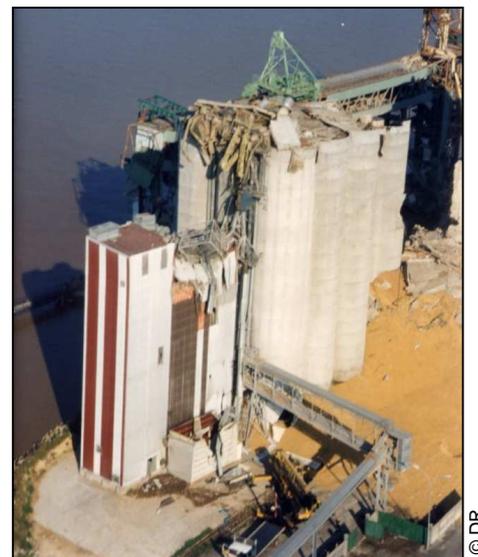
Southern silo zone

The southern tower slumped onto the tops of cells. Components of the cleaners-separators (rubber balls from the sieves) found calcinated at the surface reveal the passage of fire or expansion of burnt gases in this tower.

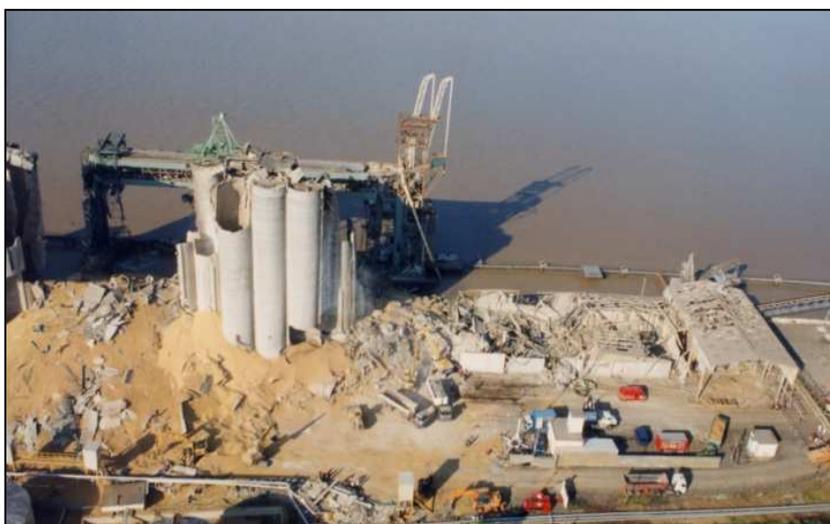
Northern silo zone

The elevators located inside the handling tower sustained heavy damage; the observations that could be recorded indicate that the drive pulleys showed no traces of slipping, as the axles of these elevators did not seem blocked in their main bearings, and the scraps of metal duct found had neither swollen nor burst; moreover, the pieces of bucket straps recovered showed no signs of combustion. The elevators located in the southern part of the silo were rather damaged by the collapse of surrounding concrete structures; no trace of combustion could be identified on these facilities other

than a mark roughly a meter long on the external part of an elevator duct. The reclaim conveyors in the under-cell space were damaged by collapse of the storage units. A good number of upper covers on cases housing these conveyors were blown off. In the northern part of the silo, a conveyor displayed unmistakable signs of friction at the head (leading part) and many blades on the conveyor chain were missing.

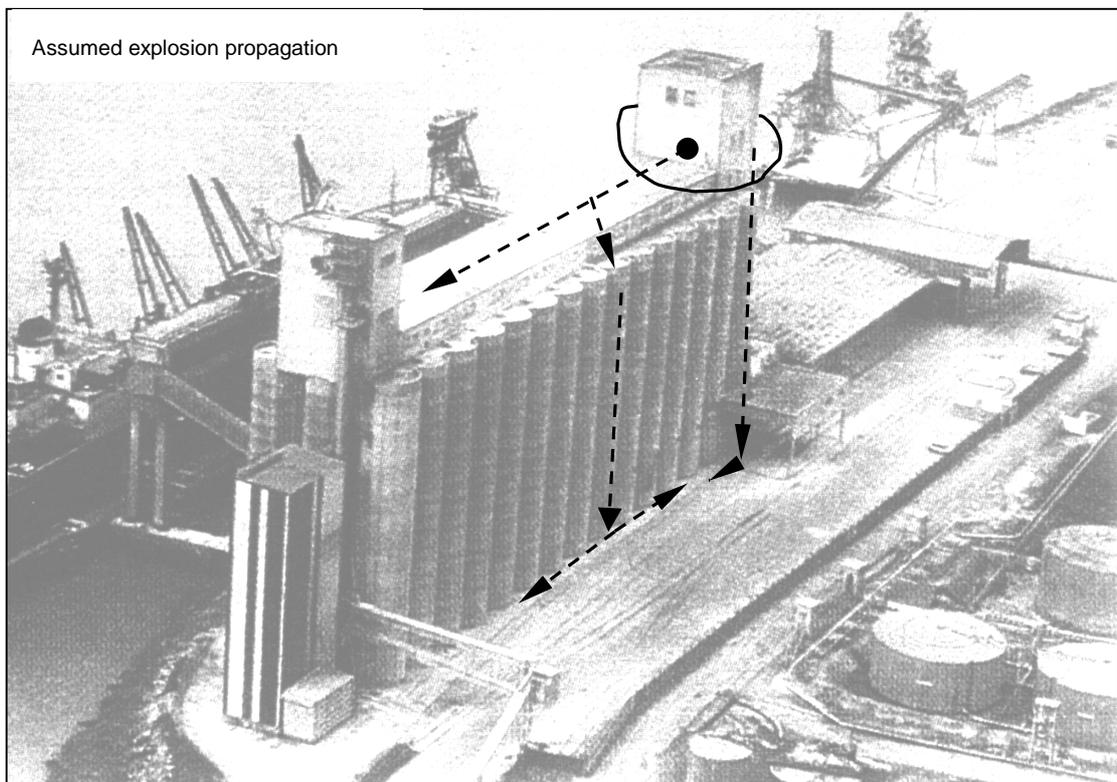
At the northern handling tower and simultaneous to bursting of the transit cell, the explosion gathered strength from top to bottom. The pressure level reached could not be contained due to the absence of venting surfaces, resulting in destruction of the northern handling tower. The vector of propagation was neither the elevator ducts nor the centralized dust suction circuit pipes. This propagation therefore probably took place within the tower volume, a finding that still presumes however the presence of an inflammable cloud within this space. In excluding the presence of eventual deposits, only an accidental dust spreading mechanism could have given rise to suspending these dust particles from top to bottom in the handling tower. The only foreseeable process capable of spreading a significant quantity of dust in this manner consists of a break downstream of the dust suction fan, under the hypothesis of a break in the dust bin.

The explosion spread to the under-cell part, either via the base of the handling tower or most likely, according to the independent investigators, via the hoppers positioned at the intersection of the two building segments. With this last hypothesis, propagation of the explosion via the hoppers would enable the flame to accelerate sharply, due to the geometric configuration (an H/D ratio near 10), while inducing sizable pressure effects. Under such conditions, the pressure waves emitted at the lower hopper outlet can easily be intensive enough to destroy the adjacent storage units and, to a large extent, the concrete shell separating the under-cell gallery from the outside. These openings at the level of the under-cell gallery, just a short time before the flame struck, were able to serve as vent surfaces, thereby limiting the pressure surge reached within this same under-cell gallery.

The photo below shows a schematic depiction of the supposed explosion path. Overall, the explosion phenomenon could have lasted several seconds.
