# Collapse of the dam of a tailings pond

25 April 1998

**Aznalcollar**

**Spain**

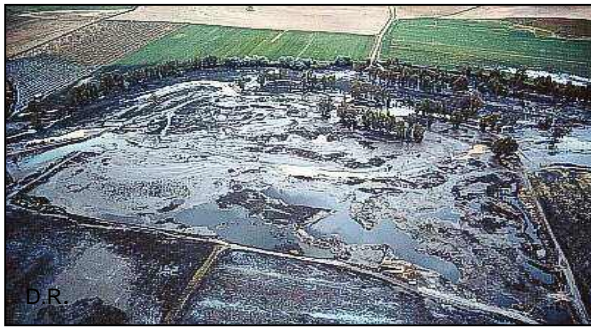
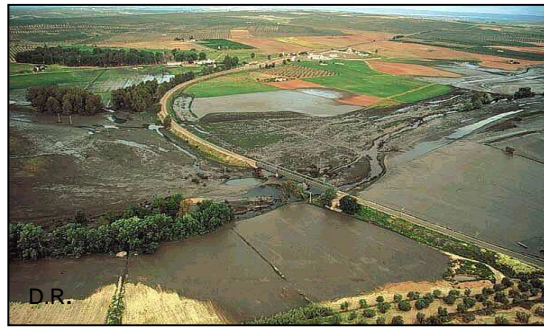
*Thousand of hectares of land polluted*

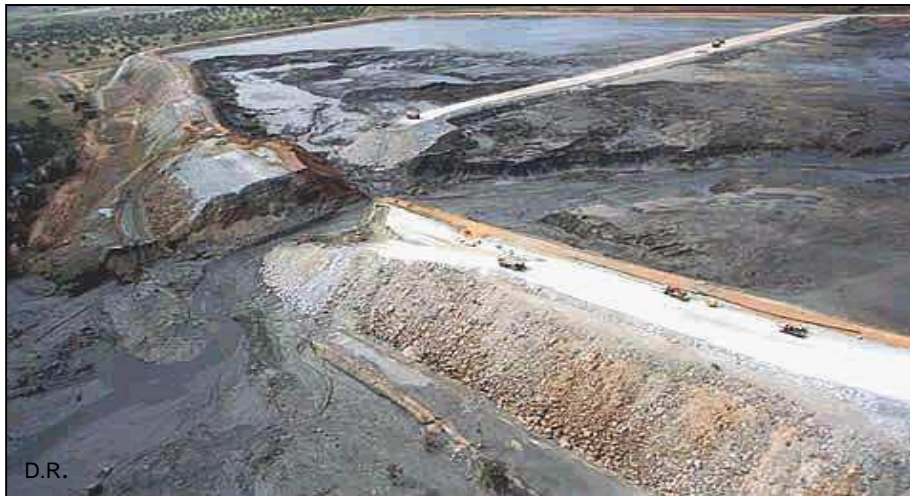
➤ **On 25 April 1998 at around 2.30 am**, a landslide caused a breach in the dam separating the two ponds, as well as in the 50m peripheral dam. The two ponds contained 31 million tonnes of waste in all. 3 million tonnes of sludge and 4 million tonnes of acid water were released that drained into the RIO AGRIO and GUADIAMAR whose level rose by 3.6 m in 30 min. The suspended matter level in the RIO AGRIO river were recorded at 30 g/l.

*Aerial view of the tailings pond*

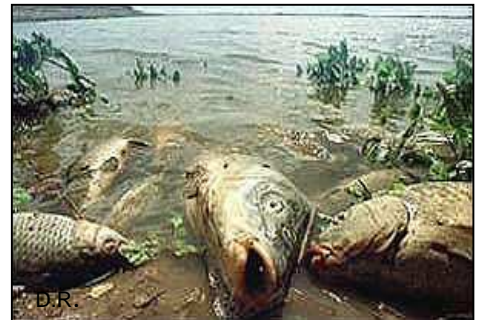
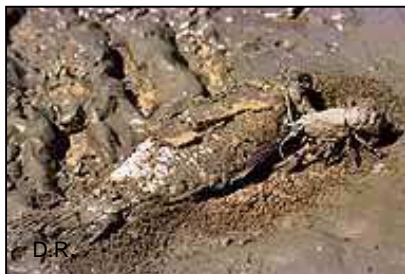
*Carp buried below sludge*

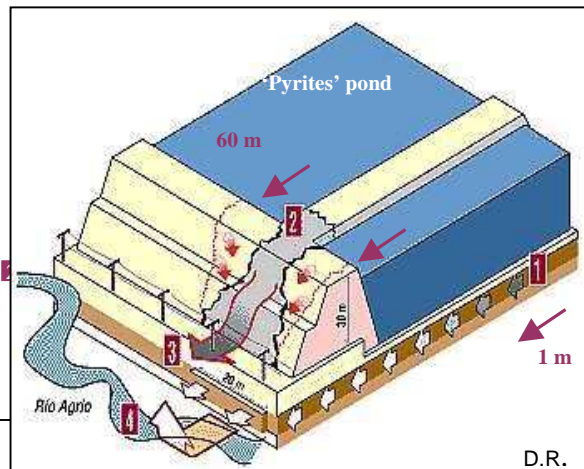
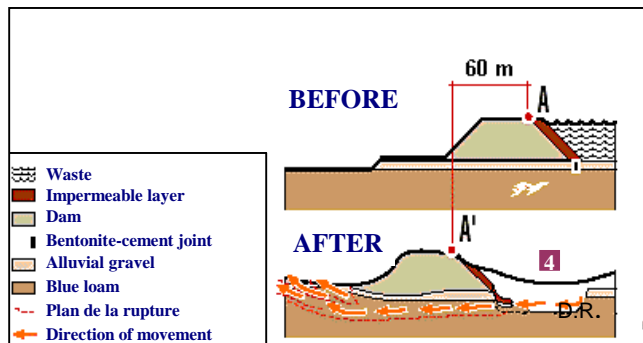
- The accident took place in 3 phases:
  - the separation barrier cracked when a 30mX20mX14m alluvial and marl plate located at the junction of the two tailings ponds slid over 1m, **1**
  - the supernatant waste in the 'pyrite' pond infiltrated the crack. The increased pressure on the peripheral dam along with a decrease in the resistance of its foundation accentuated the original sliding phenomena causing the main dam to slide up to 60m sideways, its deflection at 2-3m,, several cracks and spillage of waste, **3**
  - the waste flooded below the dam**4**, that collapsed at a 50m section releasing the sludge and acid water.

- The collapse of the dam could have been due to the combination of several factors:

- Design and construction flaws,
- Degradation of the clayey subsoil exposed to acidic waste and further strained due to the high pressure resulting from the water and sludge,
- overfilling of the tailings ponds

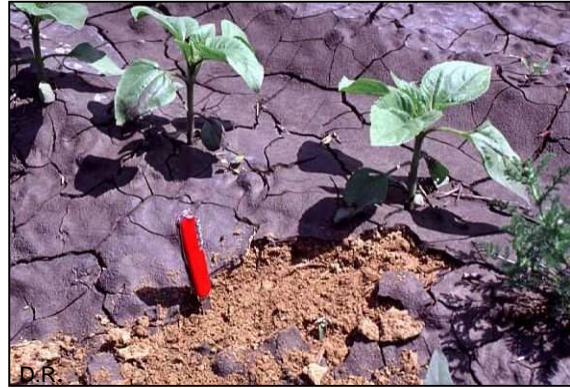
*Impact of pollution on soil (4/5/98)*

- The authorities implemented monitoring programmes coupled with restoration and surveillance of:
  - water quality at 70 sampling points spread out from RIO AGRIO till the mouth of the GUADALQUIVIR,
  - soil quality: high iron sulphide, acidity problems (treatment with lime), high concentrations of arsenic or zinc (treatment with iron oxyhydroxide), etc.
