## A violent fire in a processed pork product manufacturing plant

June 19, 1998

**Ambérieu-en-Bugey – [Ain]  
France**

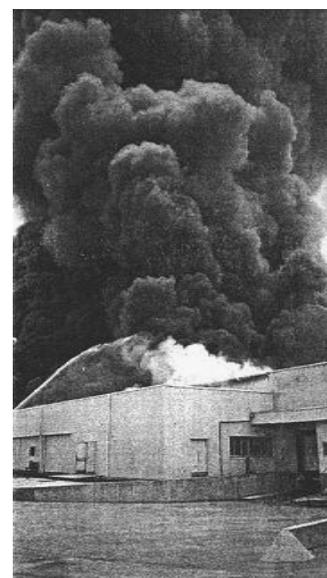
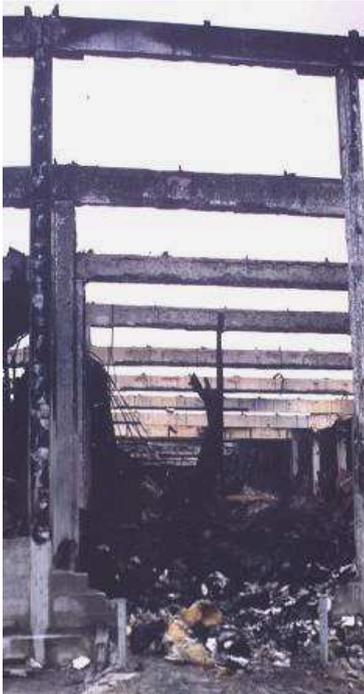
A fire broke out in the processing plant on June 19, at around 1.25 pm. The alarm was sounded and the emergency services arrived at the site 7 minutes later, although the fire had already become widespread. Four-thousand square meters of the plant were engulfed in flames in just 17 minutes (sandwich panels), spewing thick smoke.

Despite the progressive arrival of reinforcements, the 15,000 m<sup>2</sup> of the operations building and the refrigeration units (F22) were destroyed in less than 2 hours. The emergency services confirmed several elements that explain how the fire was able to spread so quickly and the difficulties in combating the fire:

- ✓ The construction principle retained, a box (sandwich panels) within a box (siding and roofs), without a smoke ventilation system, initially leads to the confinement of the heat and radiation inside the double shell preventing hot gasses from escaping.

- ✓ Insufficient, or even inexistent partitioning combined with the extensive use of polyurethane foam sandwich panels (wall and ceiling). These M1-classed panels offer no resistance above 300 °C, increase the thermal load and generate dangerous gases and volatile materials that fuel the flames which spread through the walls "like blow torches".

- ✓ The metal framework elements collapsed in the fire and the use of bituminous profiled steel roof panels lead to the melting, flowing and combustion of the bitumen.
