## Fire in an archive warehouse

January 28<sup>th</sup> 2002

Roye [Somme]

France

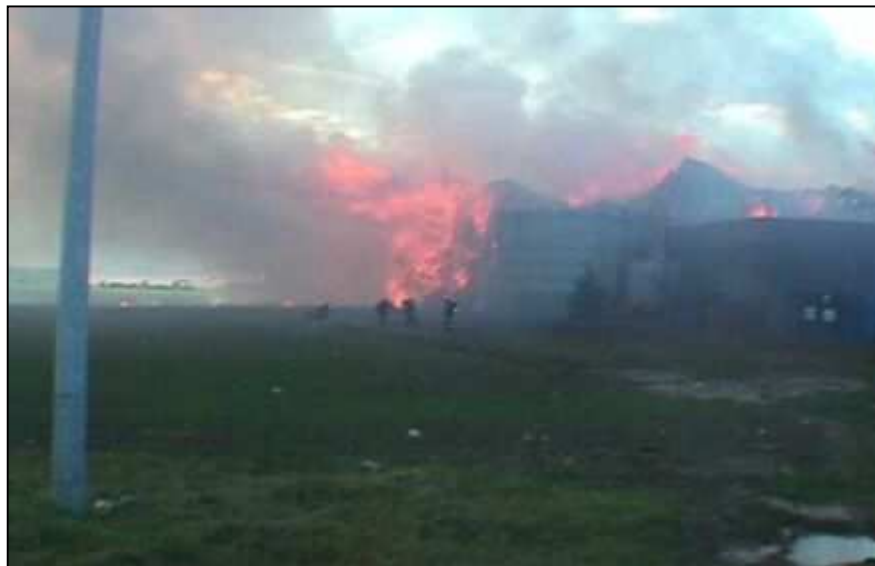
Photo DRIRE PICARDIE

Warehouse on fire, the (wind blowing towards the source)

At 11 h, the external structure of the warehouse collapsed inwards. The internal racking and gangways had already collapsed and did not resist the fire for more than half an hour.

The flames reached a height of some fifteen metres. These were beaten to the ground by the collapse. Meteorological conditions were characterised by a violent wind of over 100 km/h which probably stoked up the fire but also violently dispersed the hot gases and considerably reduced the lateral heat radiation.

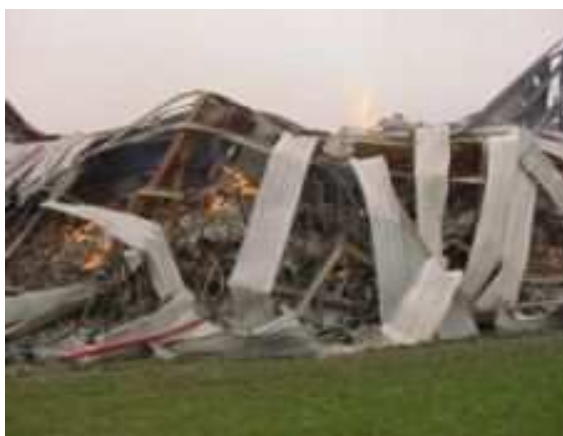
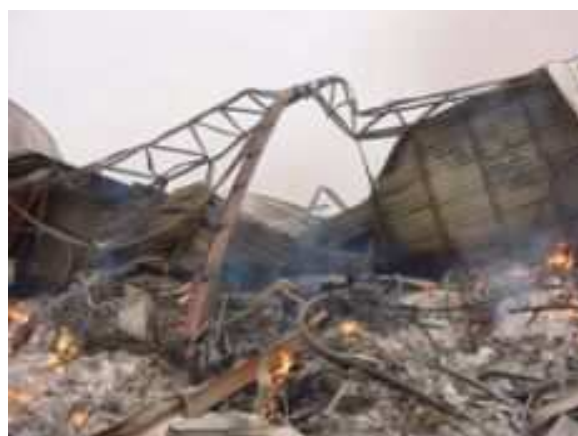
Photos DRHE PICARDE

The fire destroyed the two cells of the warehouse and everything that they contained: the archives of several financial companies and a part of those of public hospitals. The structure of the larger cell was totally ruined. The cladding of the smaller cell survived on account of the protection provided to the administrative building by the firemen. The cost of the damage not being available, this information does not appear in the scale below.

The collapse of the structure of the large cell generated the fall of the firewall and destabilised the structure of the smaller cell. The fire resistance of the internal structures was very clearly inferior to half an hour. The metallic structure of the warehouse resisted the fire for about 45 minutes.
