# Atmospheric pollution generated at a refinery

September 16, 1998

**Petit Couronne (Seine-Maritime)  
France**

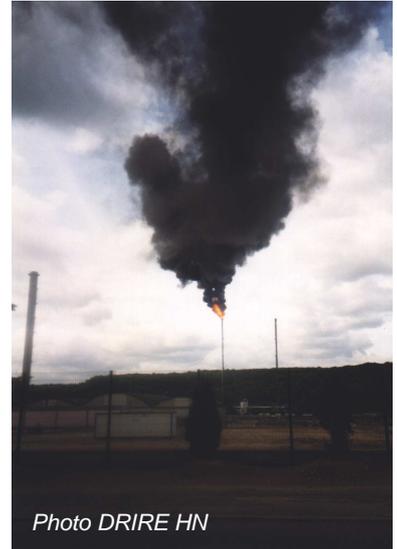
Photo DRIRE HN

Spectacular plumes of black smoke were emitted at the flare for several hours.
