Leak and ignition of toluene

December 3rd, 1998

Saint Vulbas – [Ain]

Fine chemistry
 Production workshop
 Commissioning
 Design / Ergonomics
 Underdimensioning
 Material selection
 Organisation / Management of modifications
 Procedures
 Human factor
 Automatic control systems / Instrumentation
 Electrical defect
 Victims

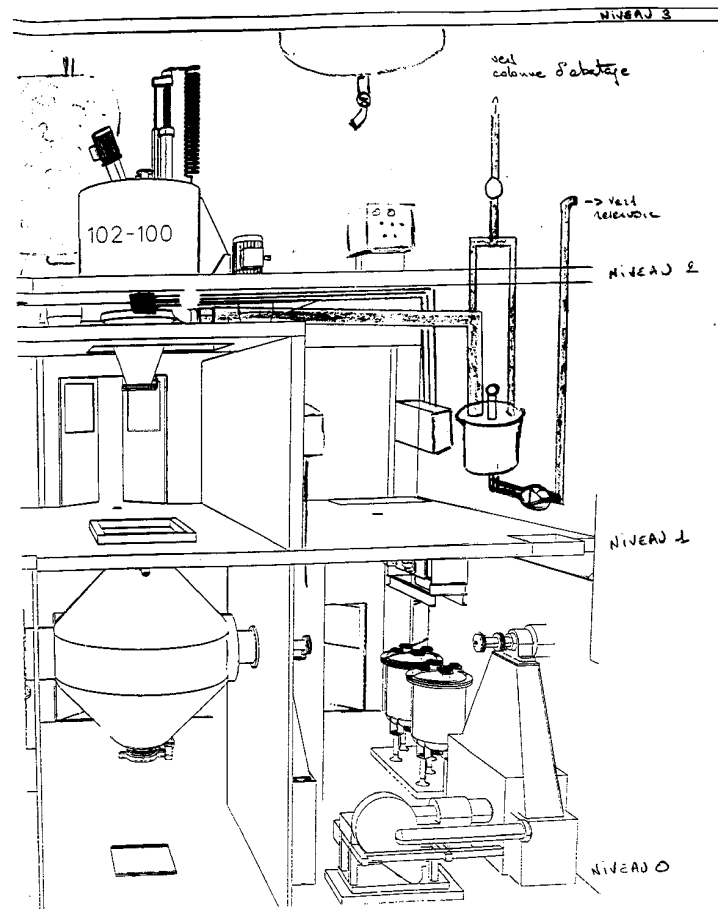
The installation which is associated with the manufacturing reactors includes a dryer (3,000 l) connected by pipe with hydraulic seal to a plastic 300-liter solvent collection tank located 2 metres below in a room without a retention system and for which the electrical equipment are explosion-proof. The collection tank, designed to resist a pressure of around 45 mb, is fitted with a cover (60 to 70cm in diameter) and a high level sensor which is slaved to a transfer pump. The solvent (sea water) is stored in a container prior to evaporation and recycling or disposal.

The accident occurred during the 1st fabrication operation. Due to an electrical malfunction on a terminal strip (lug poorly tightened), the tank's drainage pump did not start and thus lead to the overflowing of the tank. The tank's hydrostatic pressure resistance was insufficient (cover not leakproof). The vapours most certainly self-ignited due the toluene's dielectric characteristics.

- a collection tank too small in relation to that of the centrifuge implicating numerous pump starts, lacking retention and too low resistance level in relation to the maximum possible hydraulic load (at least 150g),
- the presence of a single high level sensor (no backup),

- a questionable choice in terms of the materials used for the tank and its pipelines (plastic poorly adapted to the dielectric characteristics of toluene).

- ➔ changes made in certain operating sequences,
- ➔ holding under pressure and instrumentation of centrifuge drainage tanks,
- ➔ improvement of the explosive atmosphere detection system,
- ➔ overflow prevention during automated delivery of solvents via the storage yard,
- ➔ by-pass of the mobile safety valve on the reactor supply line.
