Explosion inside a pyrotechnic plant

August 7, 1975

Pont de buis les Quimerch [29]

France

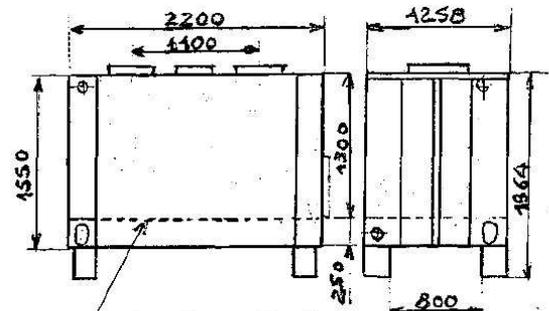
The boxes contained a thin fabric on which the powder was laid in place. The most heavily used boxes often revealed the telltale signs of handling incidents: indentations on the sheet metal; impacts on the side door closing handles, making it necessary to shim the door; torn fabric, etc. Despite having washed the boxes after each operation, the presence of powder (up to 3 kg) in the double bottom was regularly noticed during repair work.

Bottom: Perforated metal sheet, with two perforated surfaces, for 30% of the total surface area. Slot: 3 x 20

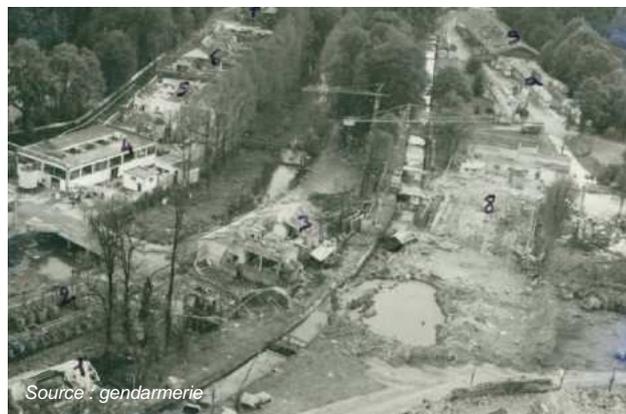
Crater where Building 211 once stood

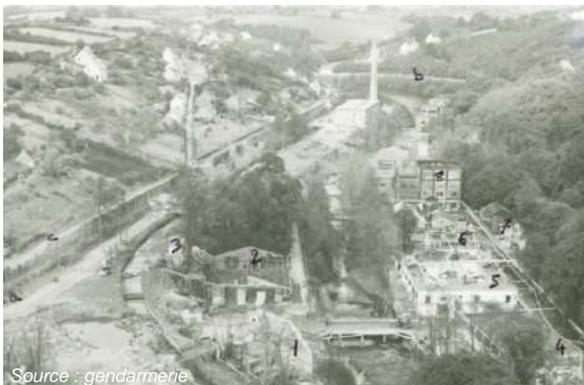
Lower left: Crater at the site of Building 211

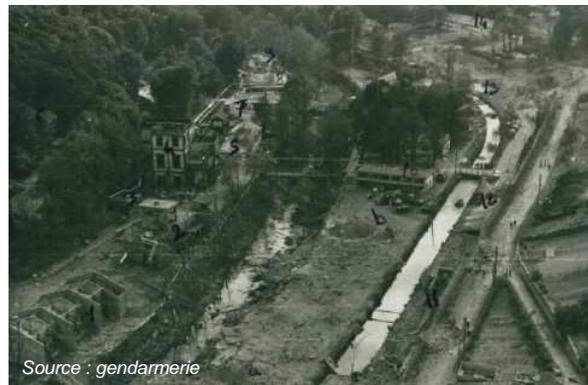
Centre: Craters where Buildings 314 - 319 stood

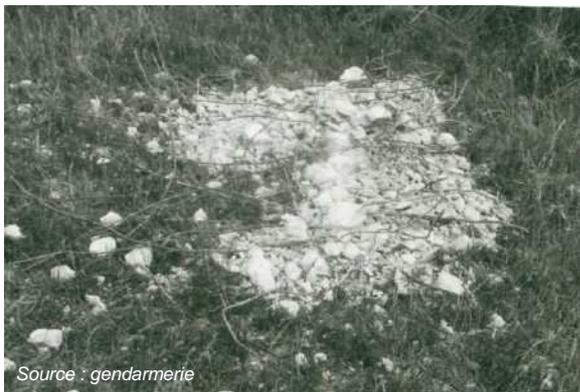
Concrete block in a field 450 m from Building 211

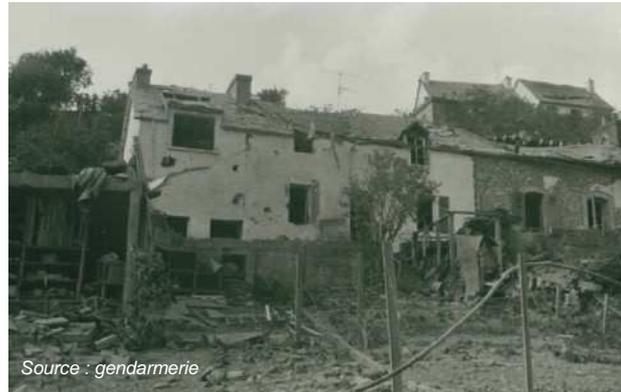
Outside the site, 90 houses were destroyed (collapsed walls and roofs), and another 300 to 400 were damaged to an extent of between 50% and 80%.

Damaged residences
