## Silane leak and fire in a gas conditioning facility

30th march 1999

**Chalon-sur-Saône (Saône et Loire)  
France**

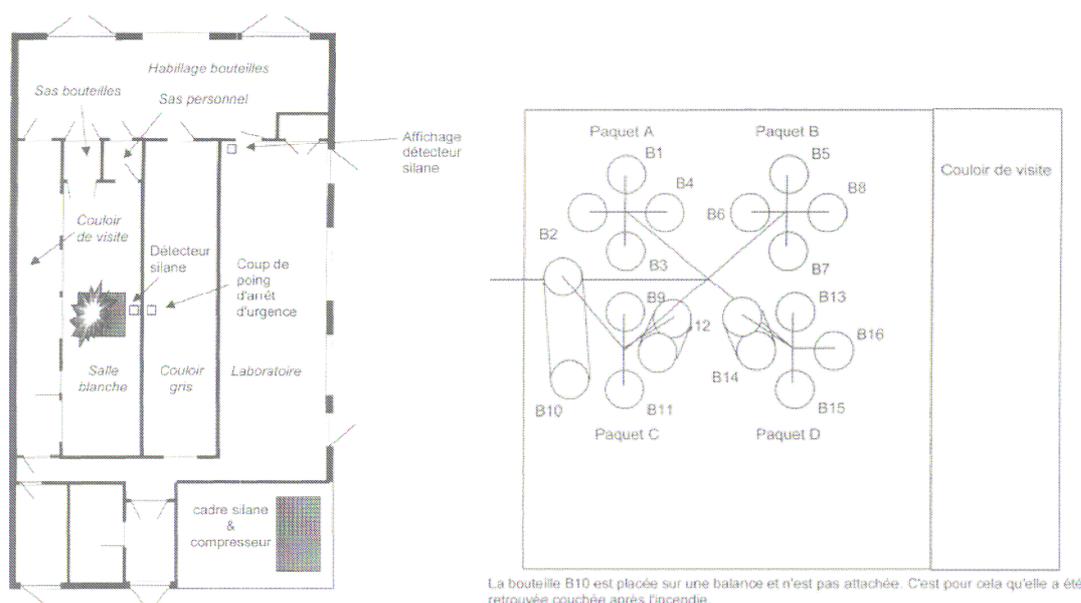
*Scheme of the building and bottle organisation within the white chamber (source operator)*

The installation itself is also at issue as it was designed to load phosphine type toxic gases: workshop confinement, dual ventilation and treatment with active carbon gas in case gas is detected. In this case, the silane caught flame spontaneously in contact with the air creating silica which quickly saturated the filters. Due to the confinement of the facility and the interconnection of the cylinders, the fire spread, strengthened by the presence of the hood and its combustible curtain. The temperature was so hot that the false ceiling collapsed. When the water sprinkler system was activated, the electricity was cut causing the ventilation system to shut down and the re-ignition of the fire when the firemen opened the doors. Also, the fire caused the Teflon seal on the cylinder valves to be damaged, resulting in silane leaks on the other cylinders.

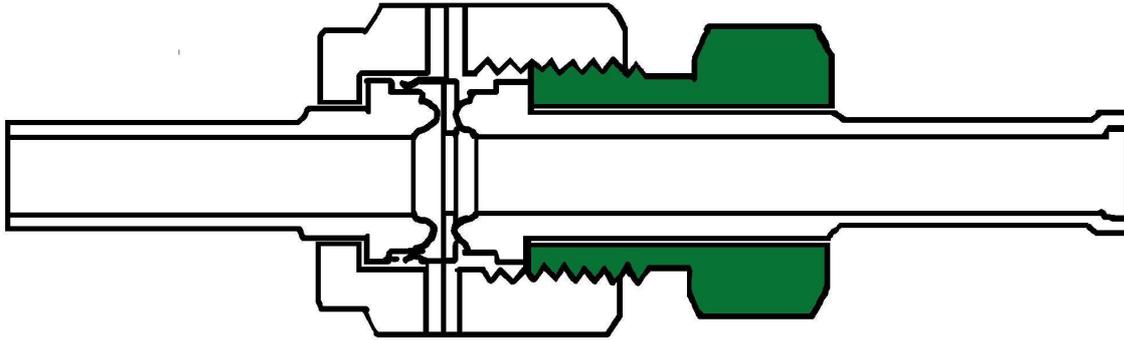
The origin of the accident was due to a defect in the design of the VCR connectors between the gooseneck and the valve on the cylinders. These components consist of parts supplied by different suppliers which lead to guide length differences of the fitting nuts. In some cases, this could lead to a cross threading which may be gas-tight at the time of leak testing but are rather precarious. In certain cases (hammering or humming transmitted by the gooseneck, shocks, vibrations...), the connection may shift slightly and develop a leak.

*Schematic diagram of a VCR fitting*

The cylinders were filled from a bank consisting of two independent half-banks: while the pressure in the system was stabilized at 17 bar, the operator switched from one half-bank to another and set the pressure of the system at the latter's pressure, or 60 bar. The overpressure probably caused the seal on the VCR connector to suddenly burst.

The VCR connectors must be reviewed (parts of the same origin, connector locking...), and leak tests should be given more importance. All of the cylinders must be able to be closed independently and be isolated by a fire protection, response in case of accident must be better studied, and finally, the design of the facility must be reviewed (hood made of non-combustible materials, heat-resistant false ceiling support structure, smoke ventilation triggered automatically upon detection of smoke, and the room must be insulated by a fire-stop door ...).
