## Explosion in a dynamite manufacturing plant

March 3, 1988

**Ablon – [Basse – Normandie]  
France**

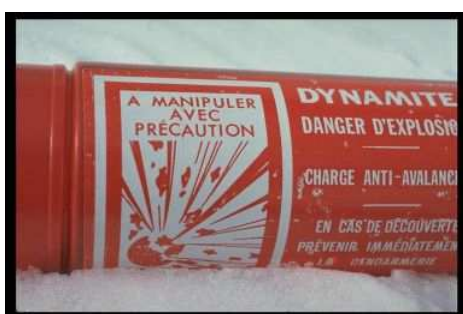
*Figure 2* – SOFRANEX dynamite cartridge

Difficulties continued despite the attempted solutions. The film appeared to move laterally in a random manner and did enable the welding head to operate in a regular and complete fashion. As the cartridges produced were poorly closed, the dynamite spread through the clipping and cutting station, and onto the transport trolley.
