Rupture of a phosphoric acid storage tank

23rd April 1999

Rouen (Seine Maritime)

France

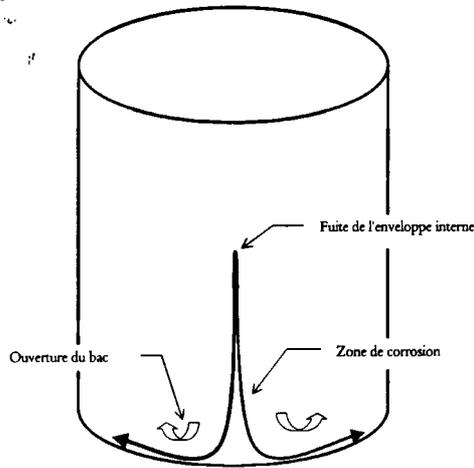
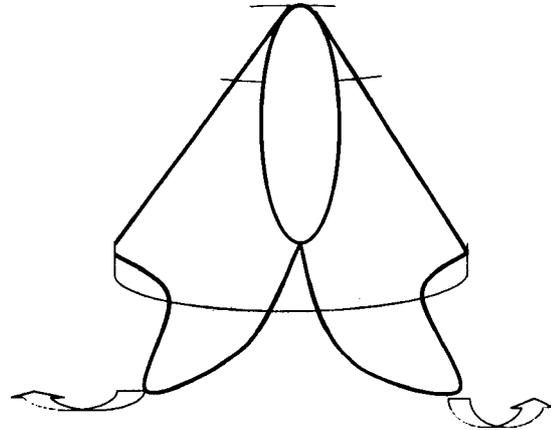
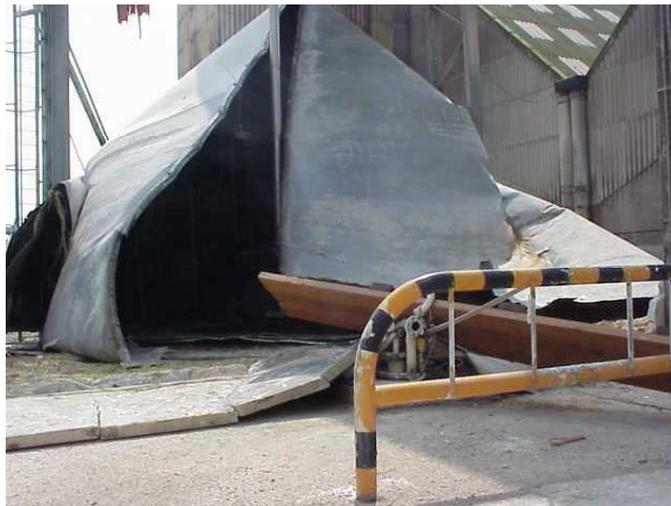
Lack of metal on the generatrix of the lower ring of the structural casing, significant thickness loss on the following three rings along the same generatrix, and a rip in the structural casing along this generatrix.

Significant corrosion was noted at the foundation skirt junction level; a symmetrical opening of the foundation skirt junction in relation to the cylinder's corroded generatrix.

There was a failure in the seal which initially occurred on the internal casing at the level of the 4th ring of the structural casing. As both casings were not bonded, the acid leak was routed vertically causing the corrosion along a generatrix and then along the foundation skirt junction. The repair carried out by the maintenance department did not correct the weak point between rings 2 and 4 of the cylinder.

Furthermore, the pressure exerted by the acid is far greater than that exerted by the water during the resistance test (1,640 kg/m³ for phosphoric acid). The rupture occurred suddenly and the wave effect created pressure on the retaining walls must be greater than the hydrostatic pressure. In addition, defects were discovered in the concrete reinforcement: the reinforcement bars were not correctly attached.

Destroyed reservoir (Source DRIRE)

The damaged tank was not returned to service. As the storage requirements for phosphoric acid were limited to 3-4 weeks, the operator wanted to use another tank normally used to stock sulphuric acid.
