Fire outbreak in a silo at an agricultural cooperative

29 June 1999

Lusignan (Vienne)

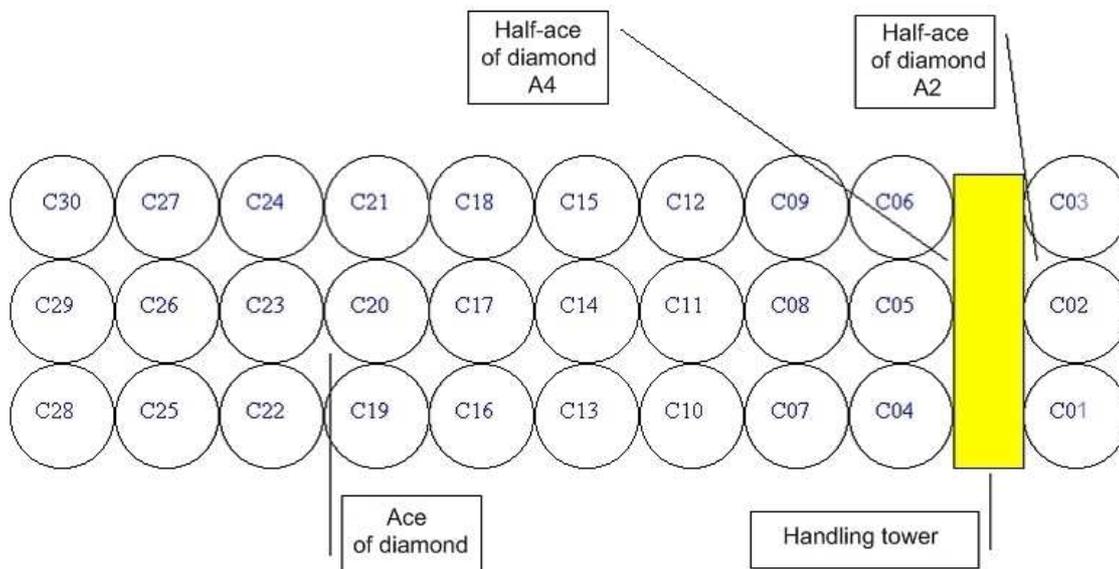
Summary diagram of these installations (Regional department environment, Poitou-Charentes)
