## Accident on a cooling box of a feed chute of a furnace in a refuse incineration plant

22 July 1999

Saint Ouen [93]

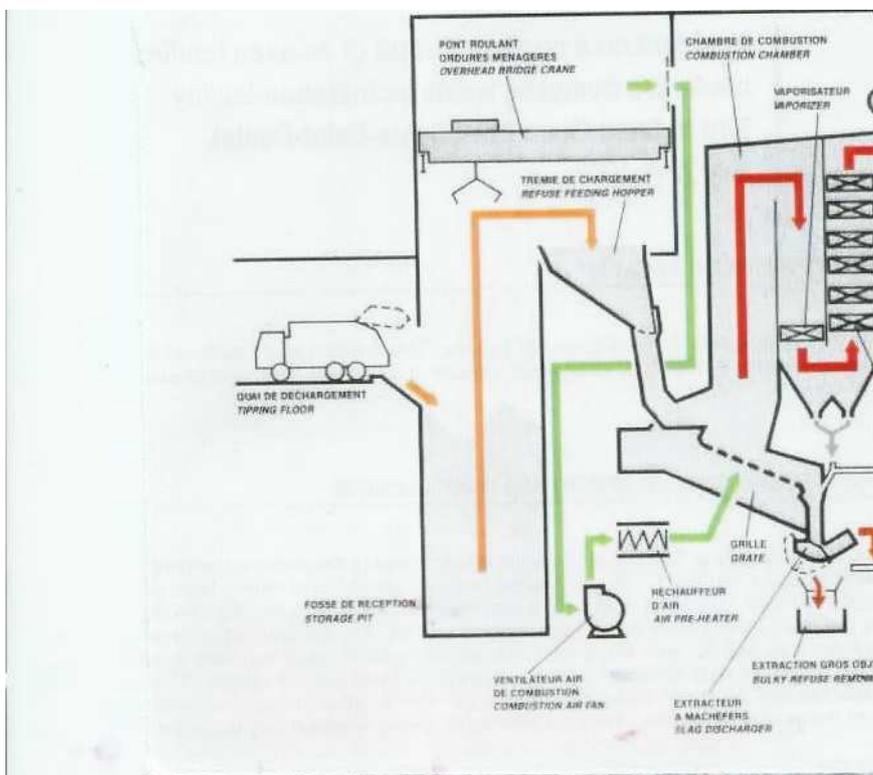
The lower part of each feed chute of the furnaces must be cooled to avoid heating and deterioration of metal plates exposed to thermal radiation from the furnace (temperature of 1000 °C). A "water jacket" system comprising 20 2.5m long cooling boxes containing water flowing at a pressure of 3 bar between the plates (8 and 16 mm thick) is used for cooling. The waterway is fitted with valves at the inlet and outlet of each cooling box divided into four compartments by three baffle plates.

Water leakage was detected between 4 and 8 July when the facility was stopped for standard maintenance. According to the operator, leakage is usual given the constraints to which the metal plates are subjected (expansion resulting in cracks). To overcome this repeated malfunctioning, the operator removed the waterway in one of the cooling boxes of furnace 1 and filled the cooling box with insulating concrete. The same operation was carried out on one of the cooling boxes of furnace 3 to observe how well the new procedure worked, since this furnace was scheduled for technical overhaul in two months. The amount of concrete used to fill the cooling box was not controlled. The drain valve was left open during drying to avoid any rise in pressure and was maintained in open position.

The facility was re-commissioned on 8 July and was reported by the operator to have functioned normally without any malfunctions until the accident. The explosion took place at the level of the concrete-filled cooling box that was severely damaged, the outer plate was ripped out and the inner plate bent towards the furnace, indicating that the explosion actually occurred in the cooling box where the valve was closed. A closer observation revealed that the inner plate was also ripped apart and the flames from the furnace inflicted serious burns on the technician. According to the initial analysis the explosion is undoubtedly due to an abrupt vaporisation of water in a closed space.

- the valves installed on each cooling box are removed
- the isolating valves at the waterway inlet and outlet of each feed chute are fitted with travel stops
- the boiler can only be switched on if these valves are in open position and the facility will be shut down following any sudden closure of the valves despite being locked in position with guidelines provided and presence of instruction plates.

An expansion balloon can be used to counteract the effect of the gradual increase in pressure. Moreover, the waterways of the cooling boxes exposed to thermal radiation of the furnace are first fitted with safety discs and then with valves since the operator must regularly shut down the furnaces to replace these discs.
