Hydrochloric acid leak at a storage site

May 12, 1999

Villeneuve-la-Garenne [92]

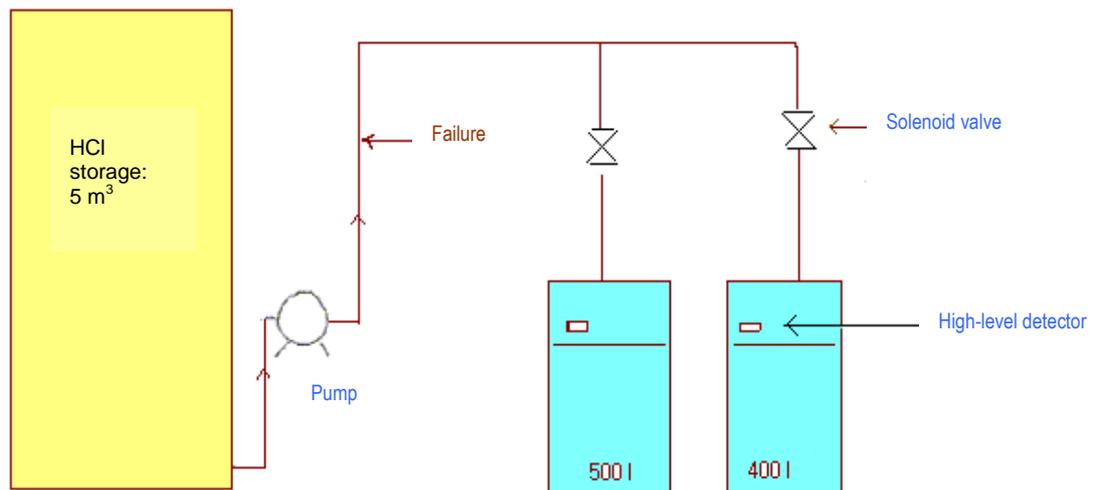
The installation:

The unit involved in this accident was dedicated to storing 35 percent hydrochloric acid used for regenerating ion-exchange resins.

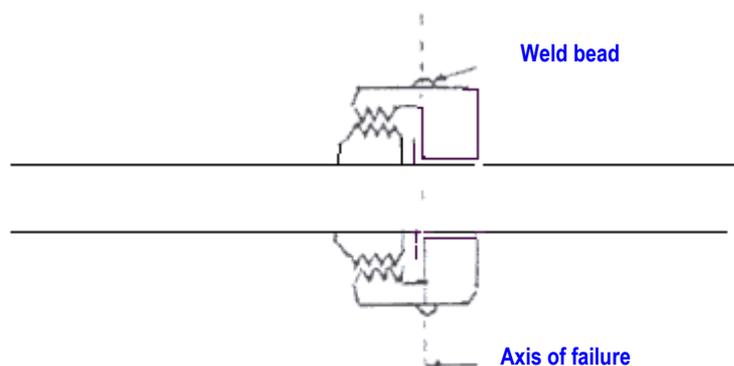
The leak resulted from a break in the 3-piece fitting; this failure had actually occurred during the previous set of works and was since re-welded by a plastics specialist. The weld turned out to be ineffective and the need for repair was not reported to the site operator.

On the day of the accident, an electrician modified the installation with the intention of programming pump start-up to coincide with the opening of solenoid feed valves on both hydrochloric acid tanks. The pump was activated but the valves remained closed. Pressure therefore increased inside the pipes until failure of the 3-piece fitting.

Not only had the pump been oversized, but the device relief valve had been placed too far from the pump (at the upper storage tank level). The pipe support structure was inadequate. As a final point, the only pump shutoff button was located adjacent to the pump itself and hence could not be easily accessed.

- √ Both the check valve and relief valve were removed.
- √ The PVC piping introduced into the installation without first inspecting all of the welds was replaced by braced PVC pipes: an expert evaluation had found defects at the level of taps located on the polyethylene tank dome.
- √ The piping was tested at 10 bar for an hour. No hydraulic trial had actually been conducted following the initial works. The remainder of the installation, which had not undergone any changes, was tested at 5 bar for a total of 5 hours.
- √ The tank was verified by being filled with water until overflowing. Three additional emergency shutoff switches were installed to allow turning off the facility remotely. All automated controls were also verified and an installation application procedure was drafted.
