## VCM leak in a chemical plant

25th August 1999

Tavaux (Jura)

VCM  
Organisation /  
Procedure  
Human / control flaw  
Autoclave

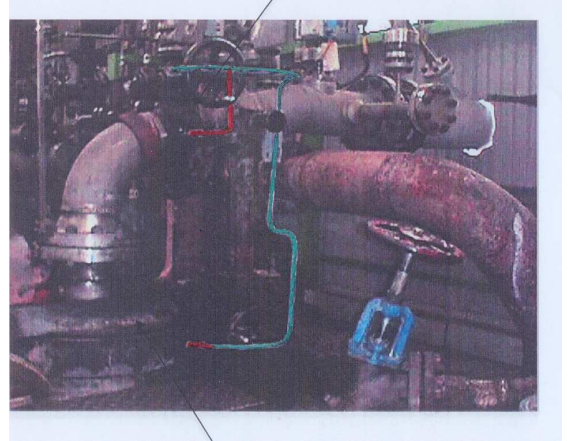
Considering its importance in the train of events, further information is provided about the autoclave's closure mechanism (see photo opposite).

It consists of a pivoting system comprised of the manhole cover and an adjoining elbow-shaped tube section enabling the autoclave to be connected to the overpressure protection system consisting of a rupture disk and a valve mounted in series. A seal is required at 2 levels: one seal is located at the cover/manhole junction, and the other is located at the junction between the elbow tube and the stationary overpressure protection pipe. Two jaws, one at each level and actuated by a lever, ensure the overall tightness of the device.

The rapid improvement of visibility in the hall enables the intervention by an operator and a fireman : they report that the jaws of the closure system on the autoclave/rupture disk junction are loose. The jaws were put back into correct position after having bent the safety rod (preventing the closure manoeuvre).

The inquiry showed that the launch of the operation was prepared normally and the technician began the habitual procedures, particularly the closure of the autoclave. However, the technician forgot to tighten the jaws of the previously described mechanism.

The leak did not occur immediately: only when the pressure was sufficiently high, that is to say at the end of the heating phase, the leak occurred suddenly at the "quick" junction. The mechanism remained in place although the seal slipped out of its housing causing the leak.

In response to the reported human failure, a mechanical device was installed by the operator. It now detects where the jaws are actually tightened during the autoclave vacuum operation.

The device and the corresponding procedures were in place as of late 1999 on all of the autoclaves of the same type and operating discontinuously.
