Toxic gas cloud emanating from a TiO₂ ore treatment plant

September 3rd and November 9th, 1999

Calais (Pas-de-Calais)

- Electrical failure
- Sulphur oxides
- Organisation / deficient process controls
- Check valve
- Automated device
- Washing tower
- Self-sustaining reaction

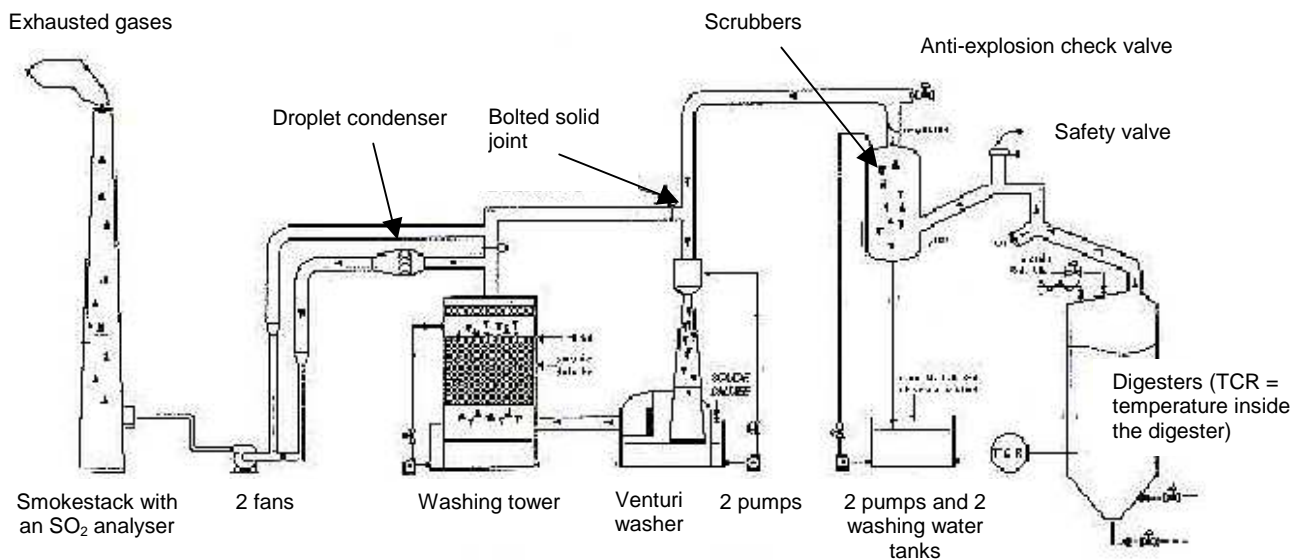
This "digestion" process consists of exposing the titanium ore to a sulphuric acid (H₂SO₄) attack. The reactive gases formed (SO₂, SO₃ and droplets of H₂SO₄) are removed by means of a water wash (using scrubbers), followed by two soda washes (Venturi washer and tower).

Treatment of digestion gases (Source: site operator)
