Rupture of a liquid fuel pipeline

July 28, 1989

Rosteig - [Bas-Rhin]

Explosion
Fire
UVCE
Piping / pipeline
Naphtha
Building works
(subcontracting)
Victims

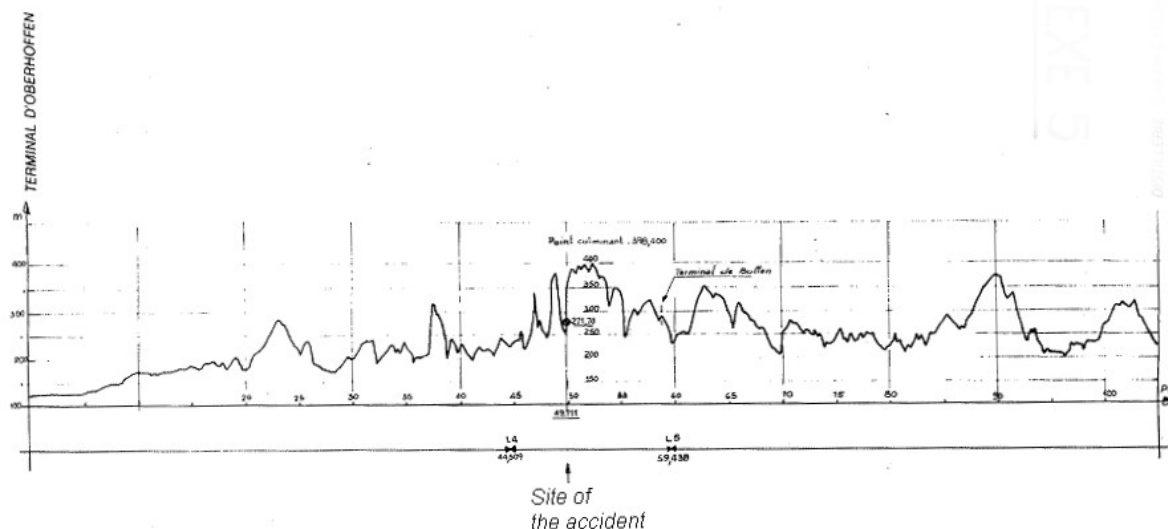
Lengthwise profile of the pipeline

Inside the zone where the accident occurred, piping was configured like a siphon with a 120-m elevation difference on one side and 100 m on the other. Three pipelines crossed this particular zone:

Once perforated, the Sarre pipeline was no longer operational, yet still contained naphtha under a hydrostatic pressure of close to 10 bar (16.6 bar at the Oberhoffen pumping station, elevation: 127.7 m). Since the pipeline was shut down, pressure at the leak point was determined by the liquid column height (approx. 120 m).

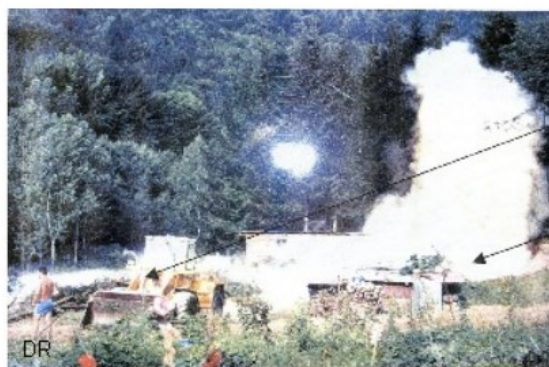
View of the project site at the time of pipeline impact

At 9:55 am, within the municipality of Rosteig, the bucket on a loader struck and punctured the Sarre oil pipeline while performing earthworks for a horizontal platform on an adjoining privately-owned parcel.

At the point of impact (elevation: 271.7 m), the loader was extracting ground materials from an embankment with a 15% slope, in which the punctured pipeline had been buried at an average depth of 1.2 m.

The size of the line opening measured about 40 cm², corresponding to the size of a tooth on the loader bucket.

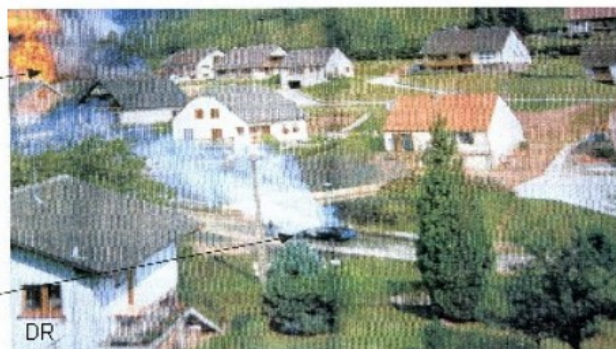
The village of Rosteig at the time of the accident

At 10:05 am, the local gendarmerie station was alerted by phone and dispatched a patrol unit to the scene. As the unit's vehicle got to within approx. 300 m of the pipeline perforation, the engine suddenly accelerated and then apparently stalled.

The thermal effects proved fatal for the two gendarme officers inside their vehicle, which had come to within 250 m of the leak before stalling, and for the civilian taking photographs roughly 150 m from the same spot.

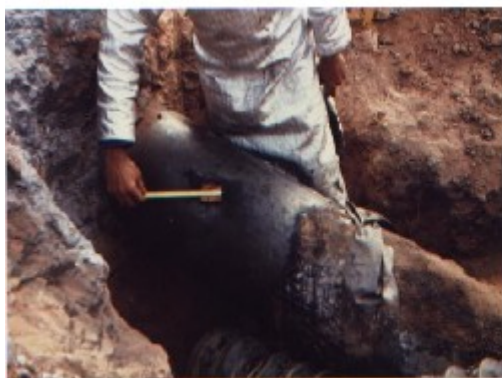
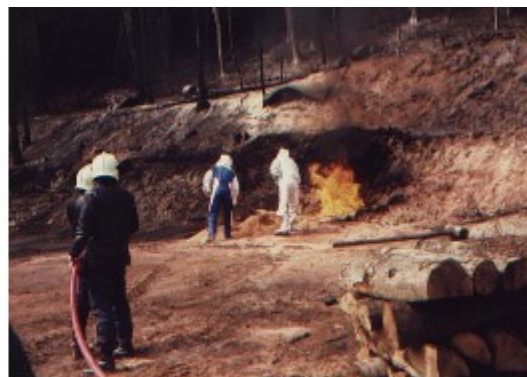
Repair work (temporary installation of a cone) and extinction (Source: DRIRE Alsace)

The decision was made to let the naphtha escaping through the break in the pipe continue to burn under close supervision: this combustion generated a flame some 2 m high that gradually diminished as line pressure decreased.

Taking advantage of the effects of a night-time drop in temperature on flame intensity, a wooden cone was forced as a plug into the pipe opening on July 30 around 6:15 am, followed at the end of the morning by installing a mechanical sleeve once the line had been partially cleared.
