Fire on an elastomer storage site

January 20, 2000

Clermont-Ferrand (63)

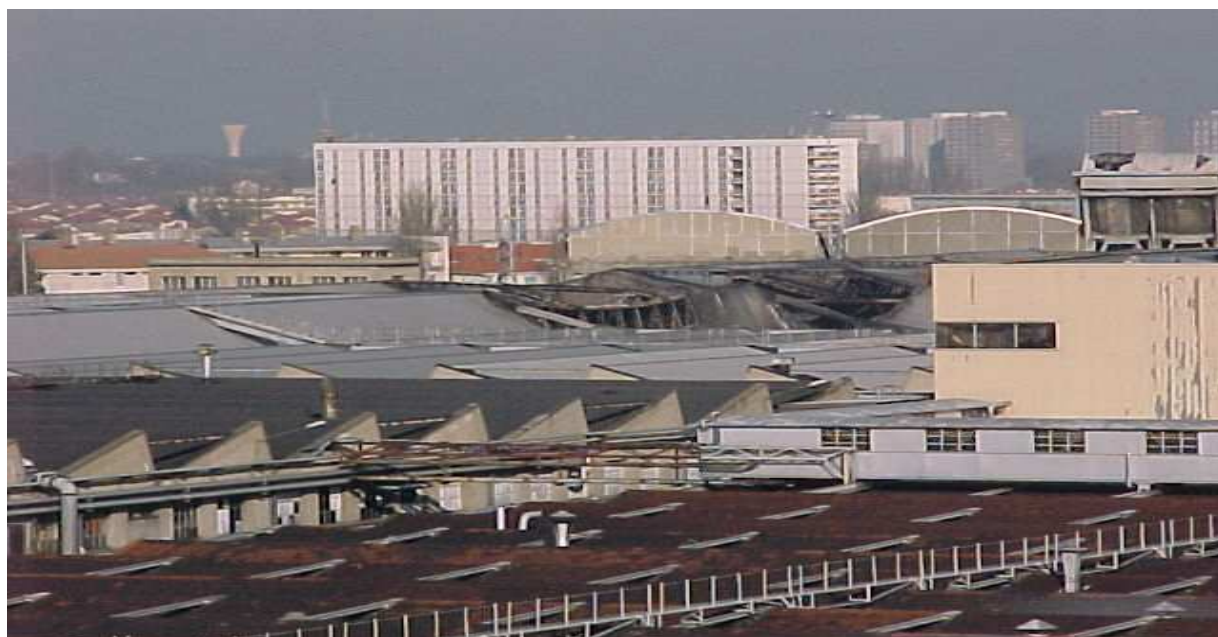
Photo DRIRE Auvergne

The plant was subject to authorisation under the terms governing installations classified as being installations principally used for combustion. The damaged building, built in 1958 and called O24 was classified by virtue of its long existence for the storage of rubber derived materials (receipt of declaration of 18th May 1987) It had been used as a tire manufacturing plant for civil engineering equipment until the early nineties.

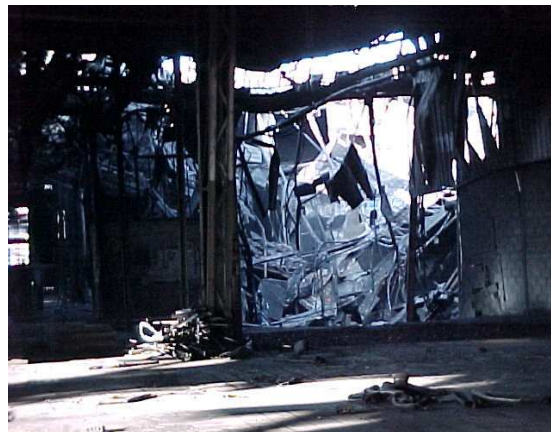
Photo DRIRE Auvergne

Material damage was serious. Most of the damaged building had to be torn down; 1 415 t of gum had been affected by the fire. The only important machine in the building, an automatic dosage weighing device (MAC BU), separated from the fire by a wall, was protected by the firemen and was not affected. This was also the case for the major part of the chemical products.

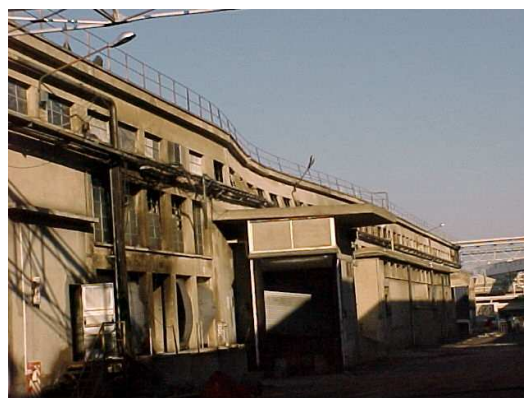
Photo DRIRE Auvergne

On the other hand, knowing the difficulties of extinguishing a generalised fire in gum, it would appear, with hindsight, that the fire could probably have been better contained and then beaten back if the in-house firemen, intervening with inadequate means, had called for assistance from the town fire brigade earlier.

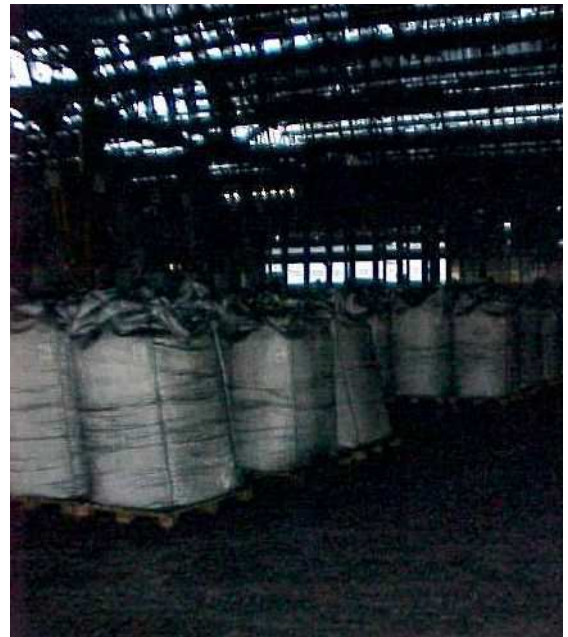
Photo DRIRE Auvergne

The absence of Vulcanox "lumps" in the sediments, the storage of 59 t of this compound close to one of the two chimneys of the fire (zone where the concrete slab had collapsed as a result of the fire) and the low apparent content of 6PPD in the sediments and the mud in the basement of the building outside certain well defined zones, made plausible the idea that a large quantity had been vaporised or burnt. This hypothesis is reinforced by several arguments from the plant operator.

- ✓ Heavy metallic elements in steel had been distorted under under the action of the temperature close to the "chimneys" of the fire, confirming that temperatures of the order of 800 to 1 000 °C had been reached,

- ✓ A plaque of 6PPD, melted then solidified, was found covering 150 m² confirming that part of the product had been liquefied by the heat (the melting point at atmospheric pressure is around 50 °C),

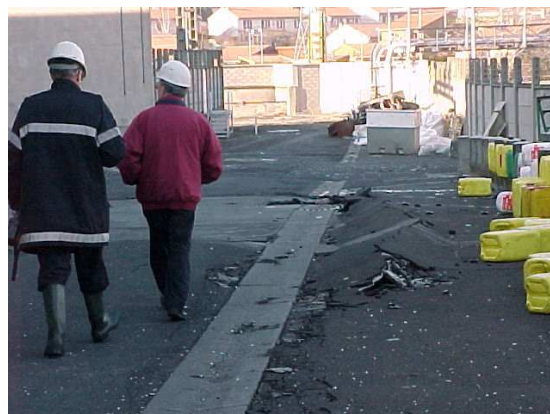
Photo DRIRE Auvergne

Special attention should be given to the state of buried pipelines: these have been susceptible to being damaged by the movements of the ground (dilation of the slabs resulting from the thermal effects of the fire).
