## Water pollution from a cyanide spill in Eastern Europe

January 30, 2000

**Baia Mare**  
**Romania**

Subsequent to the failure of a storage basin dyke on January 30, 2000, 300,000 m<sup>3</sup> of cyanide-laced effluent destroyed all of the flora and fauna over more than 600 km of river habitat.

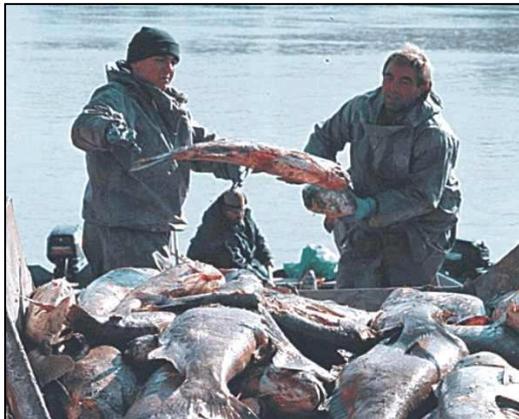
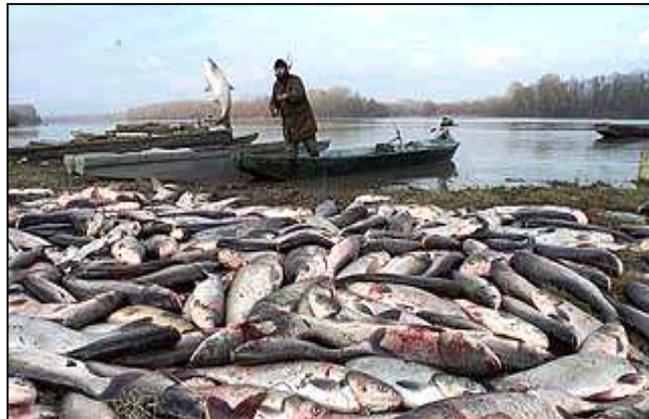
*Fishermen recover dead fish by the hundreds of tons*

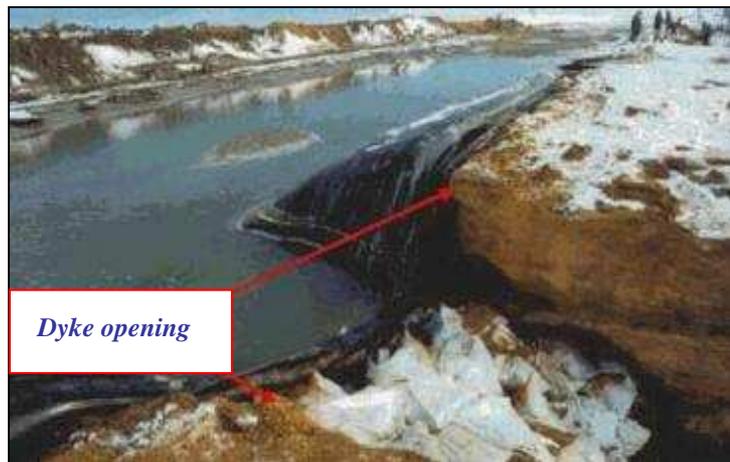
- At **10:00 pm**, due to water pressure buildup, a piece of dyke 25 m long by 2.5 m wide broke away from the interior dyke structure. A large quantity of effluent then poured out between the two dykes and flowed over the exterior dyke.
- A total of **287,500 m<sup>3</sup> of effluent** containing cyanide (115 tons) and heavy metals (Cu: 54.7 mg/l, Zn: 2.1 mg/l) contaminated a 14 ha area and polluted the SASAR River. A "wave" 30 to 40 km long with cyanide-laced effluent propagated over the ensuing days and weeks into the LAPUS, SZAMOS, TISZA and finally the DANUBE River.

➤ On **January 31 at 1:30 am**, the operator was able to partially plug the opening by using sediments from a neighboring dumpsite. The cyanide effluent, which nonetheless continued to spill at a rate of 40 to 50 l/sec, was gradually "neutralized" through adding sodium hypochlorite over a 48-hour period, until the leak had been totally obstructed. In conjunction with this effort, the southwest side of the dam was being consolidated out of precaution, and authorities in countries located downstream of the spill (Hungary, Serbia, Bulgaria and the Ukraine) were informed of the pollution event.

➤ The leak was entirely stopped on **February 2 at 1:30 am**, yet the dyke would continue to undergo further consolidation work for another 6 days. Moreover, during this time, the operator initiated works to decontaminate the polluted soils.

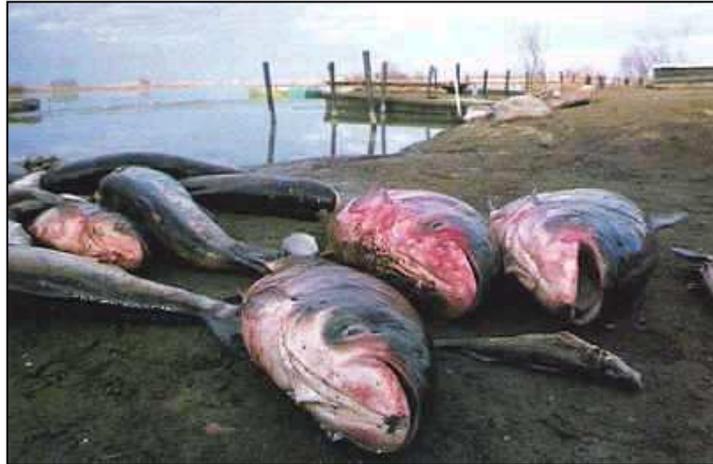
Aquatic mortality

According to Romanian authorities, only a small number of fish would have died in their country, as the introduction of an appropriate quantity of bleach had served to neutralize the cyanide and thereby limit its impact on the environment. On the other hand, the excessive addition of sodium hypochlorite by Hungarian authorities would have caused the death of most of the **1,241 tons of fish** extracted from this country's waters (sheatfish, perch, Danube salmon, sturgeon, etc.). A very high rate of fish mortality was also observed downstream over the Serbian portion of the TISZA.

While the exact causes of fish mortality could not be clearly established (cyanide or bleach?), the statement can nonetheless be made that pollutants were responsible for destroying just about all TISZA River flora and fauna over nearly 600 km, altering the entire food chain. Thousands of animals were found dead after having consumed contaminated water or other products (plants, mollusks, fish, etc.), including swans, cormorants, gulls, pheasants, pigeons, foxes, rabbits, horses, river otters, deer, hawks, ospreys and wild ducks.
