Explosion in a furnace in a metal alloy production plant

February the 21st, 2000

Feurs [Loire]

Melting furnace

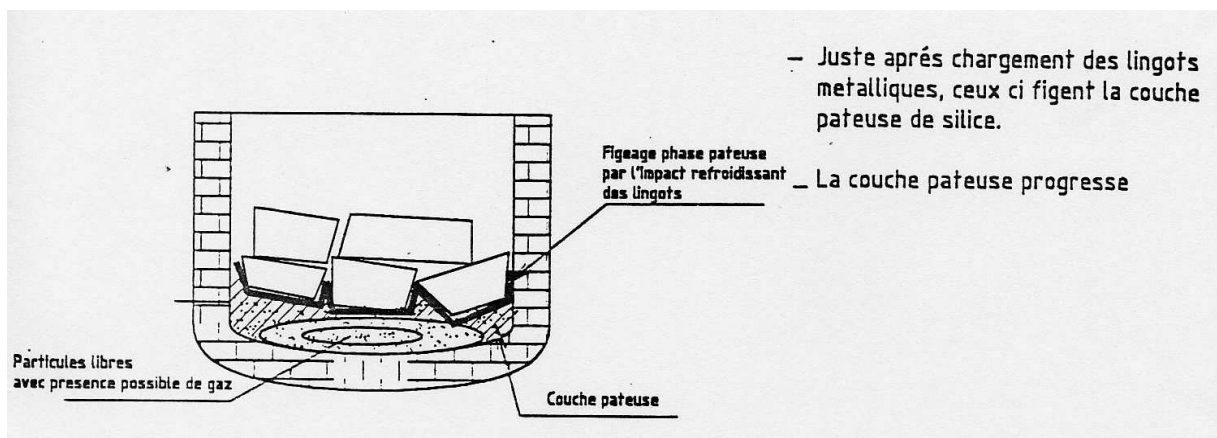
Thermal impact of the loading of the metal ingots

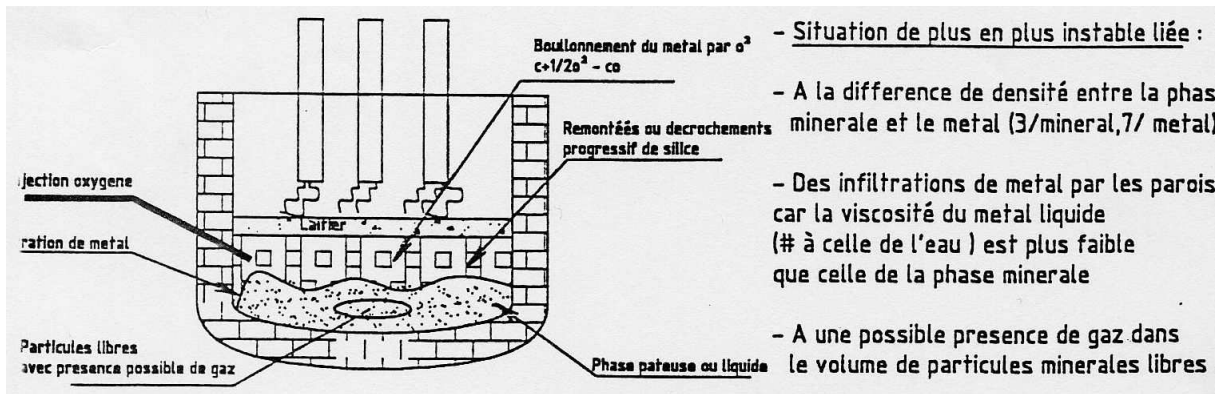
- ✗ The nickeled sand in the bottom of the furnace did not melt completely; the intense mixing of the metal by the injection of gaseous oxygen helped the nickeled sand rise to the surface. The nickel oxide was deoxidised by passing through the metal; the oxygen thus released combined with the carbon present in the bath and produced large quantities of CO and CO₂ very rapidly. This hypothesis is substantiated by the recording of the gas analysers; a calculation shows that this reaction produces 73 m³ of CO in a few seconds.

- ✗ The unmelted nickel sand in the bottom of the furnace contained a certain quantity of water and gas, held under pressure by a layer of pasty metal. The blast would have been due to the release of these gases; a calculation shows that this phenomenon generates 8 m³ of steam.

Furnace situation, melted metal (t+15min +40min : injection d'oxygène et t+15min+45min : metal fusion)
