Explosion of a fireworks warehouse

May 13, 2000

Enschede

The Netherlands

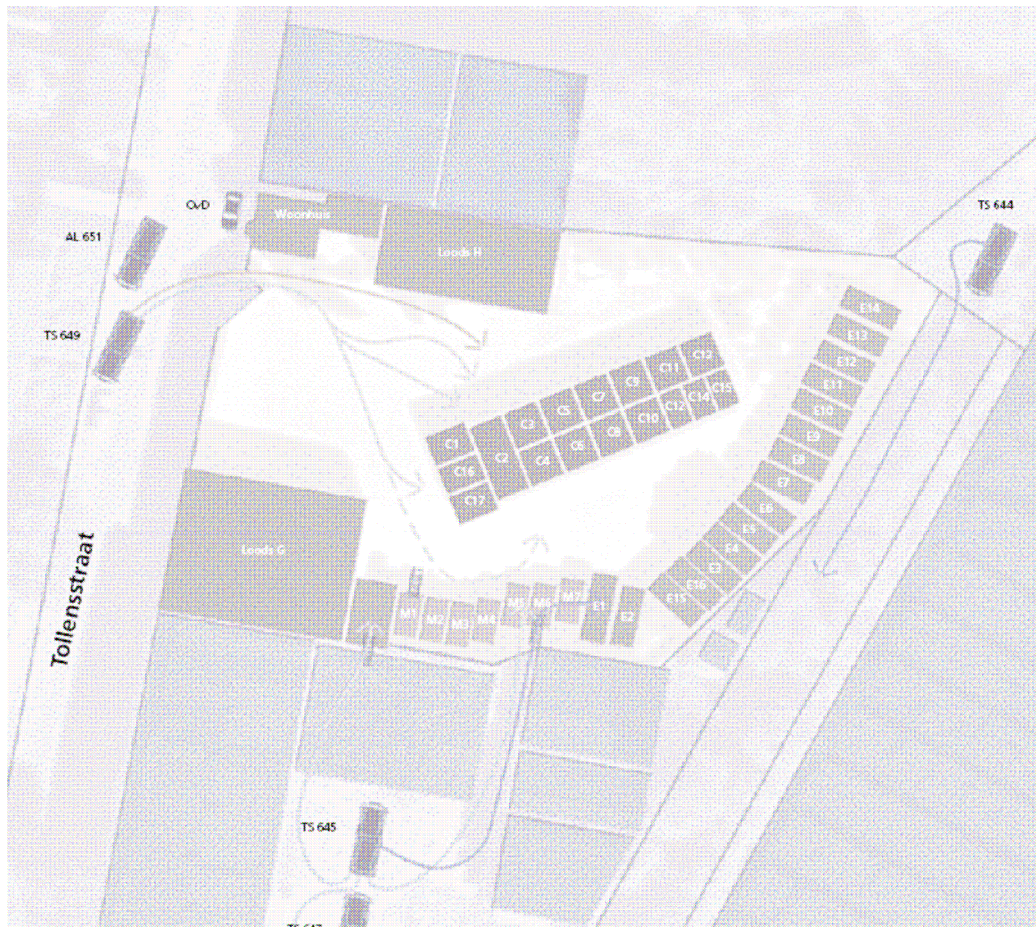
The diagram below allows locating these various structures (some of which never received nor complied with their corresponding building permit). A brewery is located just behind the row of containers E1 through E16.

According to the previous layout, the distances between containers or between MAVO boxes were less than 1 m; moreover, the distances between C storage cells and the closest E containers were on the order of 15 m.

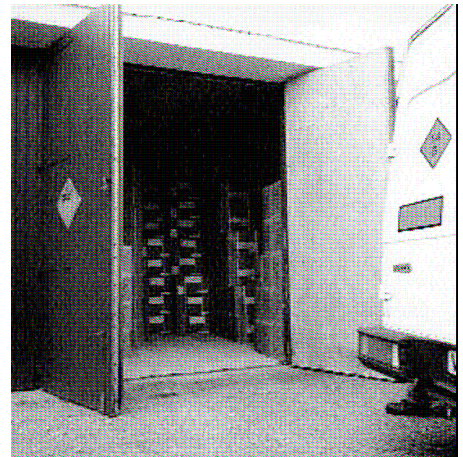
All storage openings exited towards the "free" space; however, the doors to cells C4 through C15 were actually positioned opposite the doors to containers E1 through E8, E15, E16 and M7.

Doors of a C-cell (central storage) (photo exploitant [2])

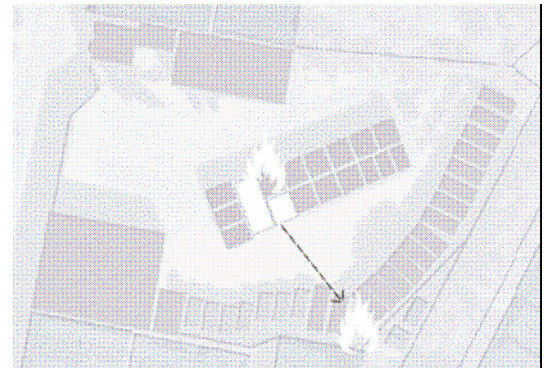
Fire broke out in cells C2 and C4, before spreading via the fireworks into a triangle-shaped blaze (complicating access for fire-fighters) formed by containers E2 and E15.

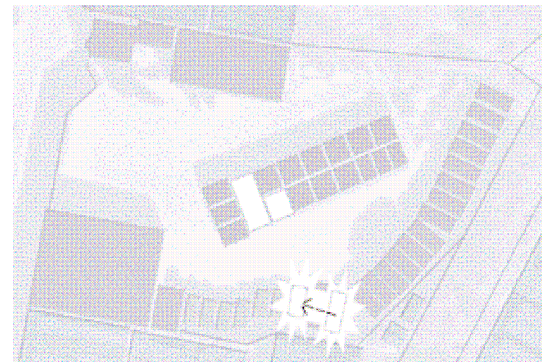
Container E2 caught fire and then exploded, in turn causing the first MAVO box, i.e. M7, to explode.

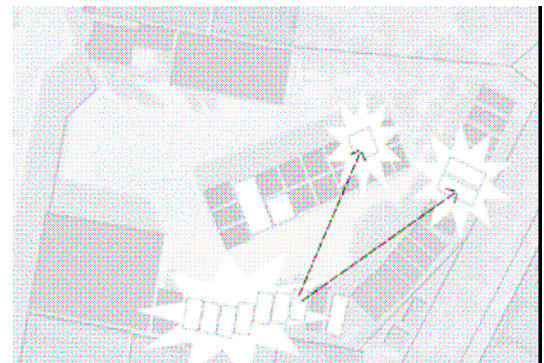
The explosion of M7 engendered the explosion sequence of all MAVO boxes and propagation of the fire to cell C11 and containers E8 through E11.

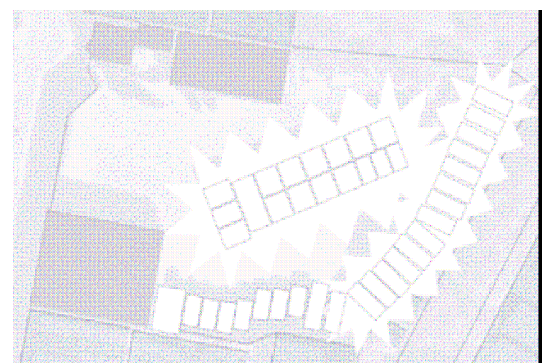
The central unit exploded simultaneously with all of the remaining containers [2].

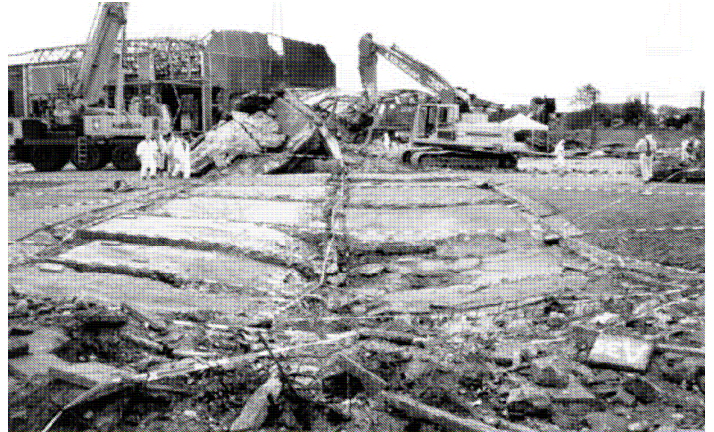
A 13-m diameter, 1.3-m deep crater could be observed at the location where concrete ground cells C9 and C11 to C15 once stood, thus confirming the massive explosion effect of the final blast, whose TNT equivalent was evaluated at between 4 and 5 tonnes⁷ [1].

Crater above the C11 [2]

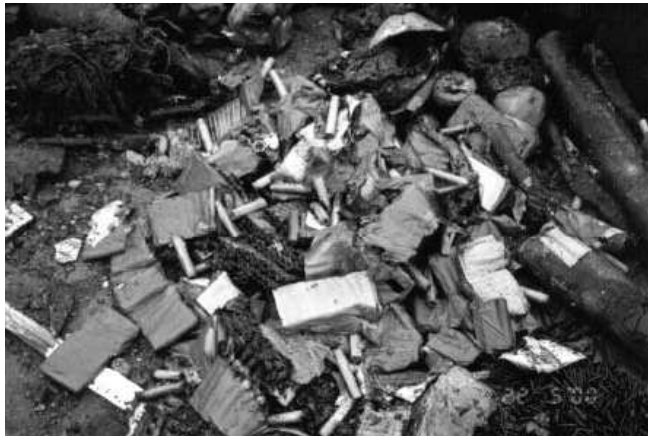
Remnants of fireworks found in workshop C2 [2]

The initial cause of the fire outbreak in workshop C2 remains a mystery. The investigation proved difficult to complete due in particular to the complete destruction of the premises. Several hypotheses have been proposed: arson (a pyromaniac had been setting fires in the area during the few weeks prior [3]), human error while handling fireworks (although no one was reported at the site at the time), a short circuit (nonconforming installation, radio, etc.) or self-combustion (following manipulations performed the day before?) [11].

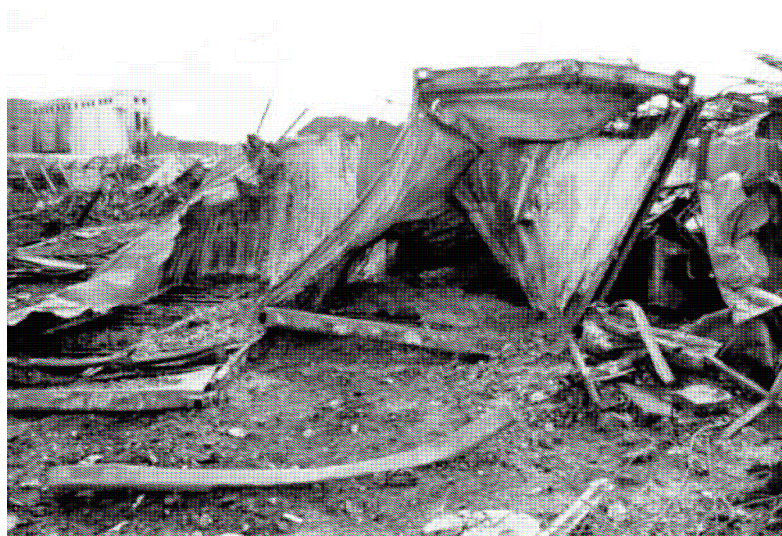
Residue of containers [2]

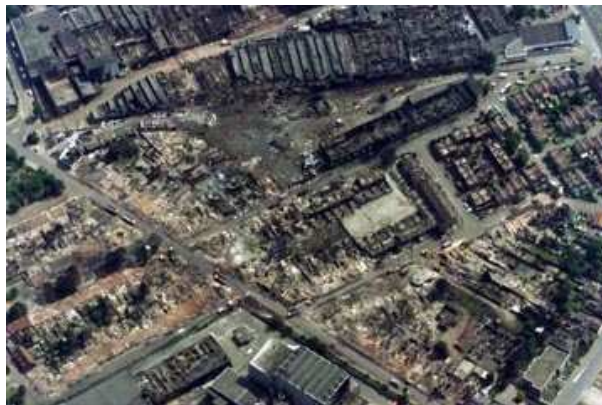
Aerial view of the site following the accident [3]
