Outbreak of fire in the supply duct of a chemical reactor

May, the 20th, 2000

Issoire – [Puy-de-Dôme]
France

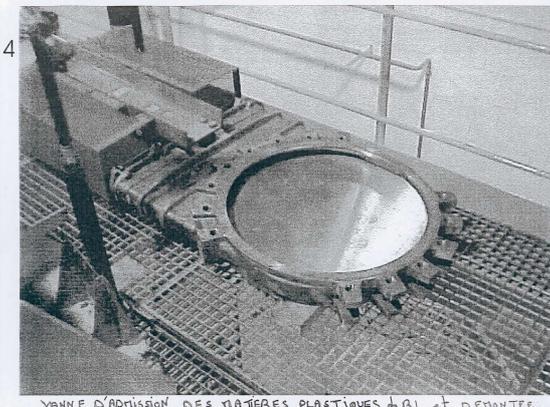
The inlet valve being open, the catalyst was inserted through the branch connection installed on the reactor. Following insertion of the catalyst and before initialisation of the insertion of the bottles, a fire started in the inlet duct. It immediately spread to the duct's acoustic liner. The liner, which was combustible, spread the fire, and "deflagrated", producing blazing droplets. Two dry chemical extinguishers were immediately used to put out the fire, which proved difficult to reach. The guillotine valve was locked and the N-flux in the reactor was sharply increased.

A fire broke out in the supply duct, which immediately heated up. The outer acoustic liner deteriorated, caught fire, spread the fire, melted and formed "droplets". Two types of fire occurred:

- ✗ The initial fire, which was caused by spontaneous ignition and the combustion of glycol vapours and condensed glycol,
- ✗ An induced fire that spread, due to combustion of the acoustic liner.

- ✗ The presence of condensed glycols and glycol vapour in the PET supply duct and the presence of oxygen in the supply duct,
- ✗ The temperature of the mix of glycols in the reactor, which was too close to the temperature of spontaneous combustion of diethylene glycol. The temperature in the reactor was 223°C and the temperature of the vapours was 220°C (the point of spontaneous combustion of DEG being 232°C),

- ✗ Aggravating factors such as:
 - ✓ The possible presence of traces of catalyst in the supply duct, which would favour combustion,
 - ✓ The absence of ground straps linking the different metal parts of the supply duct, even though the connections were made without splices and the supply duct was earthed (the absence of ground straps could explain a spark of static electricity),

- ✓ A discharge flow that may have been too weak, thus favouring the return of glycol vapours back into the supply duct,
 - ✓ The ease with which the protective liner caught fire (possible hypothesis of combustible gas forming in the supply duct, being gas resulting from the decomposition of the liner or its mounting adhesive).

- × Eliminate the oxidant by high-pressure injection of nitrogen in the PET supply duct, to prevent combustion from occurring,
- × Eliminate the presence of glycol vapours in the supply duct by strengthening the extraction at the condenser outlet, in order to prevent combustion,

- × Prevent any sparks caused by static electricity by connecting the components of the supply duct using a bonding jumper and earthing,
- × Prevent the spread of fire caused by combustion of the liner, by removing the liner,
