Pollution following an acid leak

May 26, 2000

Le Thillot – [Vosges]

Aquatic pollution
Tannery
Fixed storage tank
Sulfuric acid
Maintenance
Layout
Catchpit
Periodic inspection
Dead fish

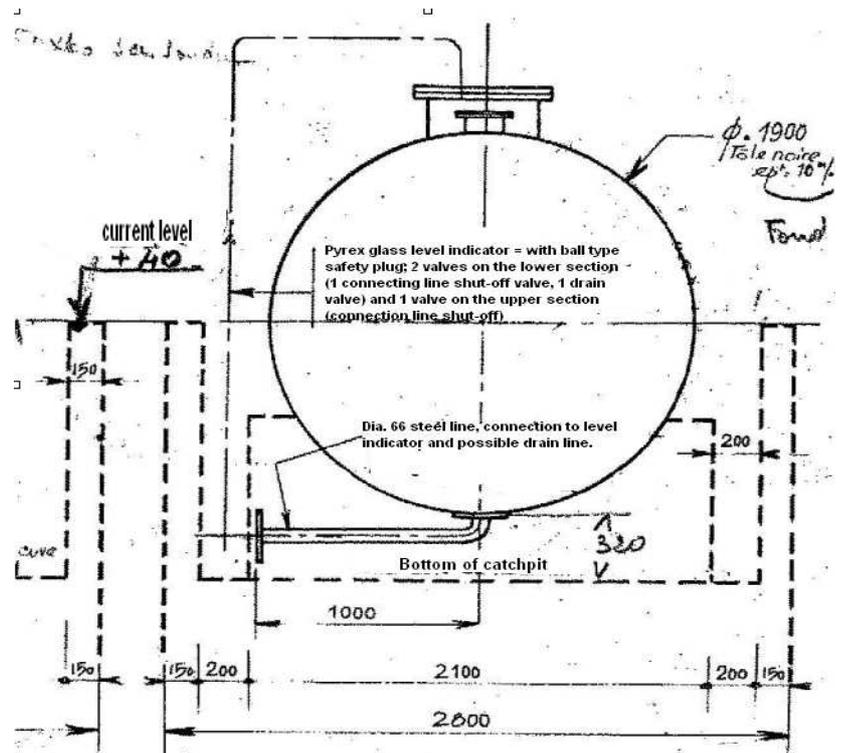
The last inspection of the tank and its concrete catchpit dates back to 1994. Although the inspection organisation had concluded that the storage tank was apt for service, it recommended that the highly corroded access catwalk be replaced and that the catchpit be refurbished as it was cracked and chipped in several locations.

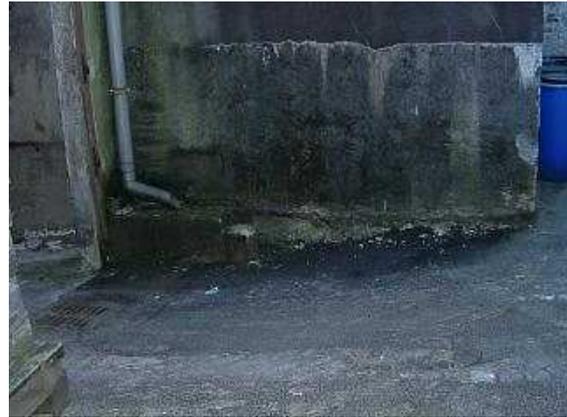
The direct and obvious origin of this type of accident was the lack of maintenance of the storage tank and catchpit installations.

The location of the leak on the lower drain pipe elbow which is always in contact with the acid and under pressure, attests a design flaw in this tank, which also does not respect the requirements of standard order type 31a regarding sulfuric acid storage facilities.

Maintenance, inspection and design faults in the storage installations are responsible for this accident. The pressurisation of the tank's gases is a drawoff method that can aggravate the consequences in the event of a leak.
