## Thermal runaway in a copolymerisation reactor

## Leak in a polymerisation reactor

**Villers St Sépulcre (60) – France**

Chemistry  
Polymerisation  
Butadiene / Styrene  
Acrylonitril  
Leak  
Thermal runaway  
Material failure  
Human failure  
Organisation / Lack of  
maintenance  
Automation / Level probe

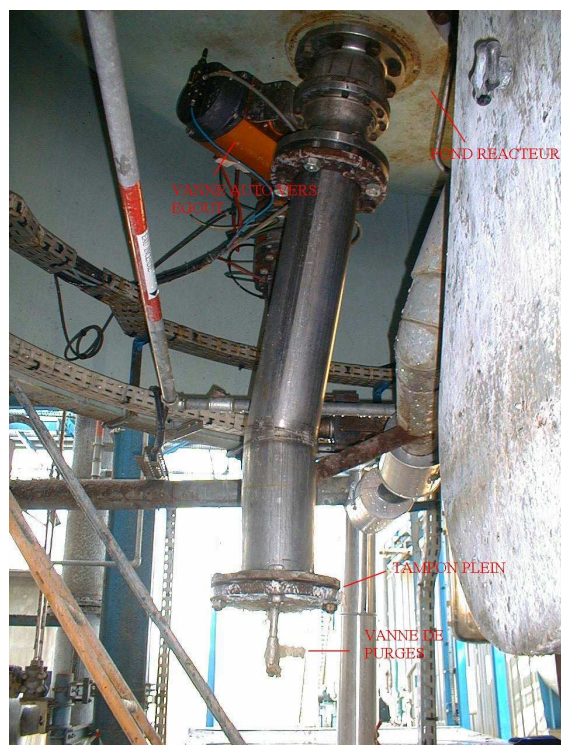
On May 15<sup>th</sup>, around 3h45, during a butadiene polymerisation reaction conducted in the reactor R 13, a leak of butadiene occurred at the base of the reactor at the level of the solid plug located below the drainage valve. The operators in the control room detected the sudden opening of the drainage valve from a blinking alarm. For the management it did not seem a major problem, the circuit being closed by a sleeve and a solid plug.

The operators tried several times to close the valve, without succeeding. One of them went to the reactor to check the position of the valve and close it. The operator, who could not reach the valve on account of the fog of foam emitted from the lower part of the reactor, smelled the odour characteristic of butadiene. At that moment, the leak set off the alarm from the network of gas detectors, one of which being located just beside the reactor. Some of these alarms were set at a level above the upper threshold for the alarm (40 % of the lower explosion limit).

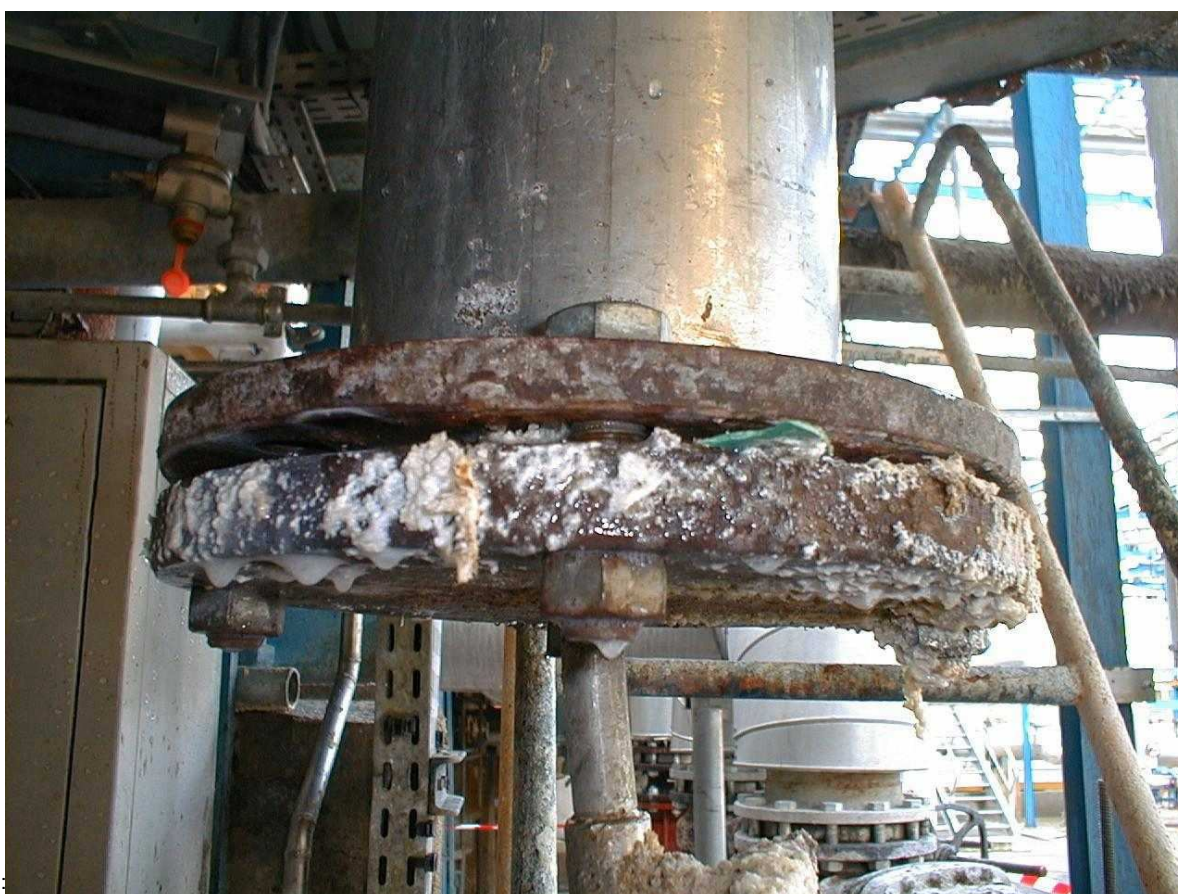
The analysis of the accident highlights three contributing factors:

- ✗ The failure of the control of the pneumatic drainage valve with, in particular, a leak of the retaining ring of the push button which commanded it. The pressure then became sufficient to force the opening of the valve,
- ✗ Defect in the gasket of the solid plug below the valve,
- ✗ Faulty placing of the solid plug with a number of incorrect bolts and inadequate tightening. Furthermore, the solid plug had not been subjected to prior pressure tests.

Since this accident, the installation concerned has not been returned to service. <thought has been given to the question of maintaining production of polybutadiene on the site. This production is henceforth handled on another production site belonging to the same group in Holland. The supply of polybutadiene to the site is provided by road tankers from the Dutch site. The company therefore no longer stores butadiene on the site.

However, a decree from the Prefect dated 14<sup>th</sup> November 2000 subordinates the possible return to service of the butadiene production unit to the respect of certain dispositions, relating in particular to:

- × Organisation of risk prevention,
- × Preparation of clear operational standing orders,
- × Preventative maintenance of the installations,
- × Periodic verification of safety measures concerning the correct operation of the installations,
- × Operating measures for the installations,
- × Equipment and set operating parameters which are important for safety (IPS)

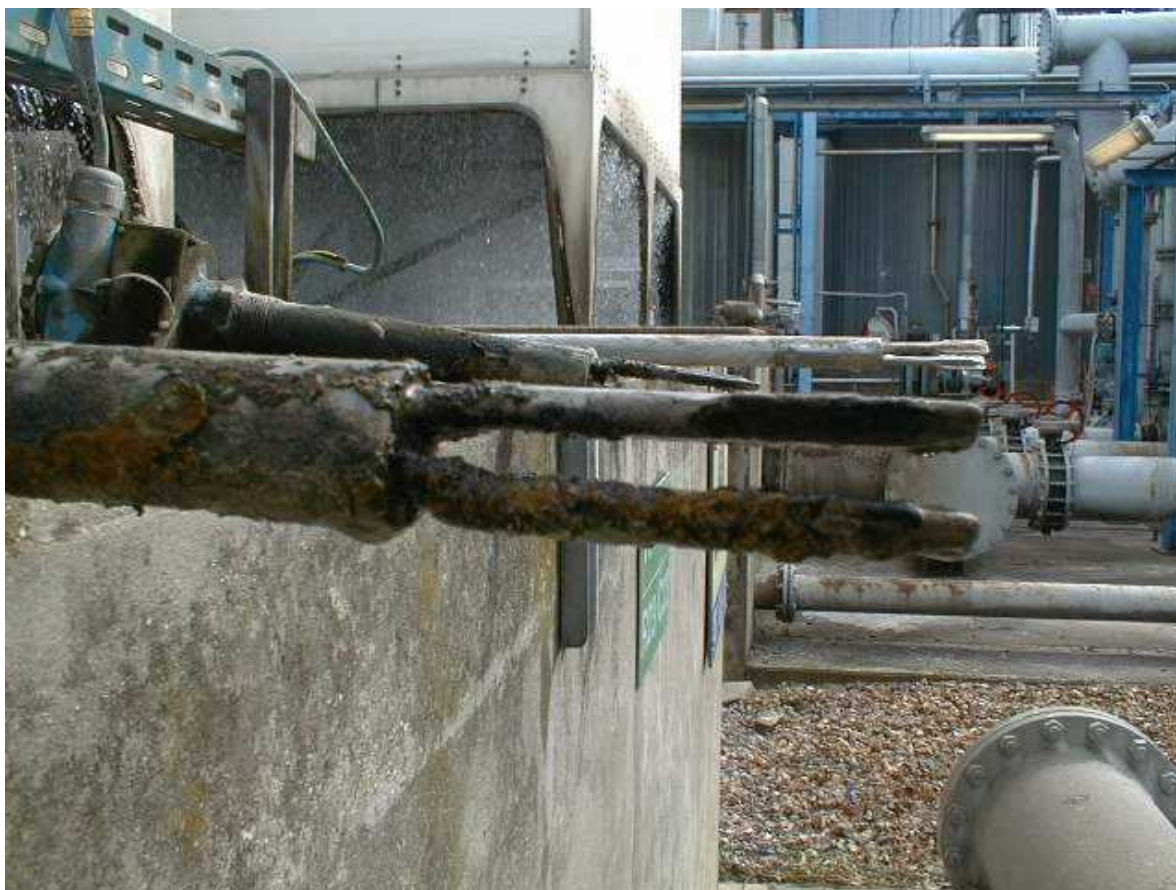
The runaway of the reactor was due to a lack of water in the jacket circuit of the reactor, leading to an insufficient heat exchange. This lack of water was itself due to a lack of water in the cooling tower basin leading to a drop in the flow towards the heat exchanger of the reactor. The temperature of the badly regulated reactor rose, causing a runaway of the copolymerisation reaction.

A closer inspection of the basin of the cooling tower revealed a failure of the level probes for “low” and “very low” levels placed in the basin which allowed for the detection of any abnormal drop in the water level. Disassembly of the probes with vibrating blades showed that they were clogged up. The failure of the “low” level probe therefore prevented the automatic opening of the water supply valve to the basin. As regards the “very low” level probe, it was so clogged up that the alarm was not set off in the control room. The authorisation to initiate the production cycle was not therefore blocked during the prior tests on the reactor.

Immediately following the accident, reactor R 23 was closed off. Later, the operator cleaned the level probes.

Furthermore, a programme for checking the state of the probes was instituted during each cleaning operation for the reactors, or every 15 days. A testing programme for the alarms and for the "low" and "very low" probes, which were also to be tested before commencing every production cycle. The management of the plant also intended to install level probes using different technologies.
