Butadiene leak in a chemical plant.

December, the 4th, 2000

Bassens – [Gironde]

France

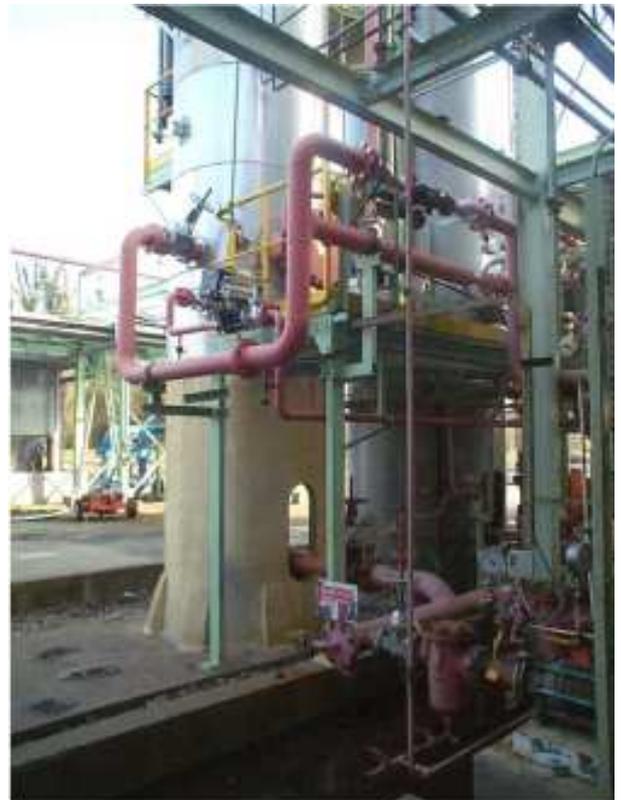
Source : DRIRE Aquitaine

On December 4th, around 6.30 p.m., on the U400 high-viscosity polybutadiene manufacturing unit, a valve ruptured downstream from a 12m³ tank, releasing its contents, 5m³ of pressurised liquefied butadiene, in 15 minutes (1,250m³ of gas). The cloud of gas drifted towards the west of the site during the first hour, then towards the south-west, in the direction of the Paris-Bordeaux TGV (French high-speed train) line. The POI (Plan d'Organisation Interne, internal contingency plan) was put into action, and a control unit was installed on the site. The production units were stopped and water curtains were installed around the tank. The SDIS (Service Départemental d'Incendie et de Secours, fire and emergency services) arrived at approximately 6.50 p.m. The road was closed to traffic south of the site at 7.10 p.m. and in the south east at 7.35 p.m. The TGV line was closed at 8.p.m.

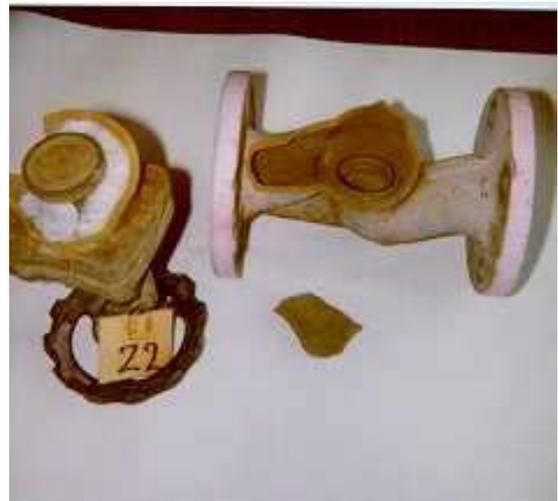
Spontaneous auto-polymerisation caused a brittle fracture of the valve in question. The valve served as a by-pass for a remote-controlled valve on the pressure control circuit in the butadiene tank. The forming of this polymer, known as "pop", in the valve cover was due to :

- butadiene stagnation : the valve, which was closed at the time of the accident, constitutes an abandoned channel, with no circulation of the product
- the ambient temperature
- the absence of an inhibitor (tert-butyl cathecol): the tank did not contain any, as the butadiene is derived from a recondensed gaseous phase and the inhibitor is eliminated during this operation.

The increase in volume during polymerisation caused the internal pressure to rise sharply, thus causing the brittle fracture of the cast iron valve, the cover of which was torn off.

- ✓ The [quarter-turn] valve in question has been replaced by a steel ball valve, pending a detailed study of the problem with the by-pass. Two other cast iron valves have been replaced.
