Fire in a factory manufacturing adhesives

December 8th 2000

Haguenau (67) - France

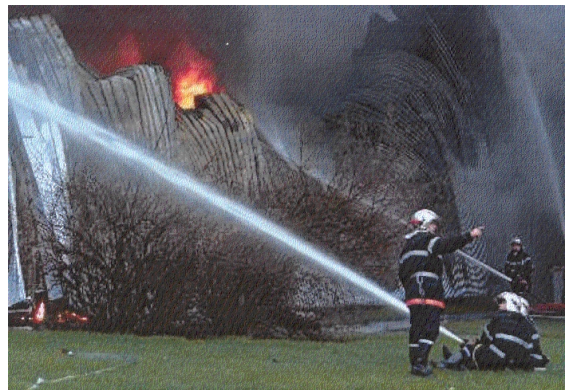
The fire ignited around 10 o'clock when an employee was pouring toluene from a 1 000 litre container into a 25 litre metal bucket using a fire-resistant pump and an anti-static flexible tube, in premises protected by inert halon gas. The employee saw sparks flying followed by instant ignition. Despite quick intervention by the personnel, the fire spread rapidly, first to the central workshop, the fire-door between the workshop and the solvent store having been left open, and then to the storage area for finished products: these two areas were insulated by a firewall; however the thermal flow generated by the fire caused the melting of the skylights of the storage hall and the conditioning workshop (lighting elements of the "sky-dome" type), spreading the fire to these areas.

The emergency services intervened rapidly. A large cloud of black smoke partially attained the urban area of Haguenau. The atmospheric conditions did not favour the rise and dispersion of the smoke cloud, the emergency services invited the population to remain indoors. The event was widely covered by the media via the broadcast on local radio of instructions to remain indoors. Three schools in the axis of the smoke cloud were evacuated. The fire was brought under control after 2h30. With the fire extinguished, the confinement measures were lifted around 13h30. The emergency services maintained surveillance for the whole day.

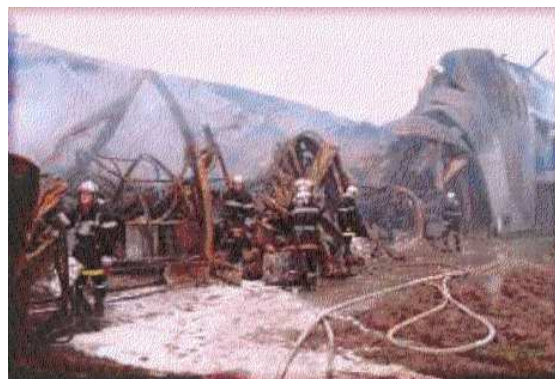
Material damages, of the order of 70 MF, were serious: plastic materials, essentially PVC, solvents (toluene and xylene) and finished products (polyurethane fillers and packaged adhesives) constituted the major part of the substances involved in the fire. The MDI store and the barrels in production, protected by the firewalls, were not affected.
