# Explosion in a cracking unit on a refinery site.

September, the 3<sup>rd</sup>, 2000

**Gonfreville l'Orcher [Seine Maritime]  
France**

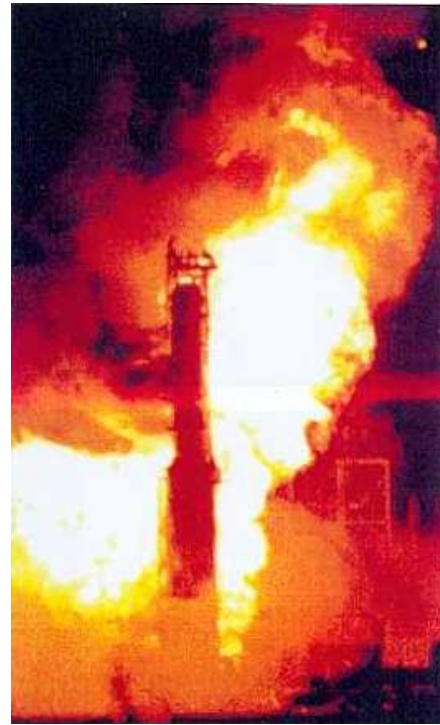
Source : Presse Paris Normandie

A fire with muted explosions broke out at the refinery in Gonfreville l'Orcher on September 3<sup>rd</sup>, 2001, around 9.15 p.m., on the desulfurization section of the cracker 7 unit. The fire burned actively until 3.15.p.m. on September 4<sup>th</sup>. The chronology of the accident is as follows:

**9.12 p.m.:** rupture of a ¾ inch connection on the suction line of pump P3B,

**9.12 and 30 seconds p.m.:** flash-up of the cloud (approximately 200kg of product) and creation of a fed torch-type fire,

9.13 p.m.: rupture of a 3 inch naphta line that was exposed to the torch, which created another, larger flaming jet,

9.18 p.m.: through a domino effect, rupture of the manifold of a cooling tower and flash-up of the leak that was caused,

- through a domino effect, rupture of the header (8 inch diameter) of tube V3, and flash-up of the leak,
- through a domino effect, rupture of the valve manifold of tube V3, which is connected to the site's flare-stack network, and flash-up of the gas leak. This led to a partial venting of the flare-stack network.

From 10 p.m. onwards: the burning leaks continued to burn until the rest of the unit was consumed and the flare-stack network could be isolated without danger, which was on September 4<sup>th</sup>, around 3 12 p.m.
