# Release of sulphur dichloride and hydrogen chloridedrogène

January, the 20<sup>th</sup>, 2000

**Castleford**  
**United Kingdom**

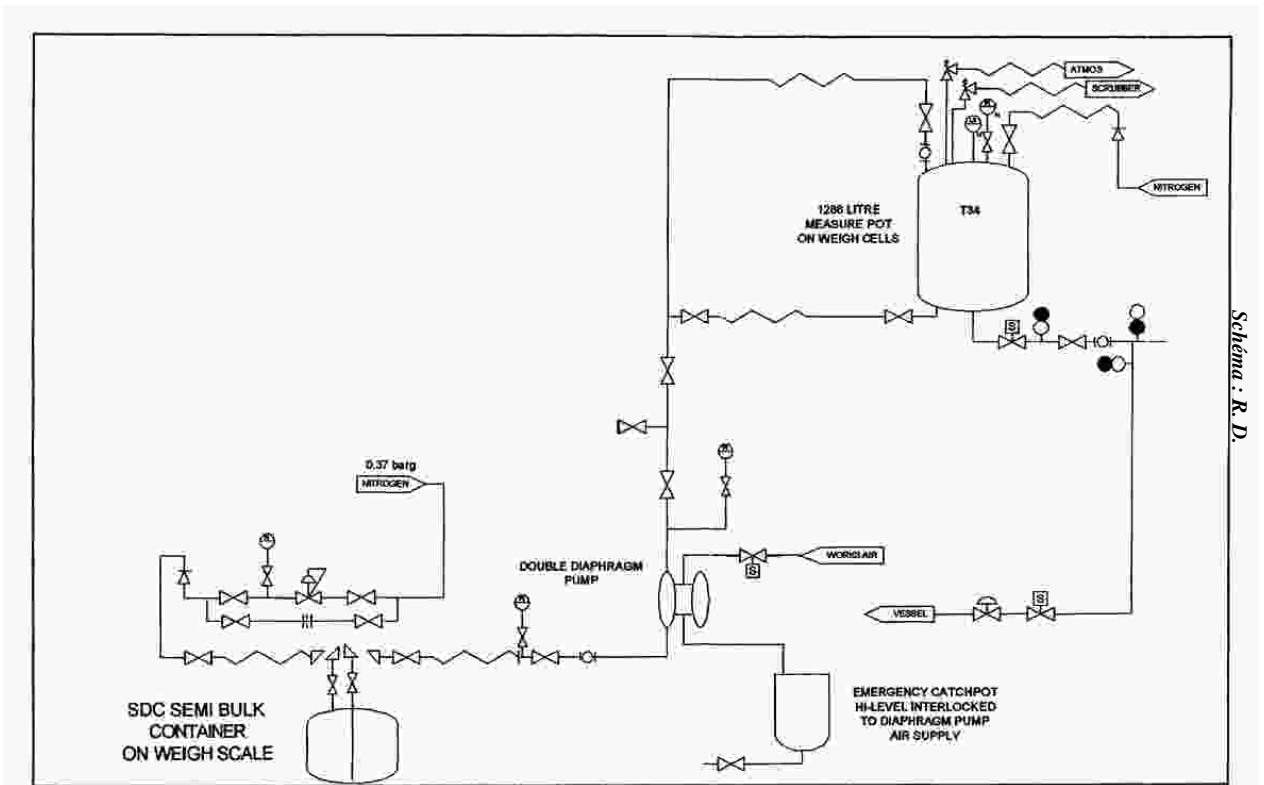
The part of the plant involved is the sulphur dichloride unit (called SDC in the following part of the document and whose formulation is SCI2). The following diagram shows the materials involved in the process, the main ones are the following ones : weight system and container venting line, transfer line with its pump, measure pot (T34). In the main lines, SDC, used in the process, is transferred in the ensuing unit from a dedicated vessel : a purpose designed pressurised steel container with nitrogen blanketing in the ullage space. This capacity is connected via a transfer system composed with : a capacity located at the top of the reactor and equipped with its own scrubber and venting system. A pump pushes the product through the flexible to the capacity. At this time, it was the first start of this installation, adapted for SDC use. Previously, the part of the line concerned had been flushed with MCB, a solvent and still contained a part of it.

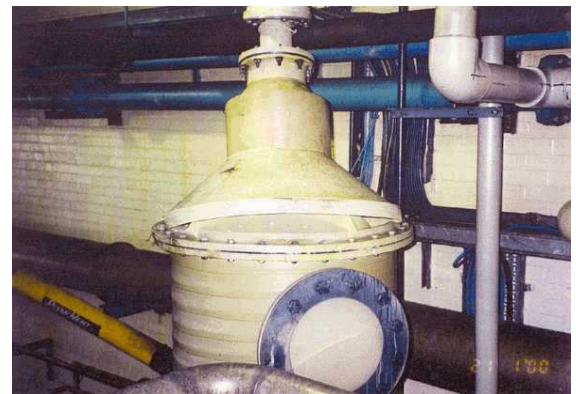
✗ The transfer pump was immediately stopped, and almost immediately, the emission of fumes from the relief valve ceased. As the operatives re-entered the main plant from the annex where the container offloading station is situated, there was a loud "thud" which was followed by a cloud of fumes being emitted into the plant area, emanating from the gas scrubbing system area for the process.

- ✗ A “water curtain” was deployed to the east of the plant to mitigate any downstream effect of the gas cloud.
- ✗ The fumes had abated by this time, and technical personnel to ascertain the damage to the equipment then entered the plant. It was quickly noted the main scrubber vessel lid had been displaced during the incident, and some further damage to pipelines in the vicinity of the scrubber lid had been damages. A low level of fuming was seen being emitted from a leak on a flexible line connecting the SDC transfer line to the top of the measure pot T34. An inspection of the plant at 9.30 PM identified that the T34 measure pot contents were approximately 50°C (close to the boiling point of SDC).

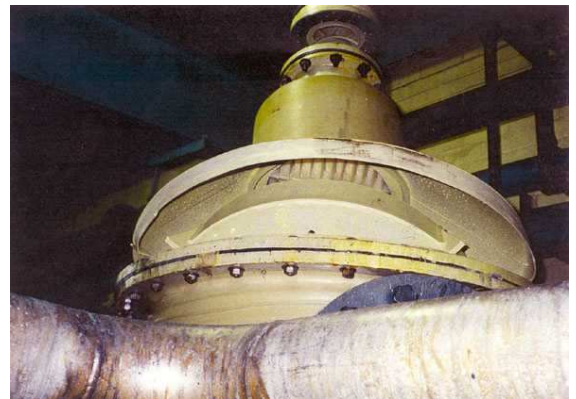
On the material level, the top of the scrubber column is ruptured, together with other materials in connection with it.
