# Explosion of dust in a silo

14<sup>th</sup> May 2001

Albert – [Picardy]

France

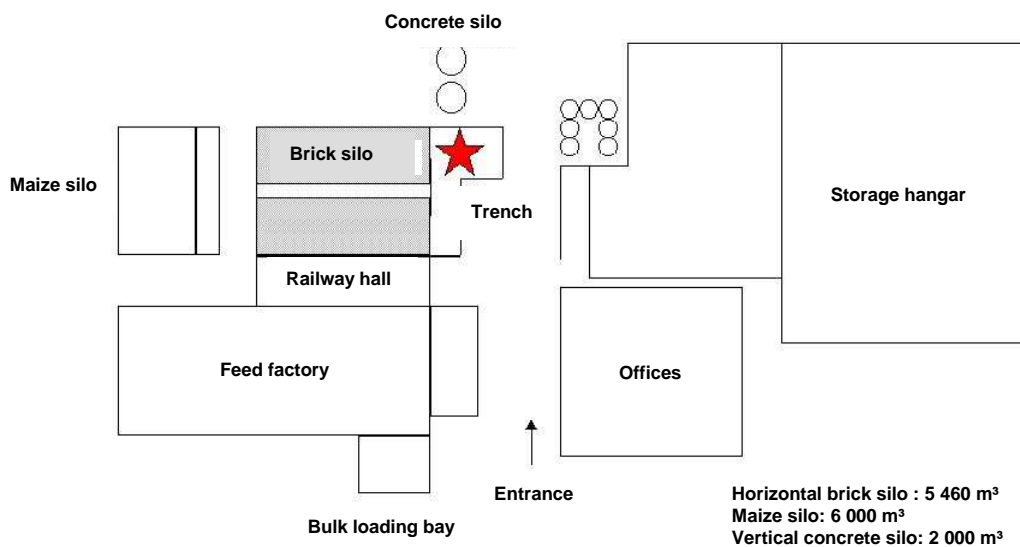
Diagram of layout of installations – Indication of locality of the explosion

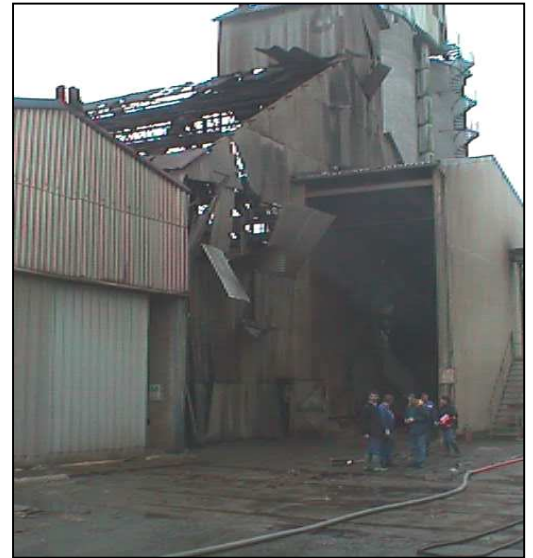
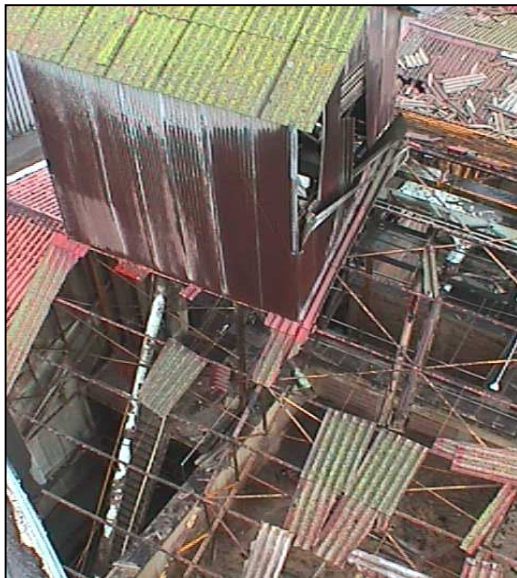
Material damage was serious. The explosion blew off half the surface area of the roofing of the silo and gutted the walls of the handling tower. Pieces of fibro-cement plates from the roofing were found 30 m away and the metal struts for the access stairway were sectioned.

The descending conduit of the bucket lift was blown away and opened over a length of nearly 4 m below the ground as well as over two thirds of the height of the tower.

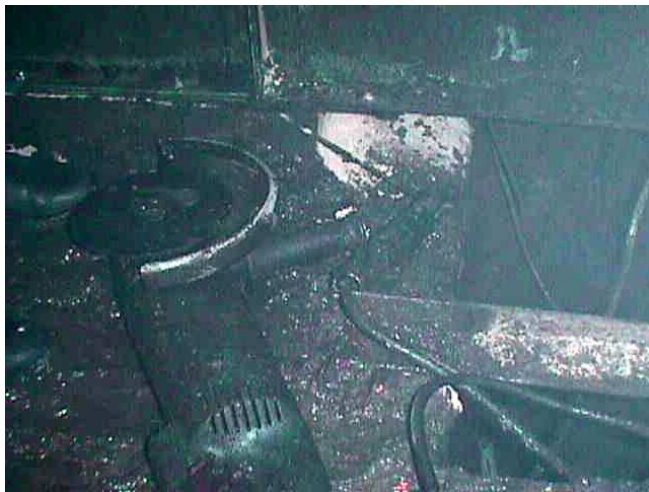
Portable grinder found on site

A maintenance operation requiring welding and grinding was undertaken in a confined space. A fire permit was signed for the form but no cleaning was undertaken. The workers intervened on the Redler conveyor while the bucket lift was in operation. Inside this, the air was saturated with dust.
