## Explosion of a railroad tank car containing toxic gas

July 14; 2001

Riverview - [Michigan]

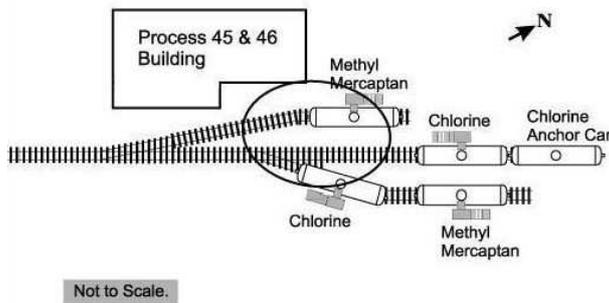
Figure 2 – Location of the methyl mercaptan and chlorine rail cars[1]

At 3.45 am, 2 employees were unloading a methyl mercaptan tank car when the connecting pipe secured on the unloading line ripped free from a faulty valve. Depending on the source, 67 [1] to 74 t of gaseous methyl mercaptan were released into the atmosphere.

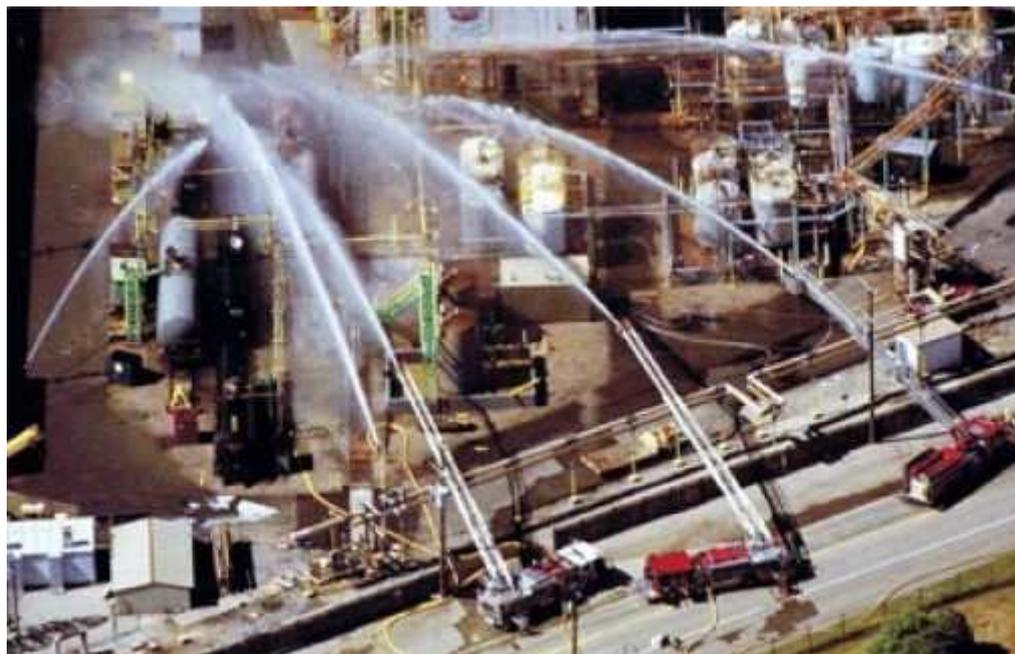
*Figure 4 – Firefighting operations [1]*

At 4.09 am, nearly 25 minutes after the start of the accident, a leak was noticed followed by a rumbling noise: the toxic gas ignited, engulfing the tank car in flames, and sending a 15 m-wide fireball 61 m into the air. The tank car exploded (BLEVE) releasing methyl mercaptan and its decomposition products into the atmosphere. The highly

volatile compound can cause skin and eye irritations, as well as respiratory troubles. The Fire Department Chief called for reinforcements from other fire stations. The tank car on fire and those parked nearby were cooled down with sprayed water. Fortunately, the fire did not spread to the rail car containing methyl mercaptan and the 3 rail cars containing chlorine.

Fire departments from 5 cities came to assist. The fire, which had spread to the chemical plant, was finally surrounded between 8.30 and 9.30 am.

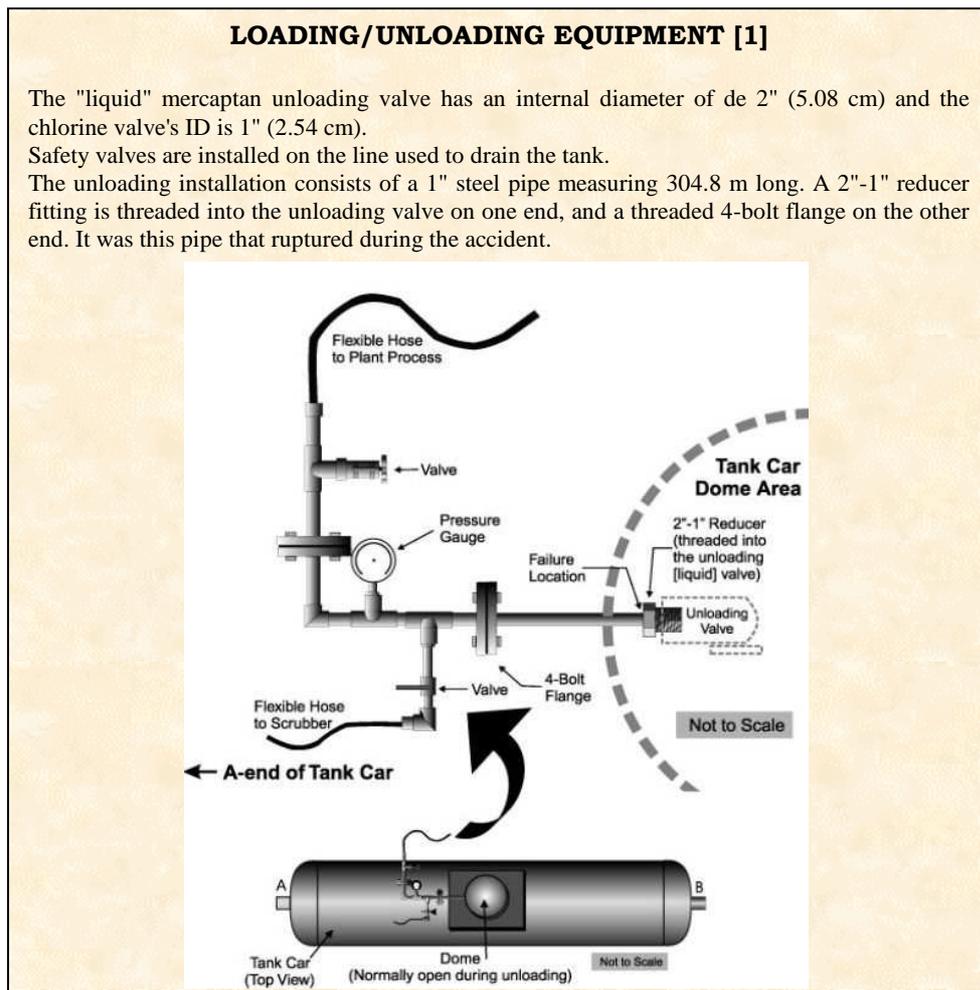
According to the National Transportation Safety Board (NTSB) [1], the primary cause of the accident was the disregard for safety rules. The NTSB's report stipulated that the transfer line was eroded and corroded; traces of rust and pitting are visible inside and outside the pipe. Routine visual inspections conducted during each unloading operation had nevertheless not detected the deterioration of the 1" (2.54 cm) steel pipe. The measurements show that the thickness of the pipe's internal wall at the fracture had decreased 23% in relation to a new pipe. The accident was the result of insufficient maintenance and inspection of the transfer equipment, as well as inappropriate monitoring of the unloading of dangerous substances by the Federal organisation. The manufacturer stated that no inspection or replacement had been made on the ruptured pipe in 5 years.

As causes of the accident were known, the company modified numerous procedures and certain pieces of equipment. The unloading installation, with all the associated piping, must be dismantled every 2 years and tested to check the integrity. In addition, the unloading equipment was redesigned. The operators must now wear self-contained breathing apparatus when they work on the mercaptan tanks and protective masks equipped with an emergency air supply when working in the rail car unloading zone. Since the accident, before opening the rail car valve, the employees conduct leak tests on the unloading installation.

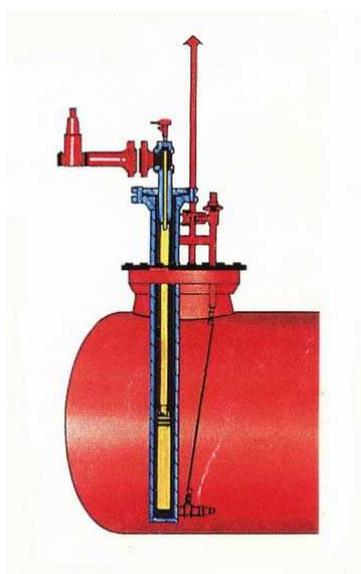
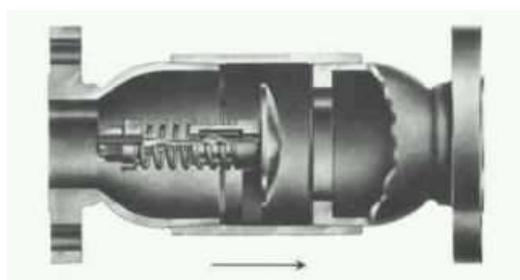
**Figure 5 – Safety valve**

- Dissemination of a bulletin pertaining to danger equipment to inform the manufacturers concerned by unloading/loading operations and particularly the safety valves installed on the dip pipe which do not allow the systematic shutdown of a leak and which can be considered a safety device in this case.
