Toxic leak in a dairy

August 29, 2001

Saint-Saviol – [Vienne]

Toxic release
Food industry
Refrigeration
Ammonia
Organisation
Training
Work
Circuit identification

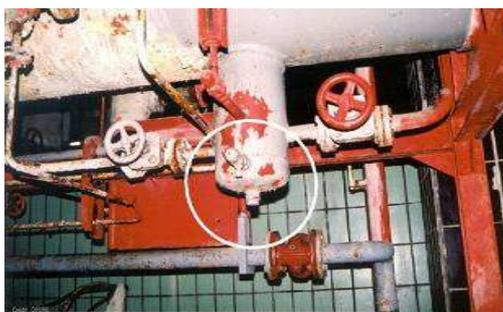
A welding contractor from an external company had to perform operations on the cooling water circuit on one of the 3 condensers. The bolted retaining flange of the end dome on the condenser's shell was eroded. Water had been leaking for 2 days and management had decided to repair the oxidised part by a local welding operation.

The installation was shut down the day before and the plant's maintenance supervisor drained the condenser's water coil.

Upon his arrival the next day, the welder found the part to be repaired to be still humid and requested a plant mechanic to finish draining the water circuit. The poorly informed mechanic thought that the purge button under the condenser should be used to perform the operation. He loosened it and allowed the welder to perform the additional drainage operation. The purge actually drained the NH₃ from the condenser.

The operator had an insufficient understanding of the circuits and the work had been poorly prepared. The installations had not been equipped in compliance with regulations designed to limit the quantity of NH₃ released.
