A series of explosions on alcohol tanks at a distillery

3 September, 2001

Lillers (Nord-Pas-de-Calais)

Explosion
Sugar refinery /
Distillery
Storage tanks
Alcohol / Ethanol
Potassium
permanganate
Explosive
atmosphere
Internal
contingency plan

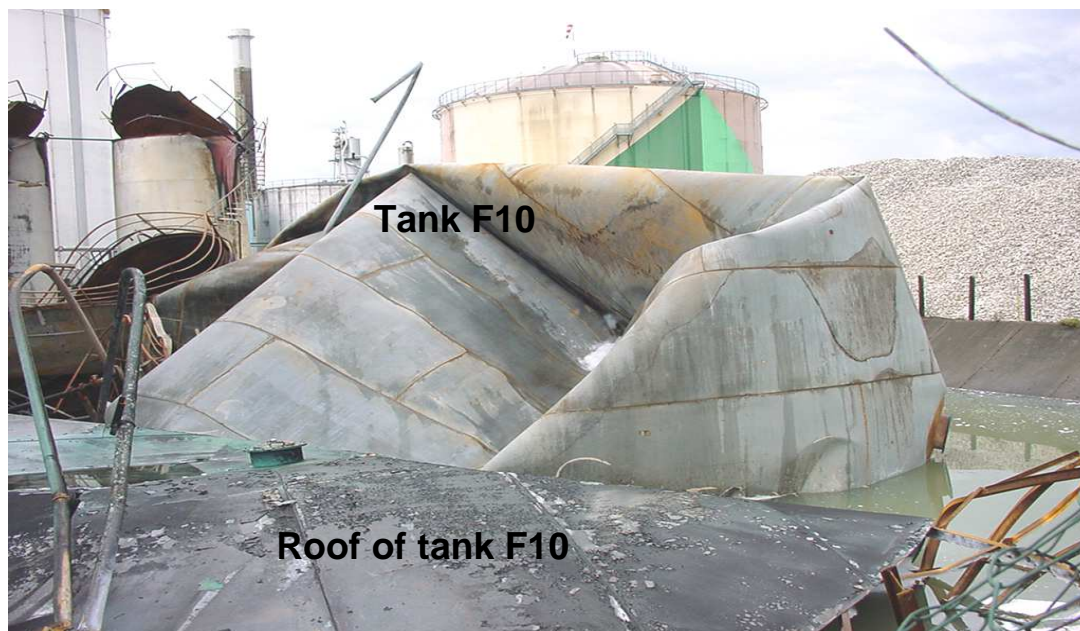
At 4.42 pm (t = 0), tank F10 exploded projecting its roof more than 10 m into the air. The roof fell onto the roof of tank R8. Bund B and tank F10 caught fire.

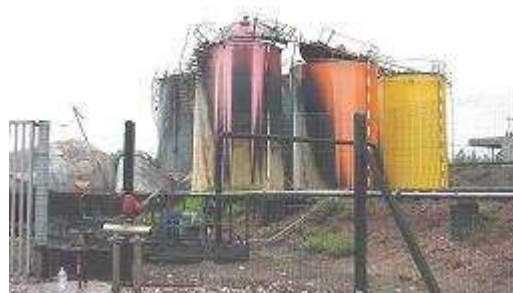
Operating losses are evaluated at 2.13 million Euros and property damage at 2 million Euros: 1,500 m³ tank (F10) (structure collapsed) and 540 m³ tank (MG11) (roof blown off) destroyed, and the roofs of three 115 m³ tanks ripped open.

15 m³ of ethanol burnt. By domino effect, the consequences of the accident were worsened by the damages caused on tanks MG11, J5, J6 and J7.
