Explosion of a gasoline vapour cloud formed in a hydrocarbon loaded effluents storage tank

10 December 1999

Arquata Scrivia
Italy

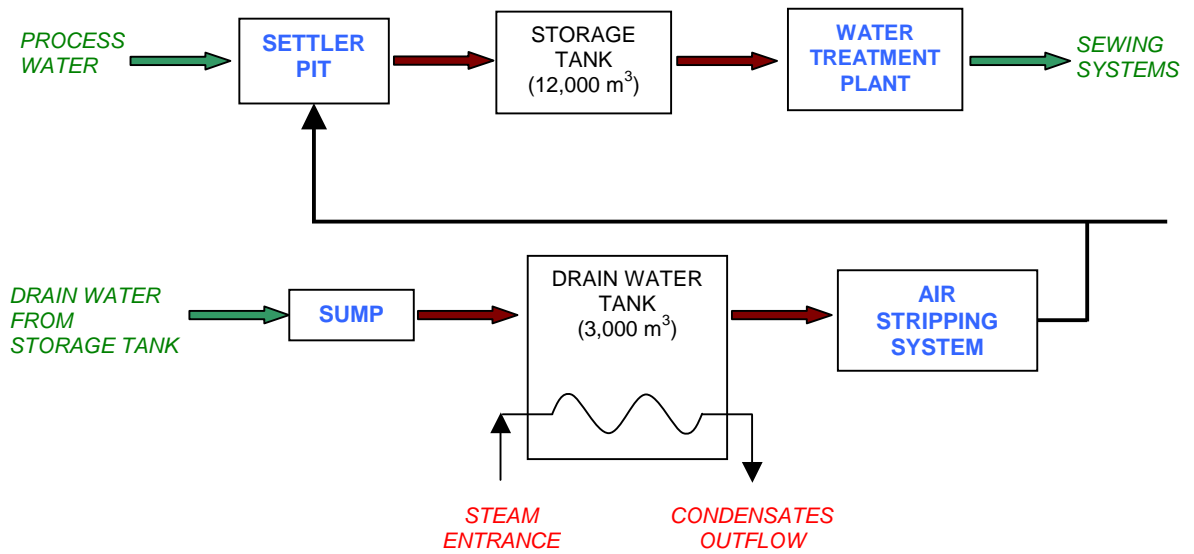
Process diagram

The figure below describes the process and the different equipments. The drain water from the storage tanks is directly sent to a sump tank by gravity and from here pumped to the drain water tank. Before joining the process water and being fed to water treatment plant, the drain water is sent to an air stripper, in order to remove the MTBE (2-methoxy 2-methylpropane). The water treatment plant is intended to remove the oil content and to enable the water to be discharged in the sewing system. Before feeding the water treatment plant, the oily waters are sent to a settler and a water storage tank.

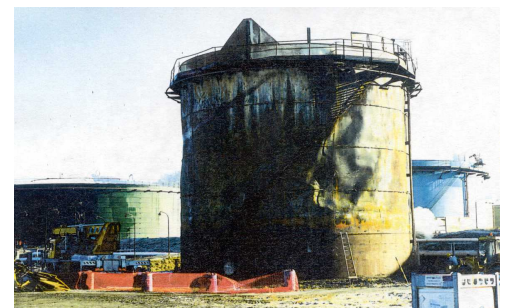
About 20 m³ of hydrocarbons are released by the safety vent of the drain water tank on the floating roof and, from here, flow through the roof draining pipe to the ground. A pool of hydrocarbons is formed near the tank. A vapour cloud is formed by the hydrocarbons evaporating from the pools on the tank roof and on the ground, reaching the neighbouring road, located about 60 metres away.

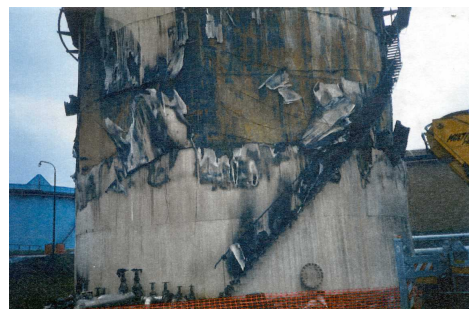
The material consequences have been more significant, due to severe damages to the drain water tank and the settler, some minor damages to a nearby building and damages to the two lorries and another vehicle.
