## Explosion in a chemical reactor

January 29, 2002

Calais – [Pas-de-Calais]

Fine chemistry  
Catalyst  
Methanol  
Washdown  
Nitrogen inerting  
Organisation

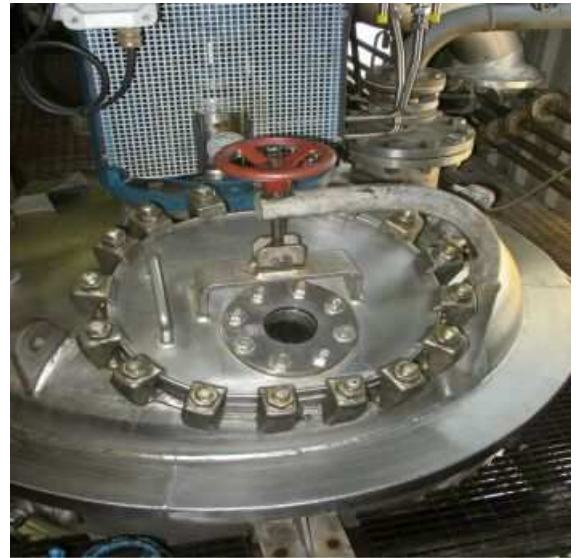
On January 29, 2002 at 6.45, an explosion occurred on R404 during the additional washdown operation that was requested during the day. A manhole had been opened to conduct the requested rinsing operation.

An operator was found lying next to reactor R404, and his face seriously burned.

The reactor and the related installations showed no signs of visible damage. The reactor's gasket had been ejected a few metres away. The reactor was immediately closed and injected with nitrogen.

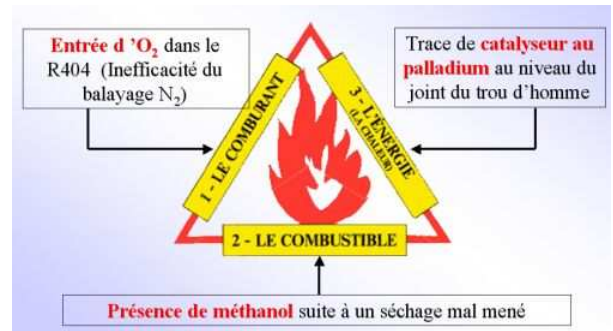
The origin of the accident was most certainly due to the sudden combustion of an explosive gaseous mixture inside the reactor.

Following what appears to be a poorly executed drying operation, traces of methanol were still present in the reactor. While evaporating, these traces lead to a concentration of vapour consistent with the explosion. Confirmed by post-accident measurements, the nitrogen bubble output only partially fulfilled its role and did not prevent oxygen from entering the reactor when the manhole was opened.

The last reaction that took place in the reactor was a hydrogenation reaction involving a Palladium catalyst, which is a substance that spontaneously ignites in contact with the oxygen in the air when it is dry. The presence of traces of this catalyst in the reactor is suspected, particularly around the reactor seal.

The combination of these 3 elements (Combustible – Oxidant - Energy) lead to the explosion.

- ✓ Implementation of a specific washdown procedure of the gasket specific to reactor R404,
- ✓ Modification of the nitrogen system, with increased output for the manhole opening and a nitrogen presence indicator,
- ✓ New written instructions and procedures displayed at the workstation,
- ✓ End of sequence by use of distilled water to clean the reactors following a reaction implementing a pyrophoric catalyser,
- ✓ A new awareness campaign among the personnel concerning the importance of the inerting operation and the strict respect for strict adherence to instructions (completion of operating logs and reactor drying procedures),
- ✓ New explosive atmosphere training for all operators.
