# Fire and explosions at a fireworks storage depot

6 march 2002

Carmel

Western australia

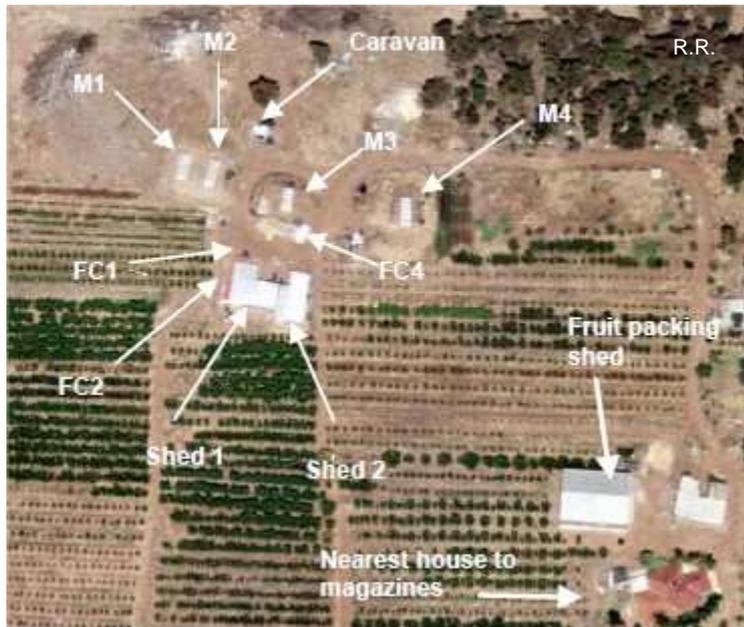
View of the storage facility - FC3 is located inside shed n2 [1]

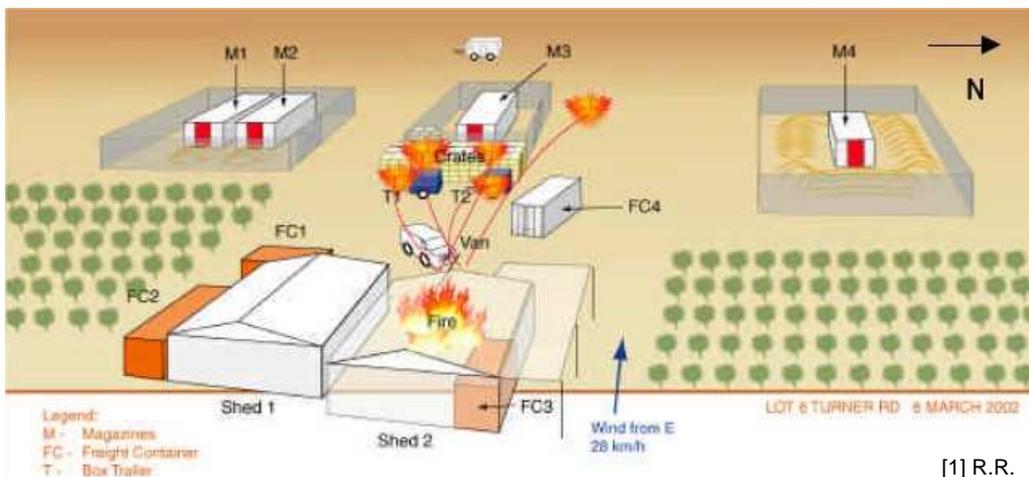
At 8h45, an operator placed a ground pack on one wooden work bench and the firework piece ignited ; the first shot initiated the 25 shots in the entire pack. Burning stars hit the roof and walls of the shed and fired in all directions, initiating other fireworks inside shed 2.

The operators ran outside for shelter, thick grey smoke could be seen emanating from shed 2 and the fire spread to FC4, box trailers, bushes...

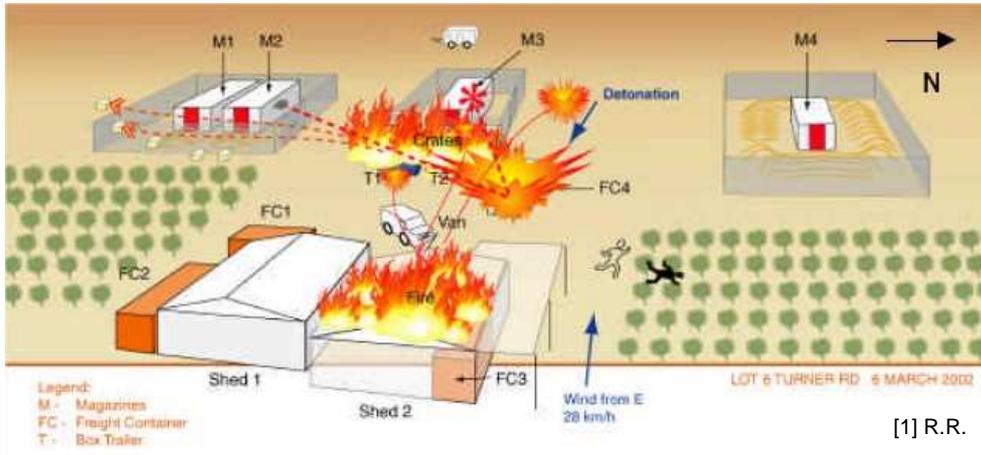
At 8h52, FC 4 exploded, knocking one of the employee to the ground (not injured). Pieces of the container pierced the walls of M2 and M3, causing fires.

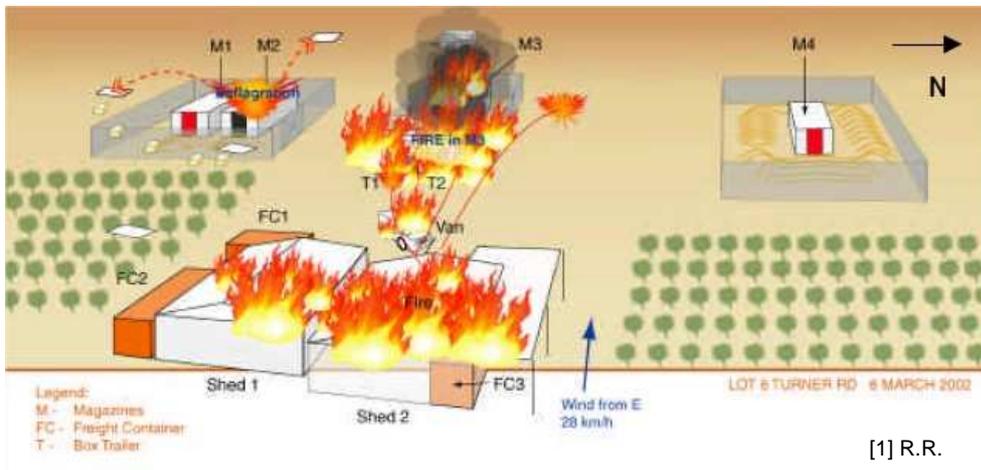
At 8h56, Magazine M2 “opened”, Shed 1 and M3 started burning.

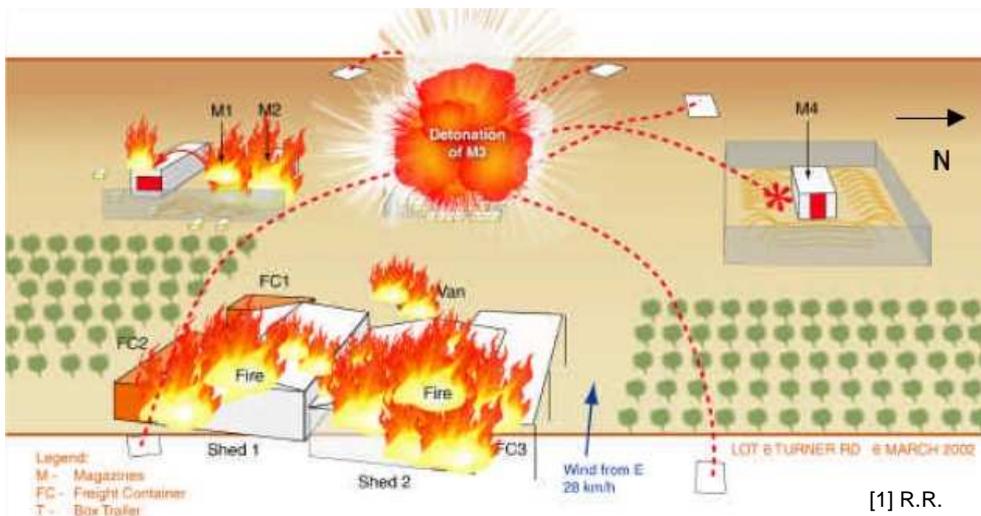
Finally, at 9h06, the M3 storage exploded violently with a 100 m fireball, spreading pieces of metal up to 510 m. The door of M3 (170 kg) was found 370 m away, the roof (380 kg) 295 m away in the opposite direction.

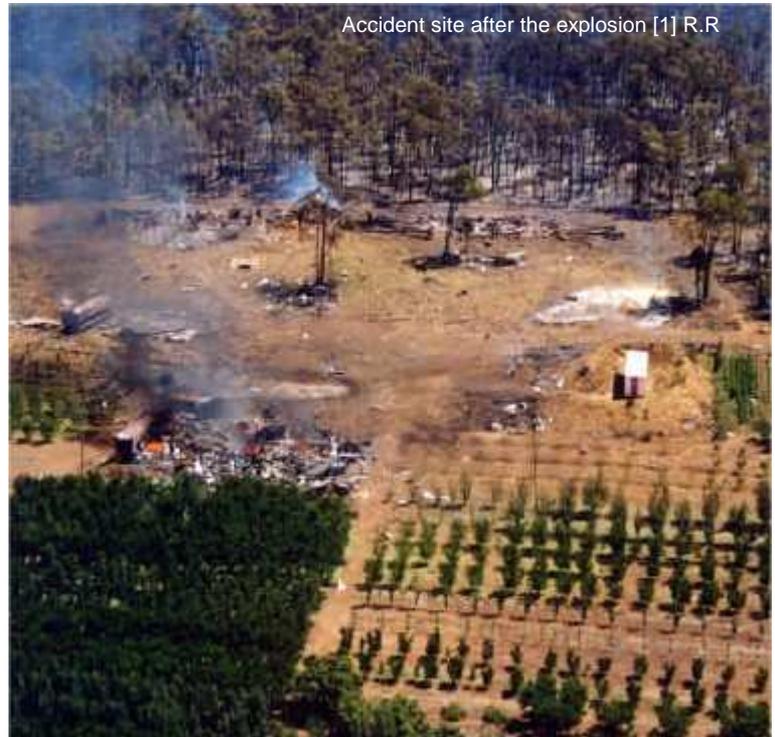
Accident site after the explosion [1] R.R

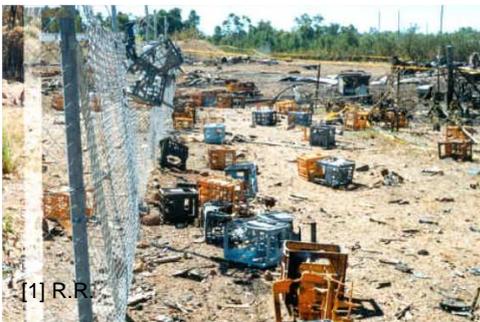
crates in front of the M1/M2 fence.

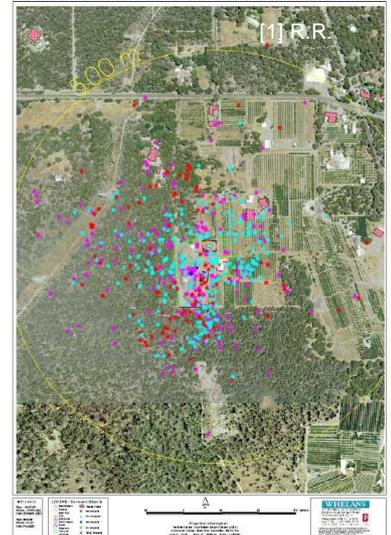
survey of the shrapnel from FC4 (light blue), M2 (dark blue) and M3 (red)

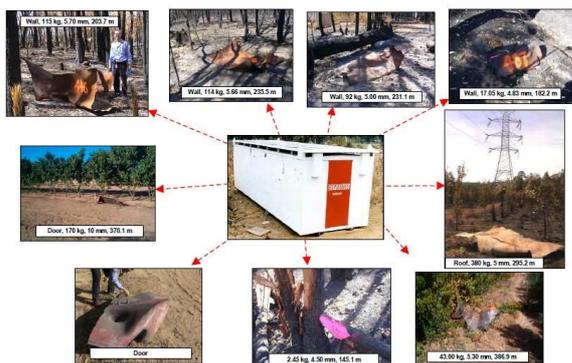
The mass explosion of M3 can be explained by its content : 200-300 mm shells, cartons of 75 mm salutes... that are nowadays classified as UN 1.1 exhibiting a mass explosion behaviour.

Left : metal scrap from M3 that mass detonated [1] - R.R
