Hydrocarbon leak on a pipeline

18 September 2001 and 09 February 2002

Lucciana – [Haute-Corse]
France

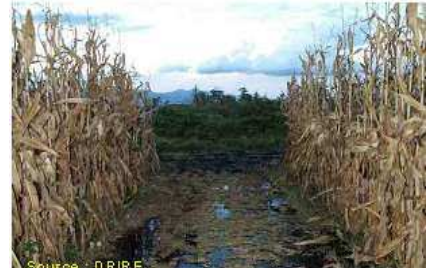
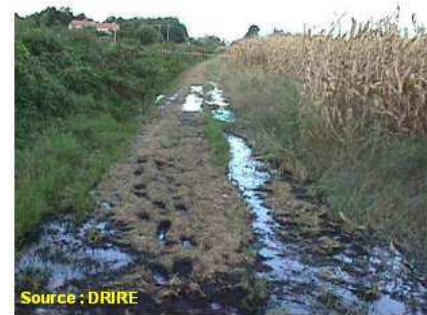
Heavy fuel was noticed approximately 600 meters from the hydrocarbon depot, in a corn field along the departmental highway, along the pipeline route.

- × Soil pollution by heavy fuel in top soil,
- × Soil pollution by light fuel (FOL) limited to underground sandy areas; this pollution was contained in the sandy layers by the massive presence of compact peat,
- × Occasional pollution of the underground water table in a restricted sector likely to migrate.
