# Butadiene leak in a petrochemical unit

## December 14th , 2000

### Lavéra – [Bouches-du-Rhône]

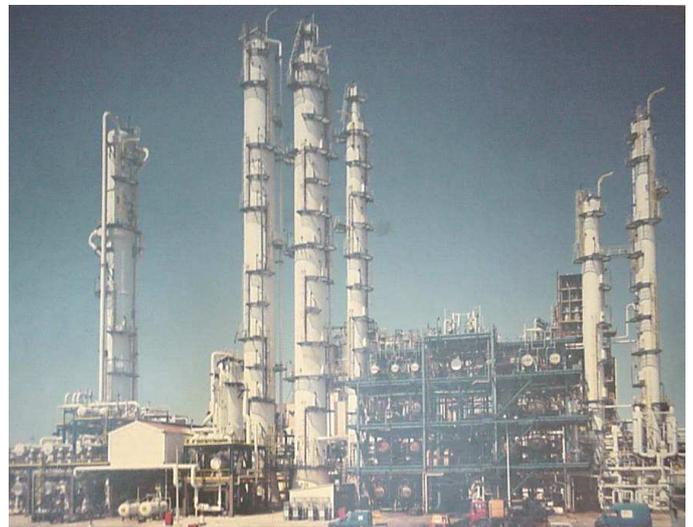
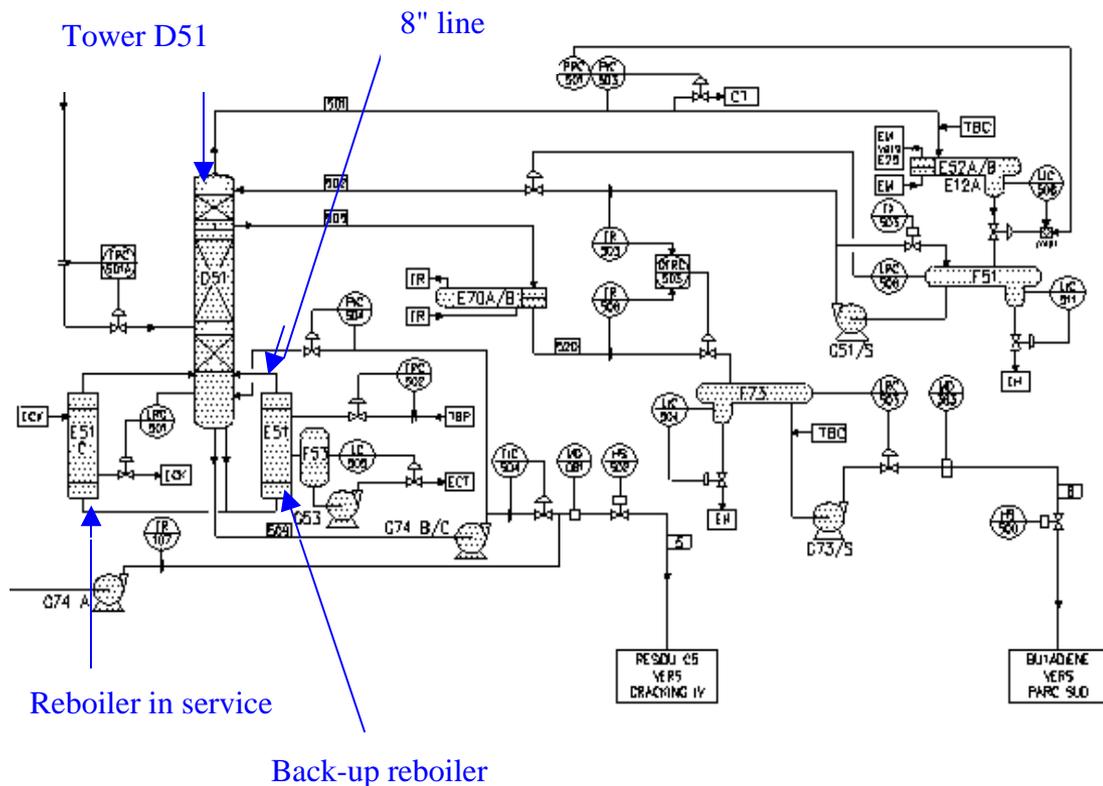
The butadiene distillation section consists mainly of a tower D51, a reflux vessel F51 and two reboilers E51 and E51C, only one of which functions in normal operation. The back-up reboiler (E51) is connected to tower D51 via a line which includes a branch connection leading to this reboiler's safety valve via an 8" pipe.

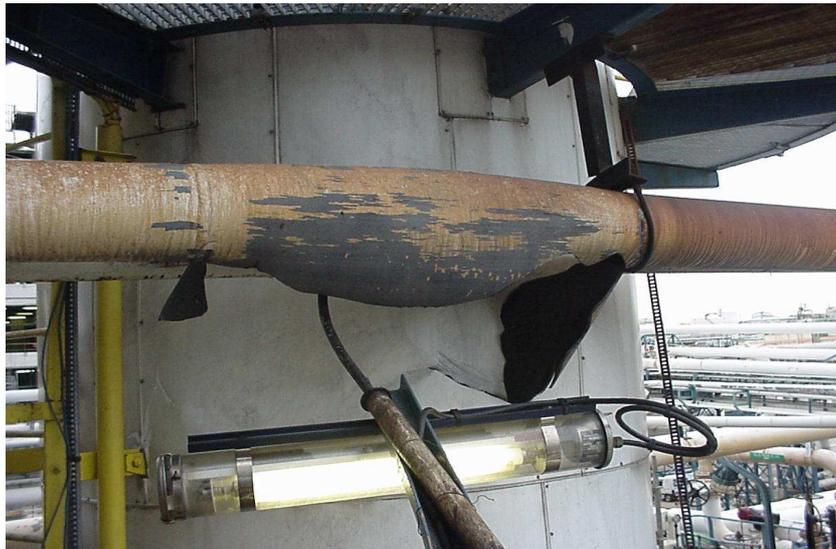
The origin of the accident is attributed to the design of the supply line of the reboiler's valve which formed a dead branch in which the gaseous butadiene accumulated, polymerising in an anarchic manner without being able to exit due to the inverse slope.

The pipe ruptured under the pressure generated by the formation of polymer in the dead branch (referred to as "popcorn"). The pipe was opened like a tulip over approximately 1 meter along the lower generatrix.

- The dead branch which caused the accident was removed. The slope of this line was modified in order to prevent "popcorn" from accumulating in the future. This line is now vertical. The same is true for the pipe of the same type on the other reboiler and the reflux vessel. For this reason, the valves of the devices were brought closer together.
- All the manholes on the fractionating tower were equipped with a internal solid plug and an external solid plug. To prevent the formation of popcorn, the space between these two plugs must be purged every 2 weeks.
- The inlet lines of main valves on the fractionating tower (D51) and scrubber (D24) were modified with a branch connection separated by a valve.
